PORT OF CORPUS CHRISTI AUTHORITY

SOUNDINGS  
CARGO DOCK 16

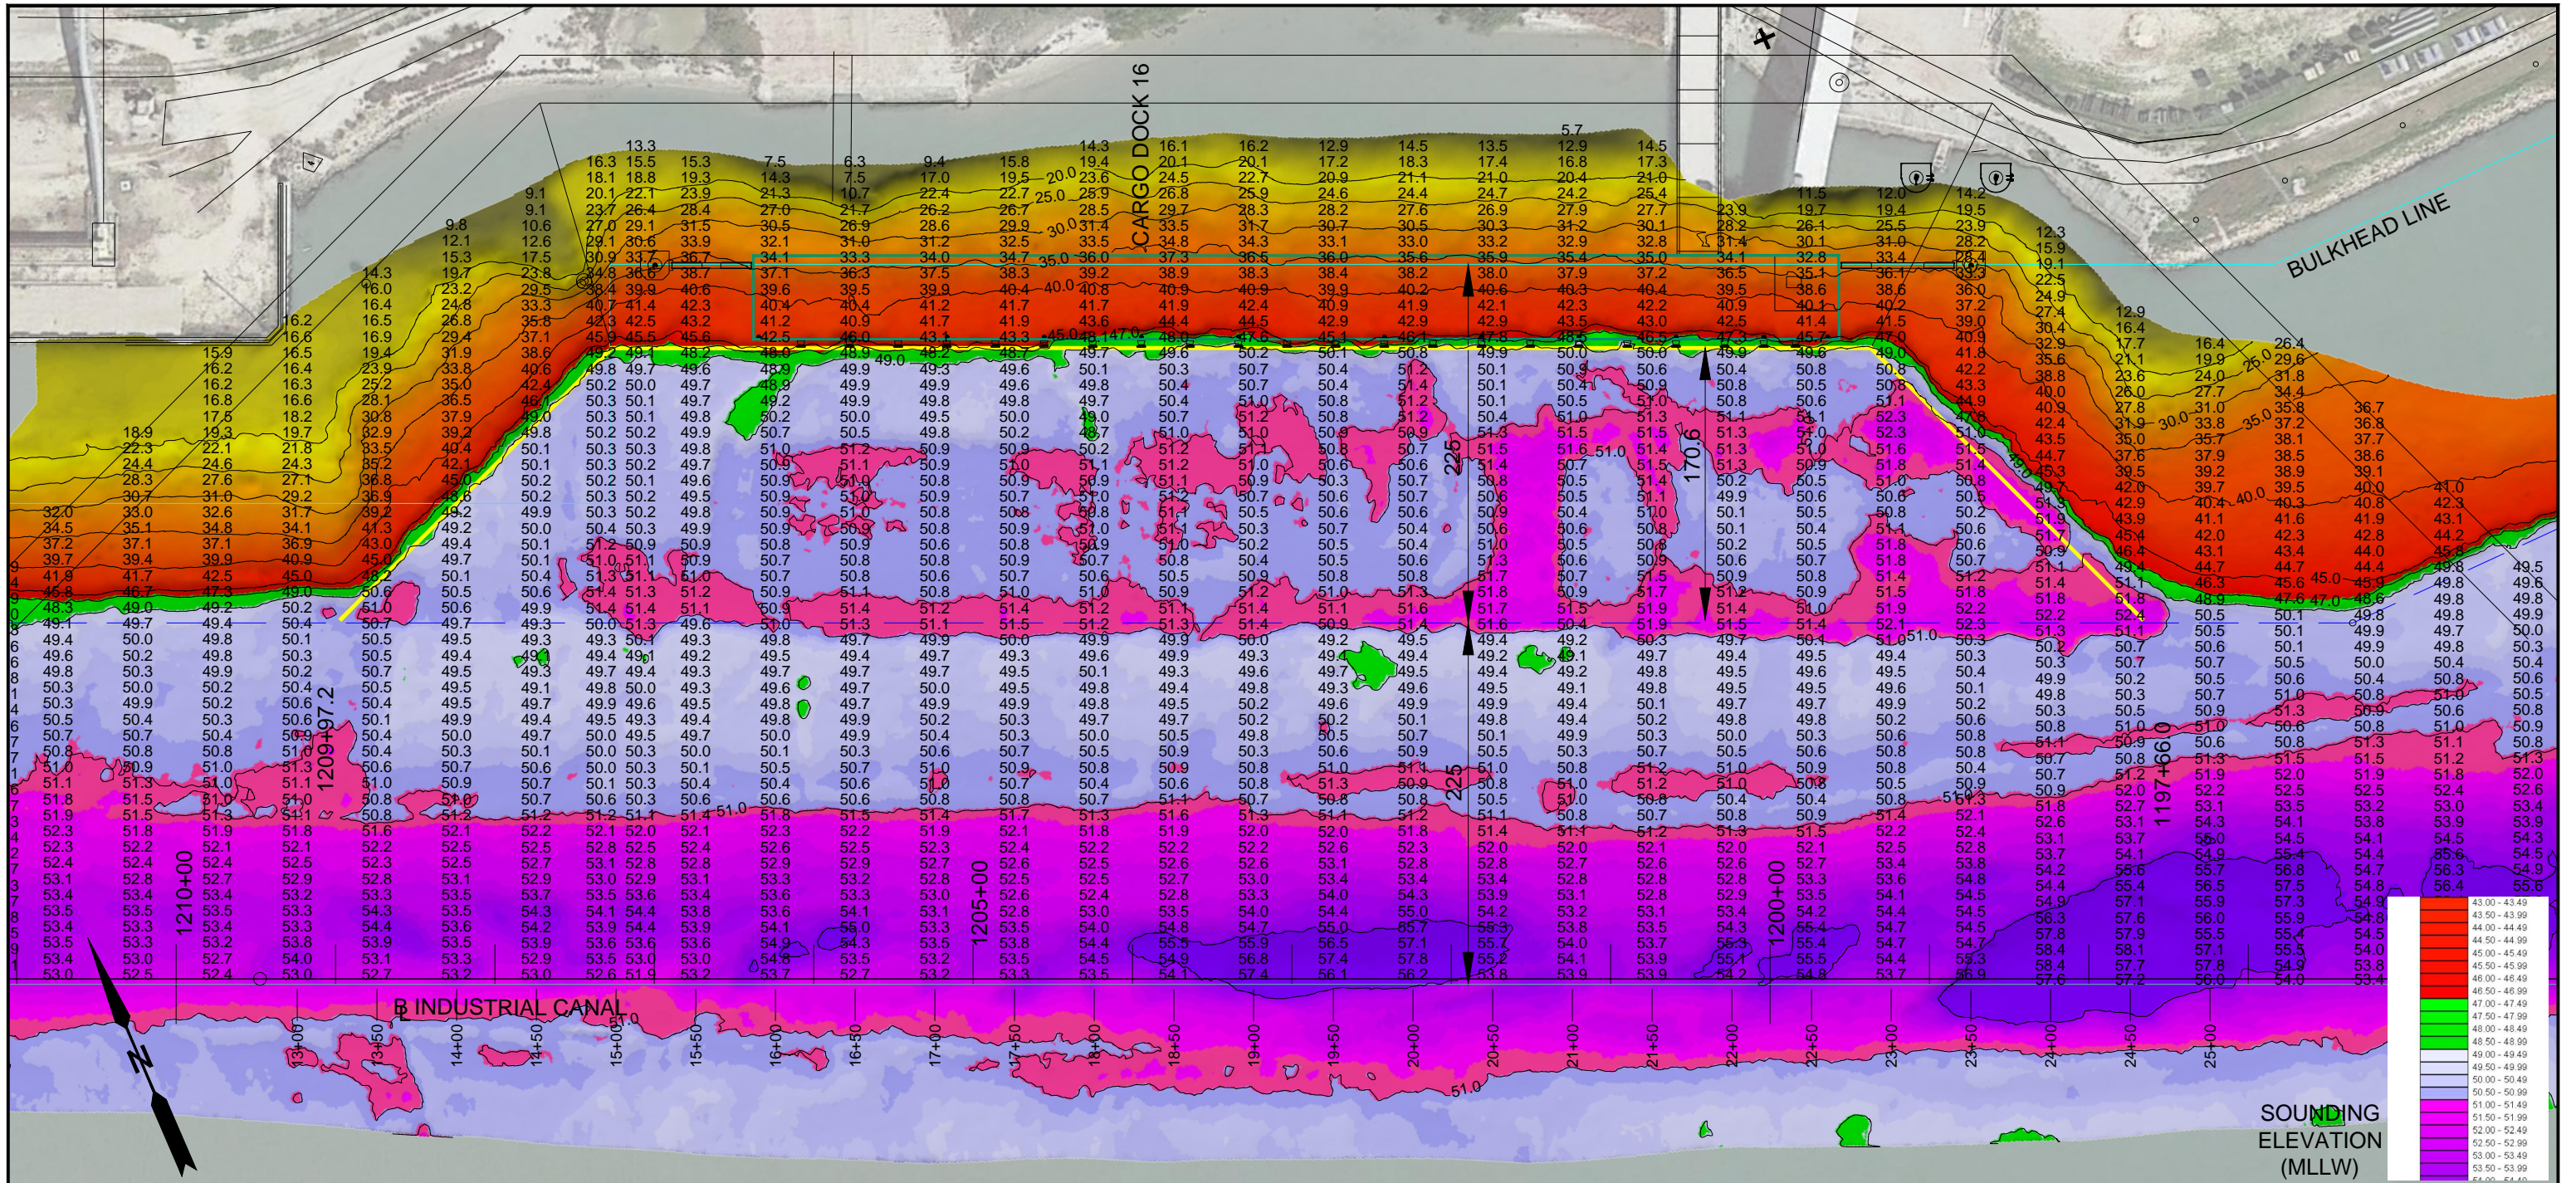
PLAN

1. SOUNDINGS WERE RECORDED BY T. BAKER SMITH ON 18 OCTOBER, 2021. SEA FLOOR CONDITIONS ARE SUBJECT TO CHANGE.
2. THE PORT OF CORPUS CHRISTI ASSUMES NO LIABILITY FOR THE ACCURACY OF THIS INFORMATION. THE INFORMATION DEPICTED ON THIS MAP REPRESENTS THE RESULTS OF SURVEYS MADE ON THE DATE DEPICTED AND CAN ONLY BE CONSIDERED AS INDICATING THE GENERAL CONDITIONS AT THAT TIME. THESE CONDITIONS ARE SUBJECT TO RAPID CHANGE DUE TO SHOALING EVENTS.
3. ALL READINGS ARE BASED ON THE NATIONAL OCEANIC AND ATMOSPHERIC ADMINISTRATION (NOAA) MEAN LOWER LOW WATER (MLLW) DATUM, (O.O')
4. ORIZONTAL DATUM: NAD-83, STATE PLANE, TEXAS SOUTH ZONE, US FEET.
5. TO GET THE DEPTH OF WATER, ADD THE CURRENT TIDE LEVEL TO THEREADINGS SHOWN. (SEE TIDE DATUM CHART).
