DATE: 03/26/2026 JOB NO: 2026.0151

DRAWING NAME: BULK DOCK 1_18FEB2026

PORT OF CORPUS CHRISTI AUTHORITY

BULK DOCK 1
2026-Q1
AN EXHIBIT OF A
BATHYMETRIC SURVEY
LOCATED IN
CORPUS CHRISTI, TEXAS

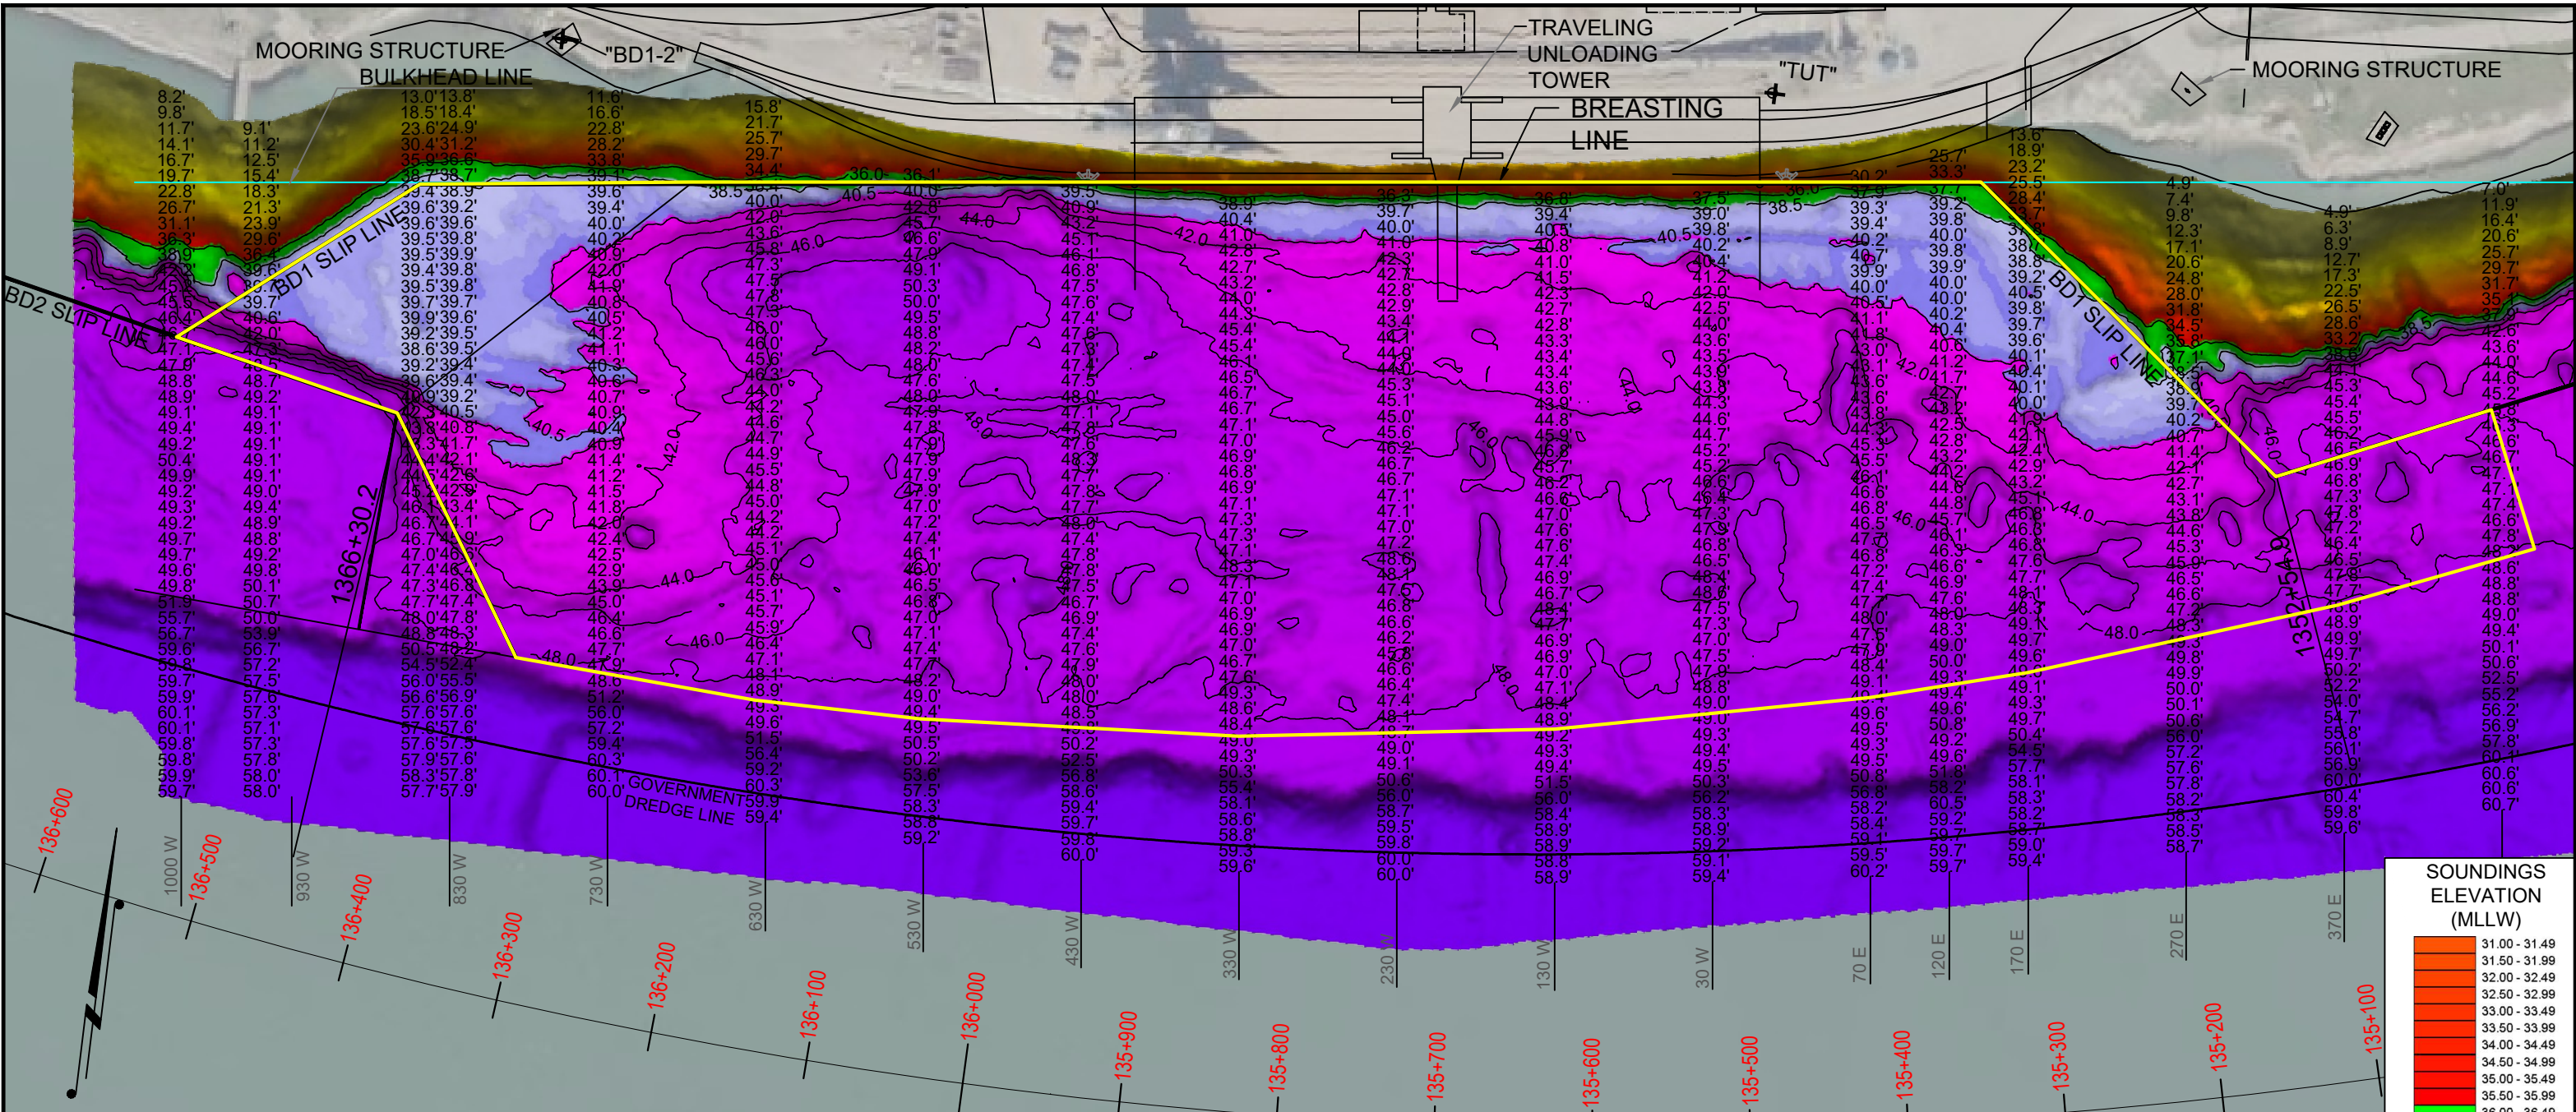
SHEET NO: 1 OF 1

- NOTES:**
- VESSEL LENGTH LIMIT IS 835 FEET.
 - SOUNDINGS WERE RECORDED BY T BAKER SMITH ON 18 FEBRUARY, 2026. SEA FLOOR CONDITIONS ARE SUBJECT TO CHANGE.
 - THE PORT OF CORPUS CHRISTI ASSUMES NO LIABILITY FOR THE ACCURACY OF THIS INFORMATION. THE INFORMATION DEPICTED ON THIS MAP REPRESENTS THE RESULTS OF SURVEYS MADE ON THE DATE DEPICTED AND CAN ONLY BE CONSIDERED AS INDICATING THE GENERAL CONDITIONS AT THAT TIME. THESE CONDITIONS ARE SUBJECT TO RAPID CHANGE DUE TO SHOALING EVENTS.
 - ALL READINGS ARE BASED ON THE NATIONAL OCEANIC AND ATMOSPHERIC ADMINISTRATION (NOAA) MEAN LOWER LOW WATER (MLLW) DATUM, (O.O')
 - HORIZONTAL DATUM: NAD-83, STATE PLANE, TEXAS SOUTH ZONE, US FEET.
 - TO GET THE DEPTH OF WATER, ADD THE CURRENT TIDE LEVEL TO THE READINGS SHOWN. (SEE TIDE DATUM CHART).

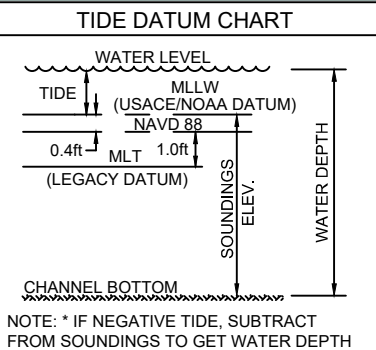
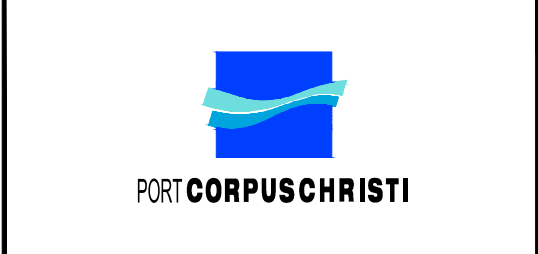
POINT	NORTHING	EASTING	DESCRIPTION
1	17187524.2	1319937.5	pile face
2	17187528.2	1319967.2	dock corner
3	17187574.9	1320360.2	dock corner
4	17187576.7	1320376.8	pile face
