DRAWN BY:	MMC	APPROVED BY:	AWK
DATE:	11/06/2023	JOB NO:	2023.0091
DRAWING NAME: BULK DOCK 1 1NOV2023			
PROJECTION: TEXAS STATE PLANE SOUTH ZONE GEO. DATUM: NAD83 (2011) VERT. DATUM: NAVD88 GRID UNITS: US SURVEY FEET			
SHEET NO:	1	OF	1

PORT OF CORPUS CHRISTI AUTHORITY
BULK DOCK 1
SOUNDINGS
AN EXHIBIT OF A
BATHYMETRIC SURVEY
LOCATED IN
CORPUS CHRISTI, TEXAS

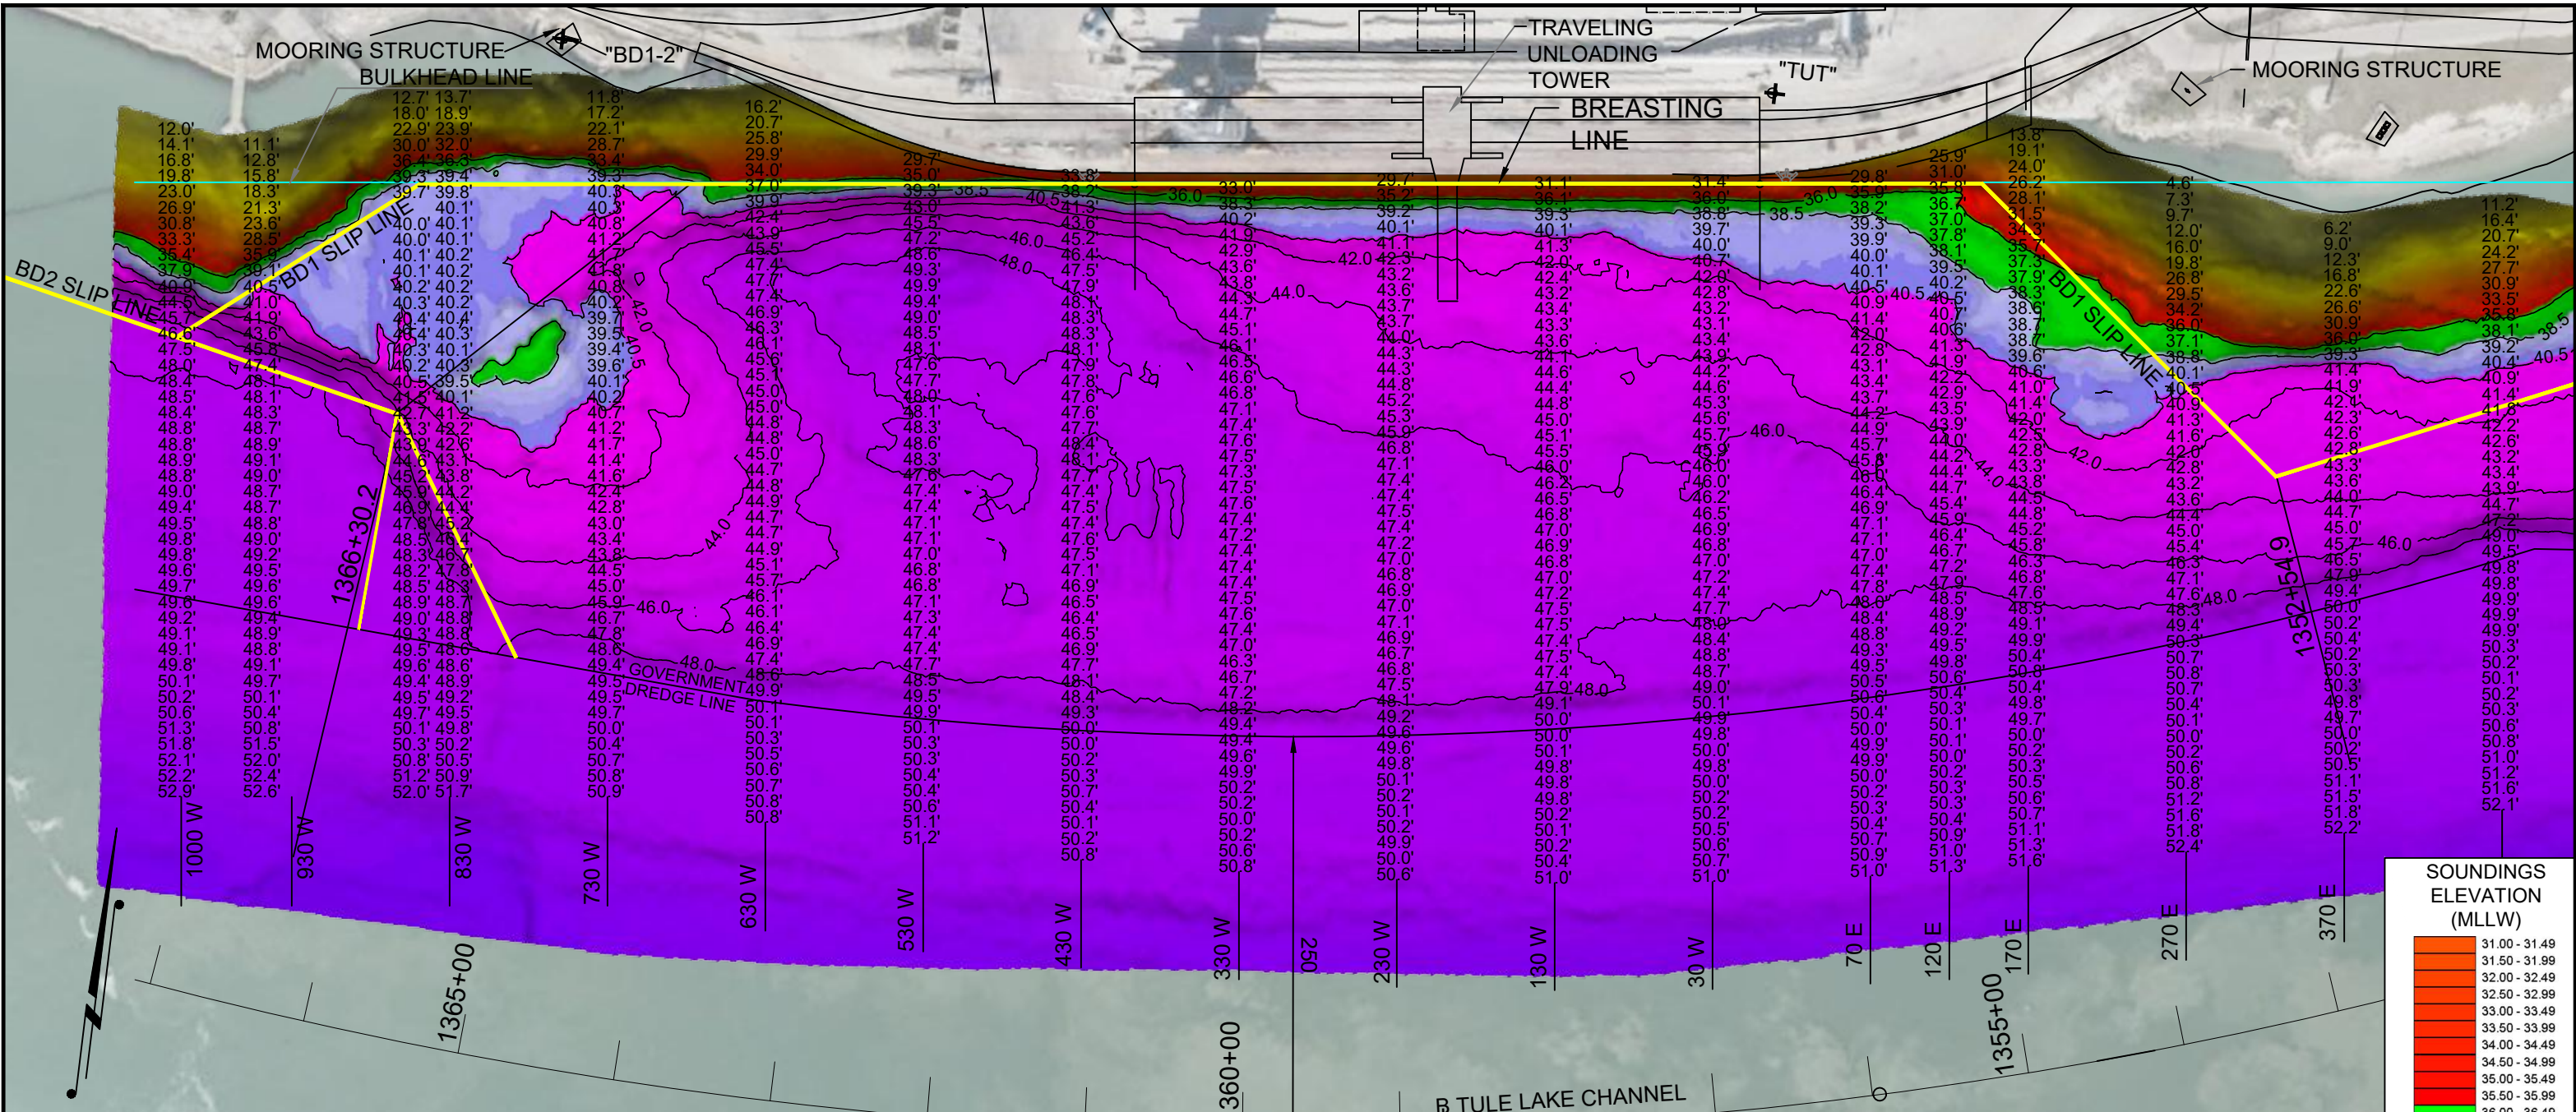
- VESSEL LENGTH LIMIT IS 835 FEET.
- SOUNDINGS WERE RECORDED BY T BAKER SMITH ON 1 NOVEMBER, 2023. SEA FLOOR CONDITIONS ARE SUBJECT TO CHANGE.
- THE PORT OF CORPUS CHRISTI ASSUMES NO LIABILITY FOR THE ACCURACY OF THIS INFORMATION. THE INFORMATION DEPICTED ON THIS MAP REPRESENTS THE RESULTS OF SURVEYS MADE ON THE DATE DEPICTED AND CAN ONLY BE CONSIDERED AS INDICATING THE GENERAL CONDITIONS AT THAT TIME. THESE CONDITIONS ARE SUBJECT TO RAPID CHANGE DUE TO SHOALING EVENTS.
- ALL READINGS ARE BASED ON THE NATIONAL OCEANIC AND ATMOSPHERIC ADMINISTRATION (NOAA) MEAN LOWER LOW WATER (MLLW) DATUM, (O.O')
- HORIZONTAL DATUM: NAD-83, STATE PLANE, TEXAS SOUTH ZONE, US FEET.
- TO GET THE DEPTH OF WATER, ADD THE CURRENT TIDE LEVEL TO THE READINGS SHOWN. (SEE TIDE DATUM CHART).
