DATE: 06/24/2024    JOB NO: 2024.0287

DRAWING NAME: BULK\_DOCK\_1\_AD\_23JUNE2024

**PORT OF CORPUS CHRISTI AUTHORITY**

**BULK DOCK 1**  
SOUNDINGS  
AN EXHIBIT OF A  
BATHYMETRIC SURVEY  
LOCATED IN  
CORPUS CHRISTI, TEXAS

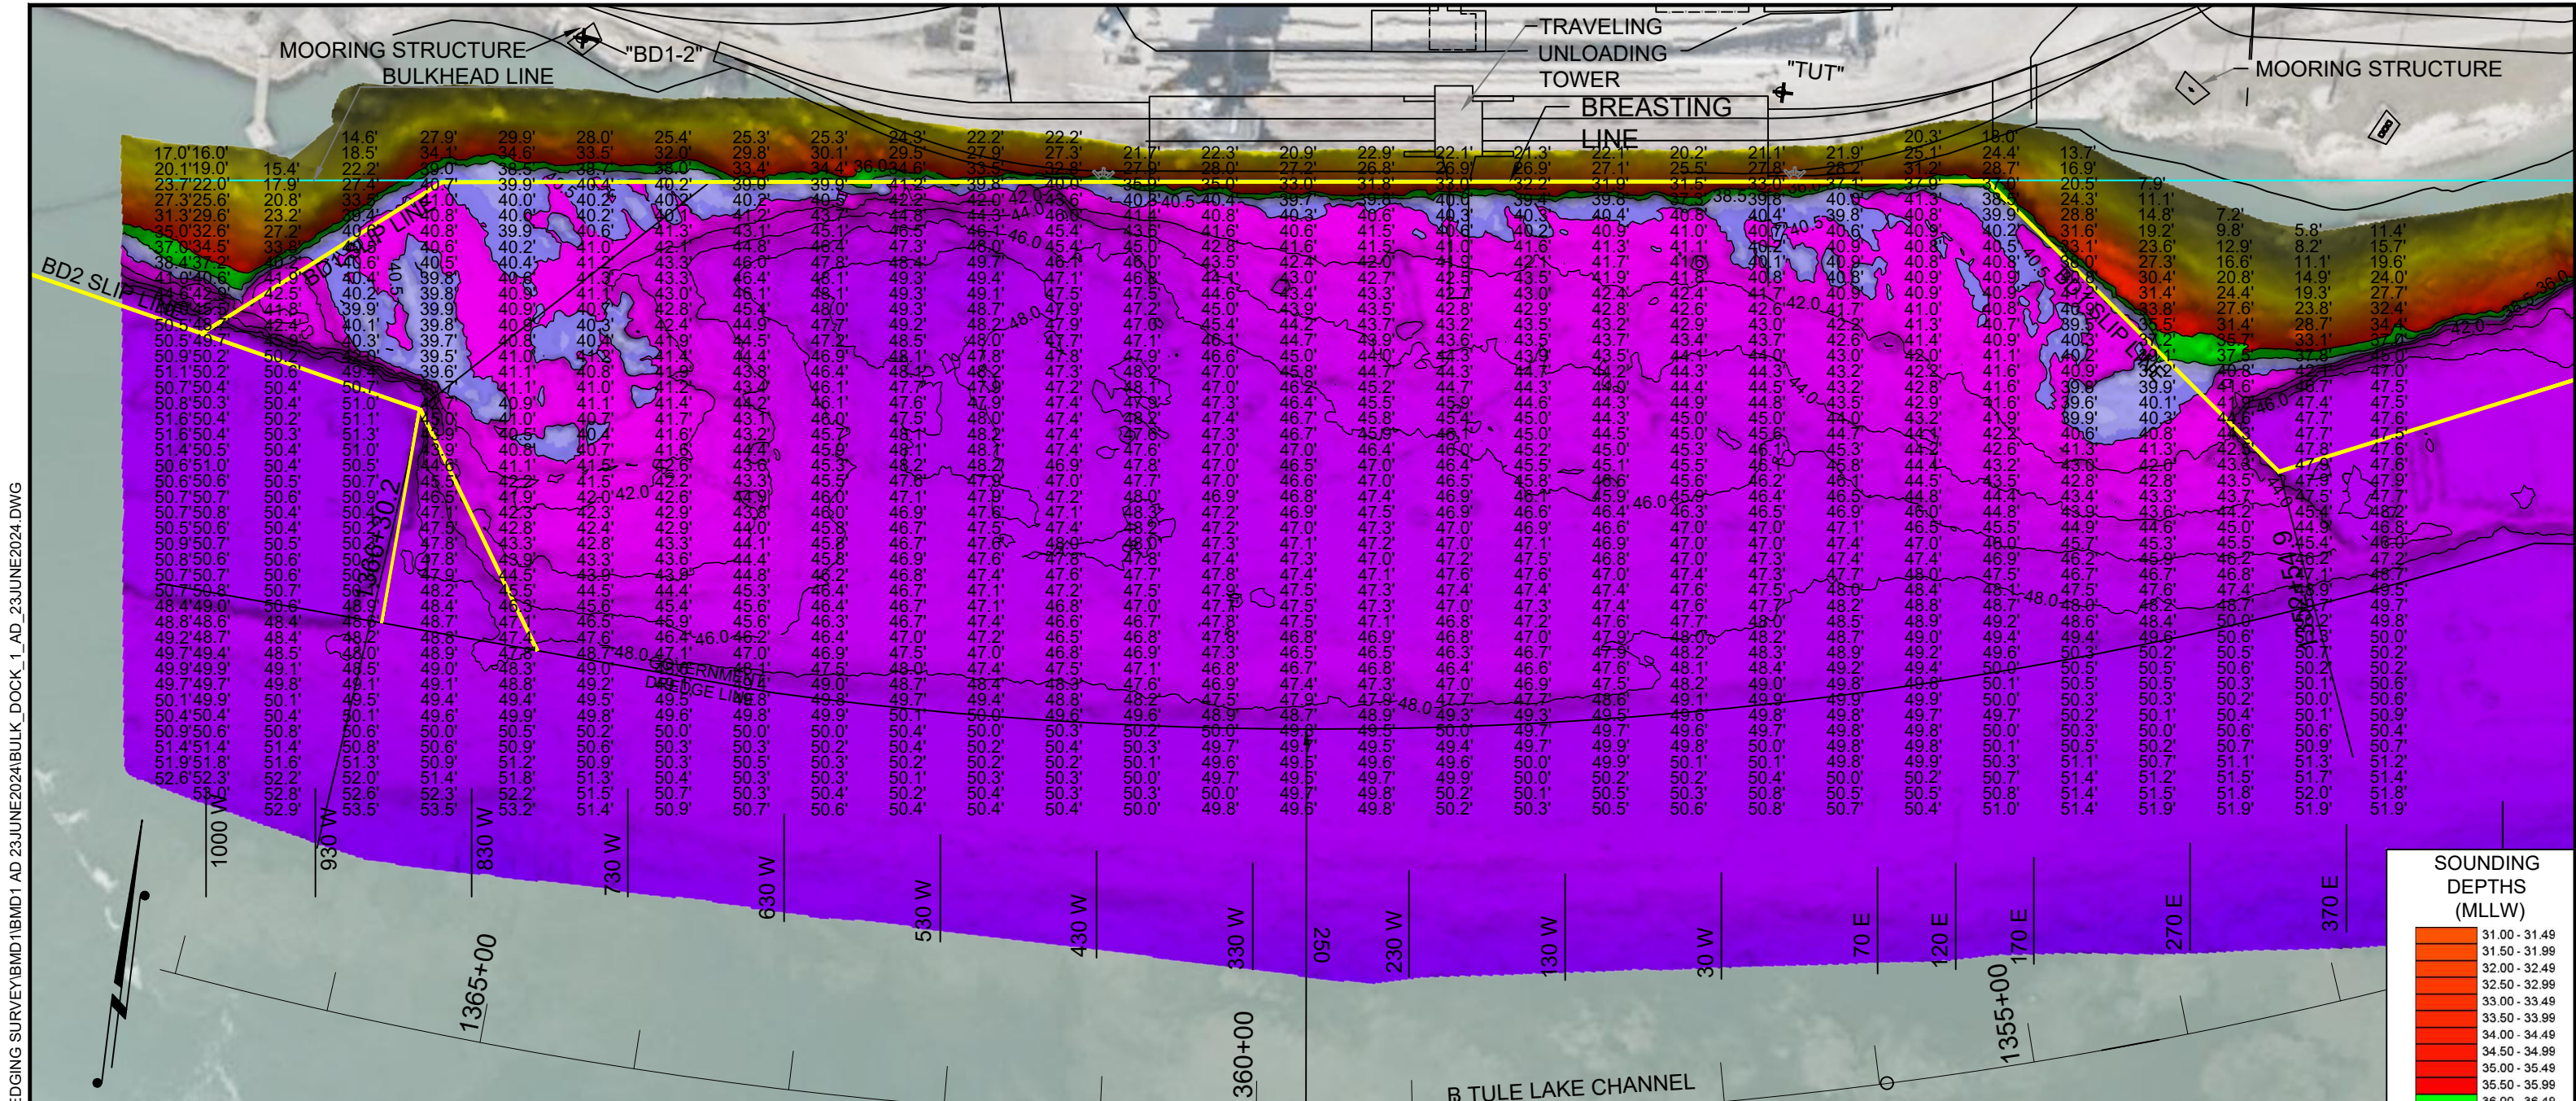
SHEET NO: 1 OF 1

- NOTES:**
- VESSEL LENGTH LIMIT IS 835 FEET.
  - SOUNDINGS WERE RECORDED BY T BAKER SMITH ON 23 JUNE, 2024. SEA FLOOR CONDITIONS ARE SUBJECT TO CHANGE.
  - THE PORT OF CORPUS CHRISTI ASSUMES NO LIABILITY FOR THE ACCURACY OF THIS INFORMATION. THE INFORMATION DEPICTED ON THIS MAP REPRESENTS THE RESULTS OF SURVEYS MADE ON THE DATE DEPICTED AND CAN ONLY BE CONSIDERED AS INDICATING THE GENERAL CONDITIONS AT THAT TIME. THESE CONDITIONS ARE SUBJECT TO RAPID CHANGE DUE TO SHOALING EVENTS.
  - ALL READINGS ARE BASED ON THE NATIONAL OCEANIC AND ATMOSPHERIC ADMINISTRATION (NOAA) MEAN LOWER LOW WATER (MLLW) DATUM, (O.O')
  - HORIZONTAL DATUM: NAD-83, STATE PLANE, TEXAS SOUTH ZONE, US FEET.
  - TO GET THE DEPTH OF WATER, ADD THE CURRENT TIDE LEVEL TO THE READINGS SHOWN. (SEE TIDE DATUM CHART).
