DRAWING NAME: CARGO DOCK 1-2 18MAY2023

**PORT OF CORPUS CHRISTI AUTHORITY**

**CARGO DOCK 1 & 2**  
SOUNDINGS  
AN EXHIBIT OF A  
BATHYMETRIC SURVEY  
LOCATED IN  
CORPUS CHRISTI, TEXAS

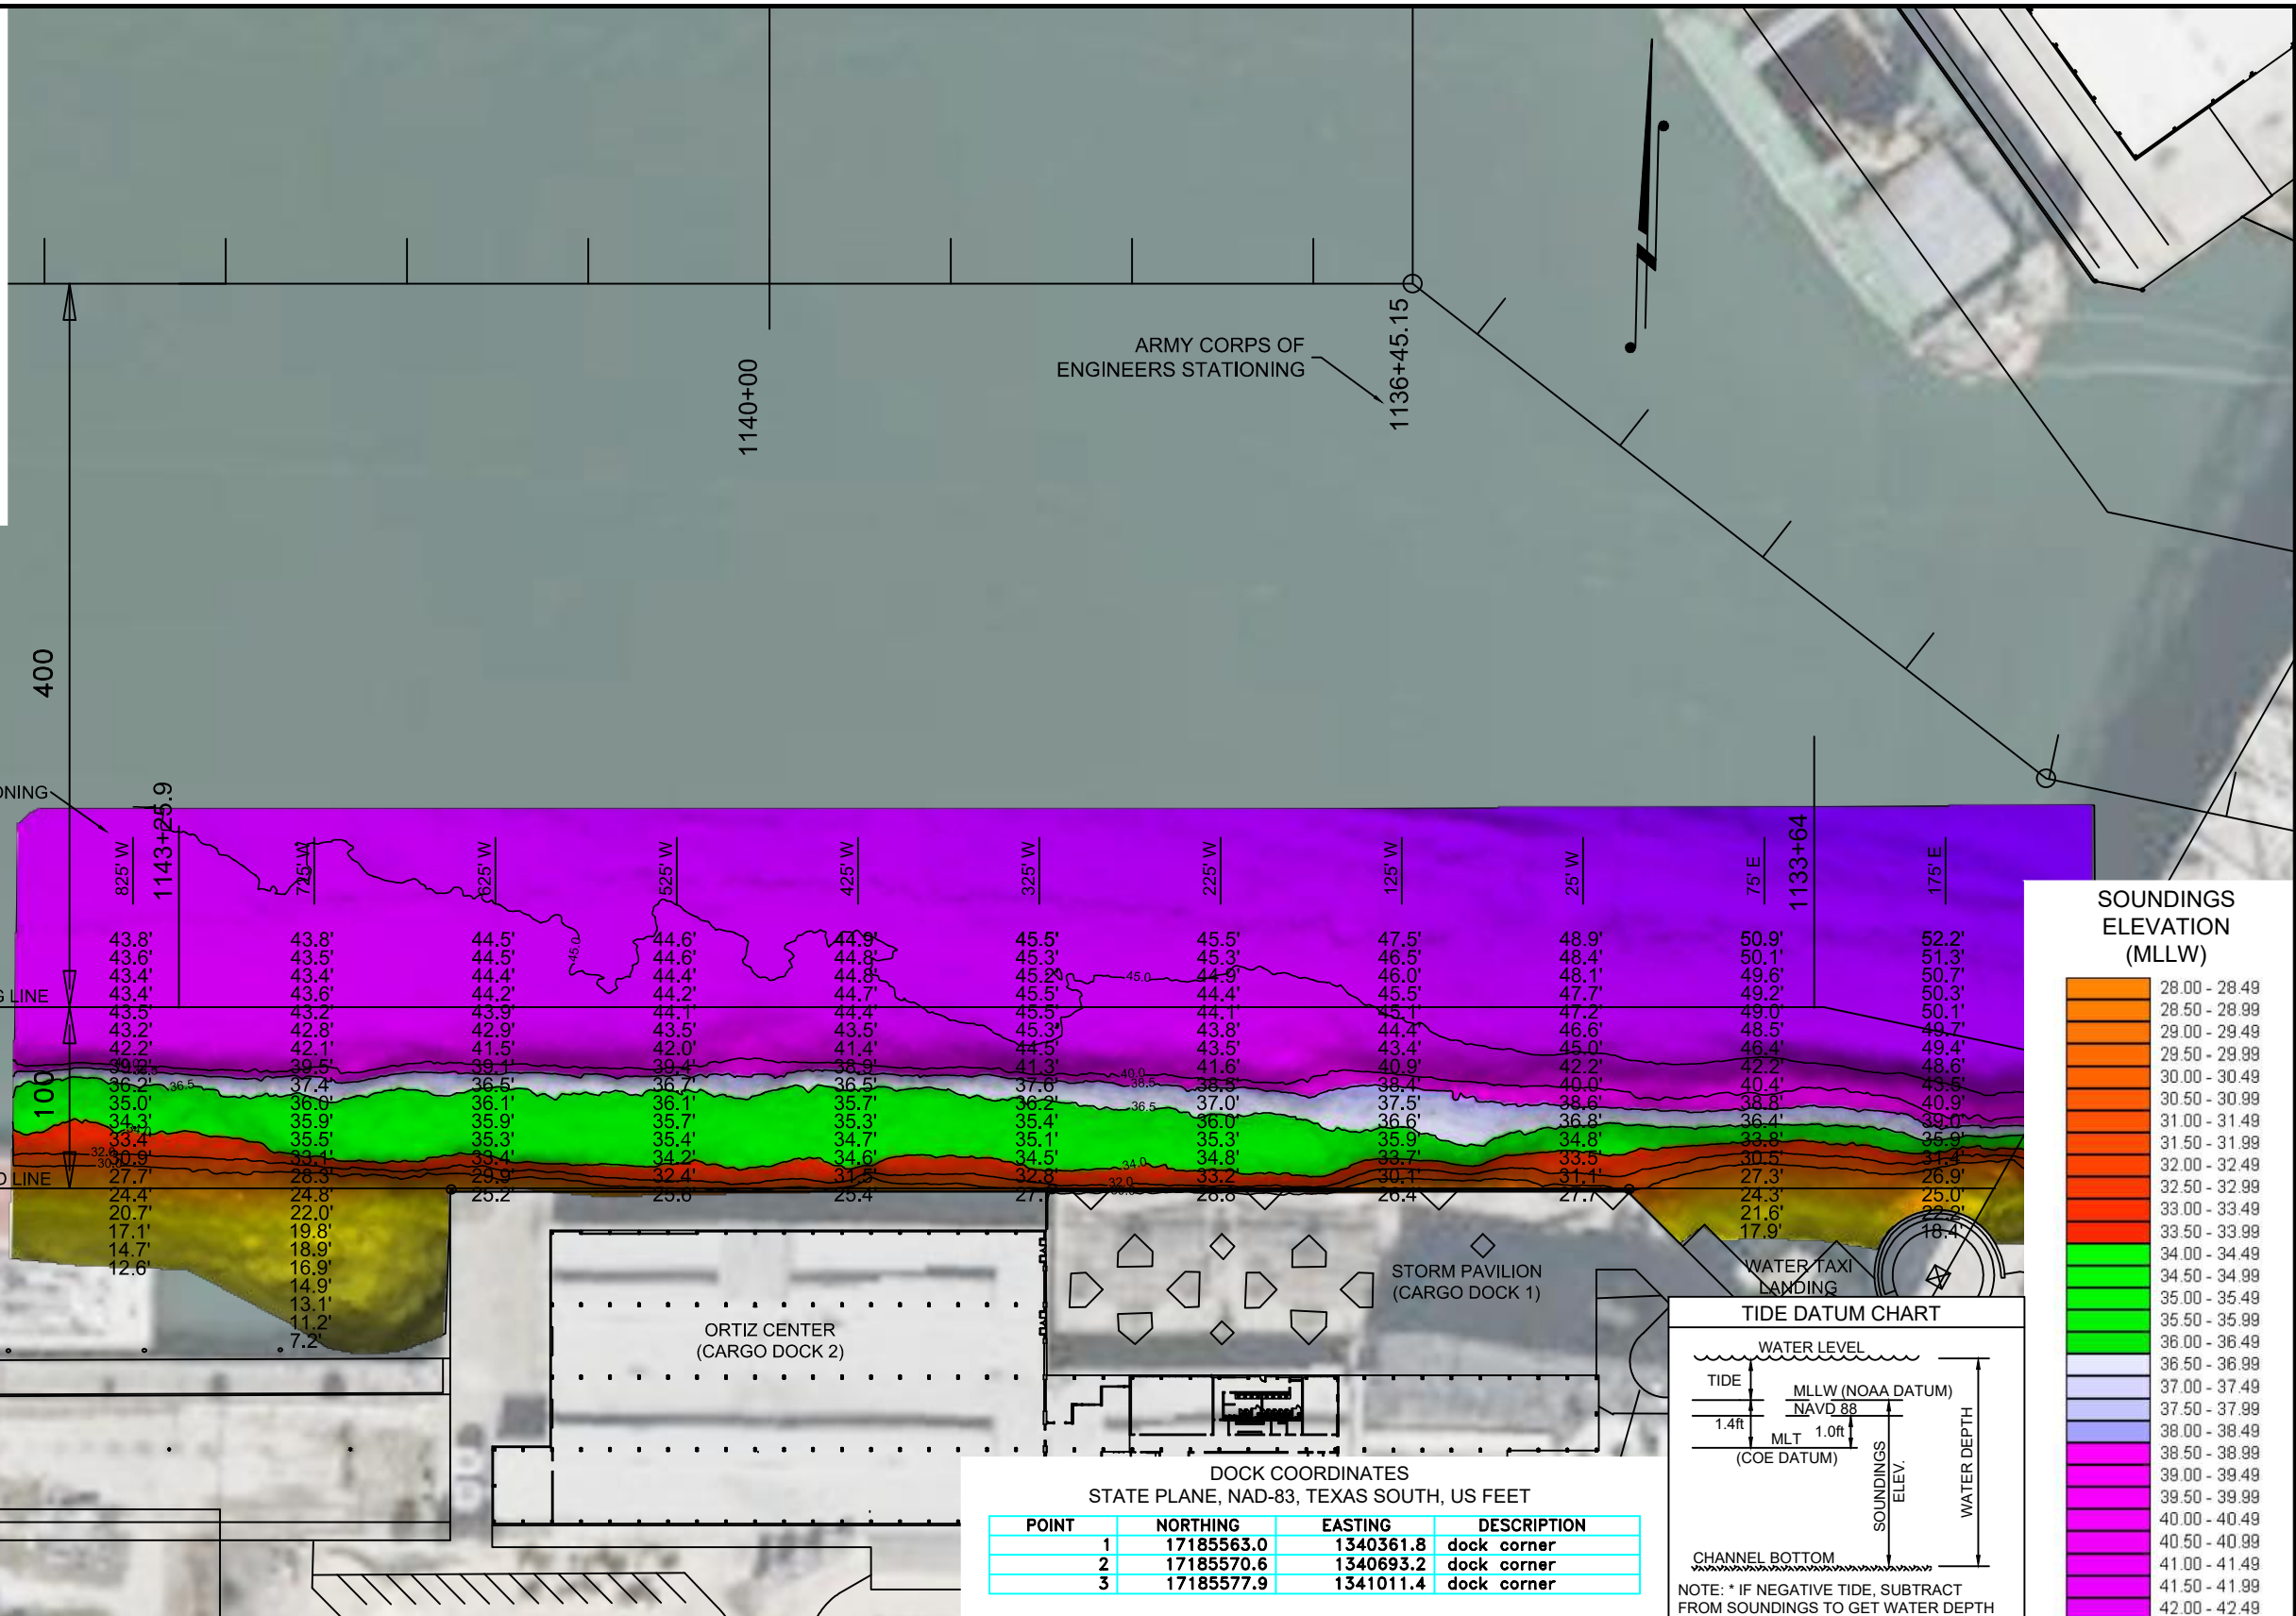
- NOTES:**
1. VESSEL LENGTH LIMIT IS 350 FEET OR MORE IF ADJACENT BERTHS ARE UNOCCUPIED.
  2. SOUNDINGS WERE RECORDED BY T BAKER SMITH ON 18 MAY, 2023. SEA FLOOR CONDITIONS ARE SUBJECT TO CHANGE.
  3. THE PORT OF CORPUS CHRISTI ASSUMES NO LIABILITY FOR THE ACCURACY OF THIS INFORMATION. THE INFORMATION DEPICTED ON THIS MAP REPRESENTS THE RESULTS OF SURVEYS MADE ON THE DATE DEPICTED AND CAN ONLY BE CONSIDERED AS INDICATING THE GENERAL CONDITIONS AT THAT TIME. THESE CONDITIONS ARE SUBJECT TO RAPID CHANGE DUE TO SHOALING EVENTS.
  4. ALL READINGS ARE BASED ON THE NATIONAL OCEANIC AND ATMOSPHERIC ADMINISTRATION (NOAA) MEAN LOWER LOW WATER (MLLW) DATUM, (0.0')
  5. HORIZONTAL DATUM: NAD-83, STATE PLANE, TEXAS SOUTH ZONE, US FEET.
  6. TO GET THE DEPTH OF WATER, ADD THE CURRENT TIDE LEVEL TO THE READINGS SHOWN. (SEE TIDE DATUM CHART).
