PORT OF CORPUS CHRISTI AUTHORITY

CARGO DOCK 1 & 2

SOUNDINGS

BATHYMETRIC SURVEY

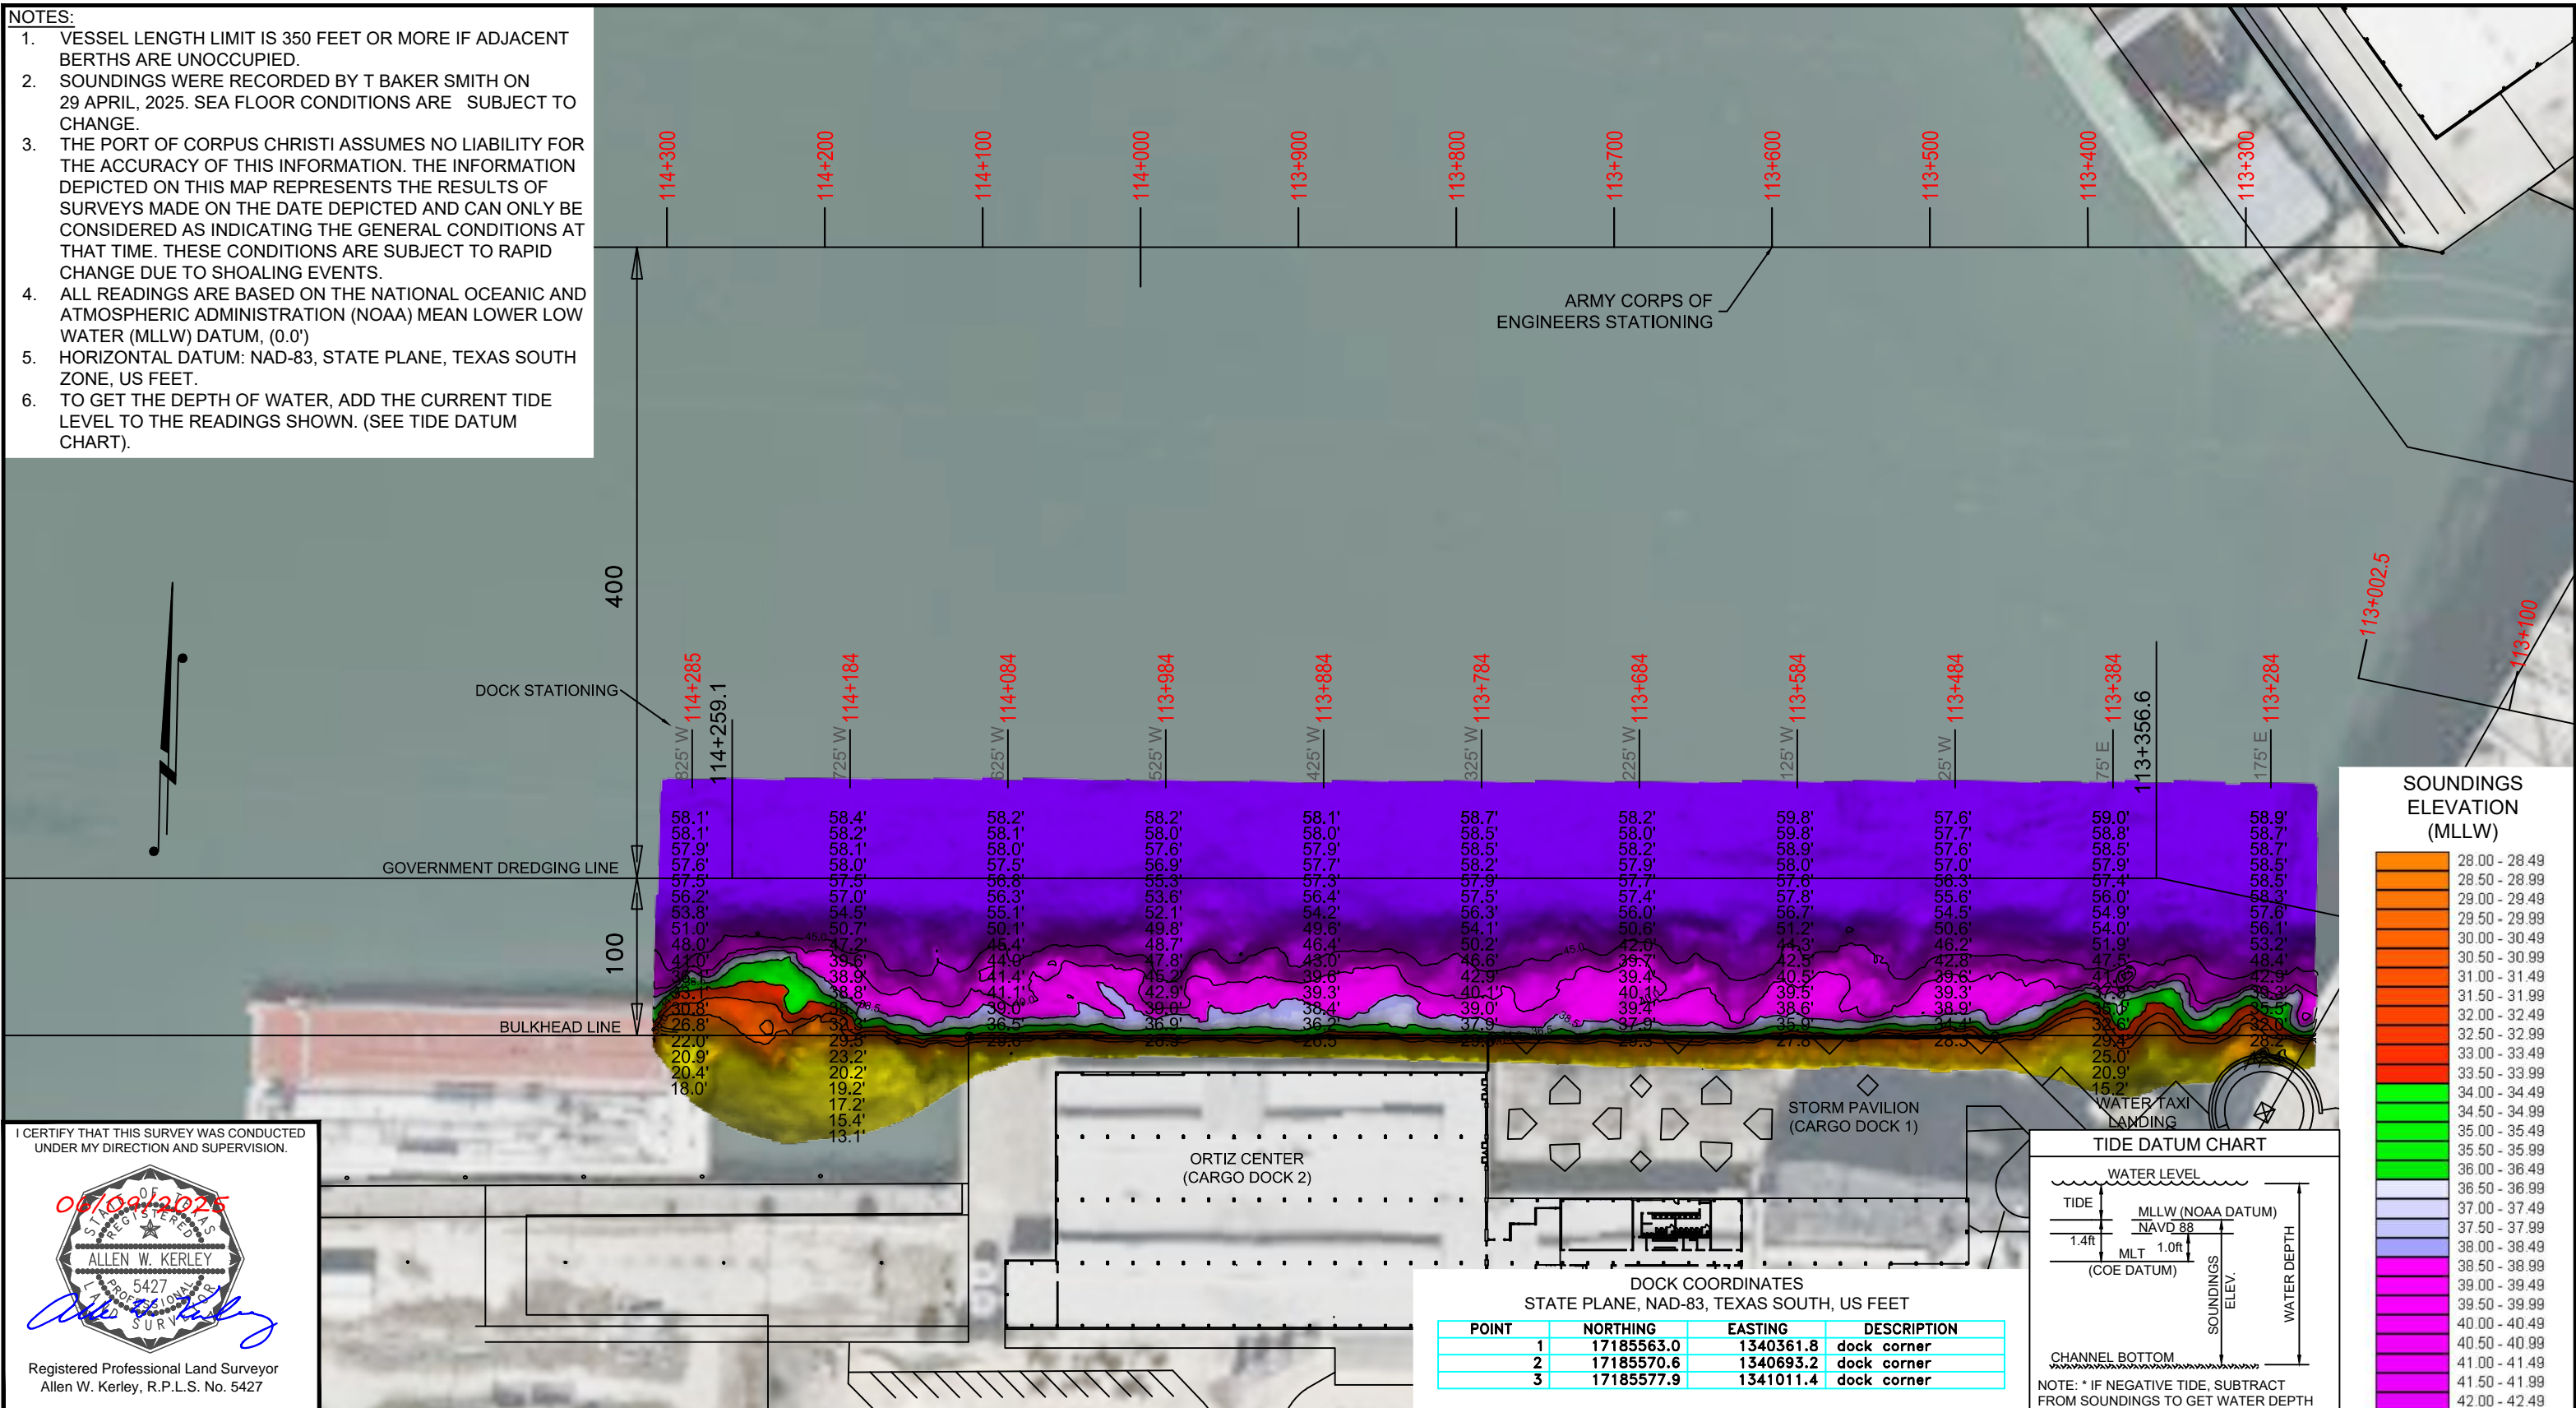
1. VESSEL LENGTH LIMIT IS 350 FEET OR MORE IF ADJACENT BERTHS ARE UNOCCUPIED.
2. SOUNDINGS WERE RECORDED BY T BAKER SMITH ON 29 APRIL, 2025. SEA FLOOR CONDITIONS ARE SUBJECT TO CHANGE.
3. THE PORT OF CORPUS CHRISTI ASSUMES NO LIABILITY FOR THE ACCURACY OF THIS INFORMATION. THE INFORMATION DEPICTED ON THIS MAP REPRESENTS THE RESULTS OF SURVEYS MADE ON THE DATE DEPICTED AND CAN ONLY BE CONSIDERED AS INDICATING THE GENERAL CONDITIONS AT THAT TIME. THESE CONDITIONS ARE SUBJECT TO RAPID CHANGE DUE TO SHOALING EVENTS.
4. ALL READINGS ARE BASED ON THE NATIONAL OCEANIC AND ATMOSPHERIC ADMINISTRATION (NOAA) MEAN LOWER LOW WATER (MLLW) DATUM, (0.0')
5. HORIZONTAL DATUM: NAD-83, STATE PLANE, TEXAS SOUTH ZONE, US FEET.
6. TO GET THE DEPTH OF WATER, ADD THE CURRENT TIDE LEVEL TO THE READINGS SHOWN. (SEE TIDE DATUM CHART).
