DRAWN BY: MM	APPROVED BY: AWK
DATE: 02/27/2023	JOB NO: 2023.0091
DRAWING NAME: CARGO DOCK 14-15_15FEB2023	
PROJECTION: TEXAS STATE PLANE SOUTH ZONE GEO. DATUM: NAD83 (2011)   VERT. DATUM: NAVD88 GRID UNITS: US SURVEY FEET	
SHEET NO: 1	OF 1

**PORT OF CORPUS CHRISTI AUTHORITY**

**CARGO DOCK 14-15**  
SOUNDINGS  
AN EXHIBIT OF A  
BATHYMETRIC SURVEY  
LOCATED IN  
CORPUS CHRISTI, TEXAS

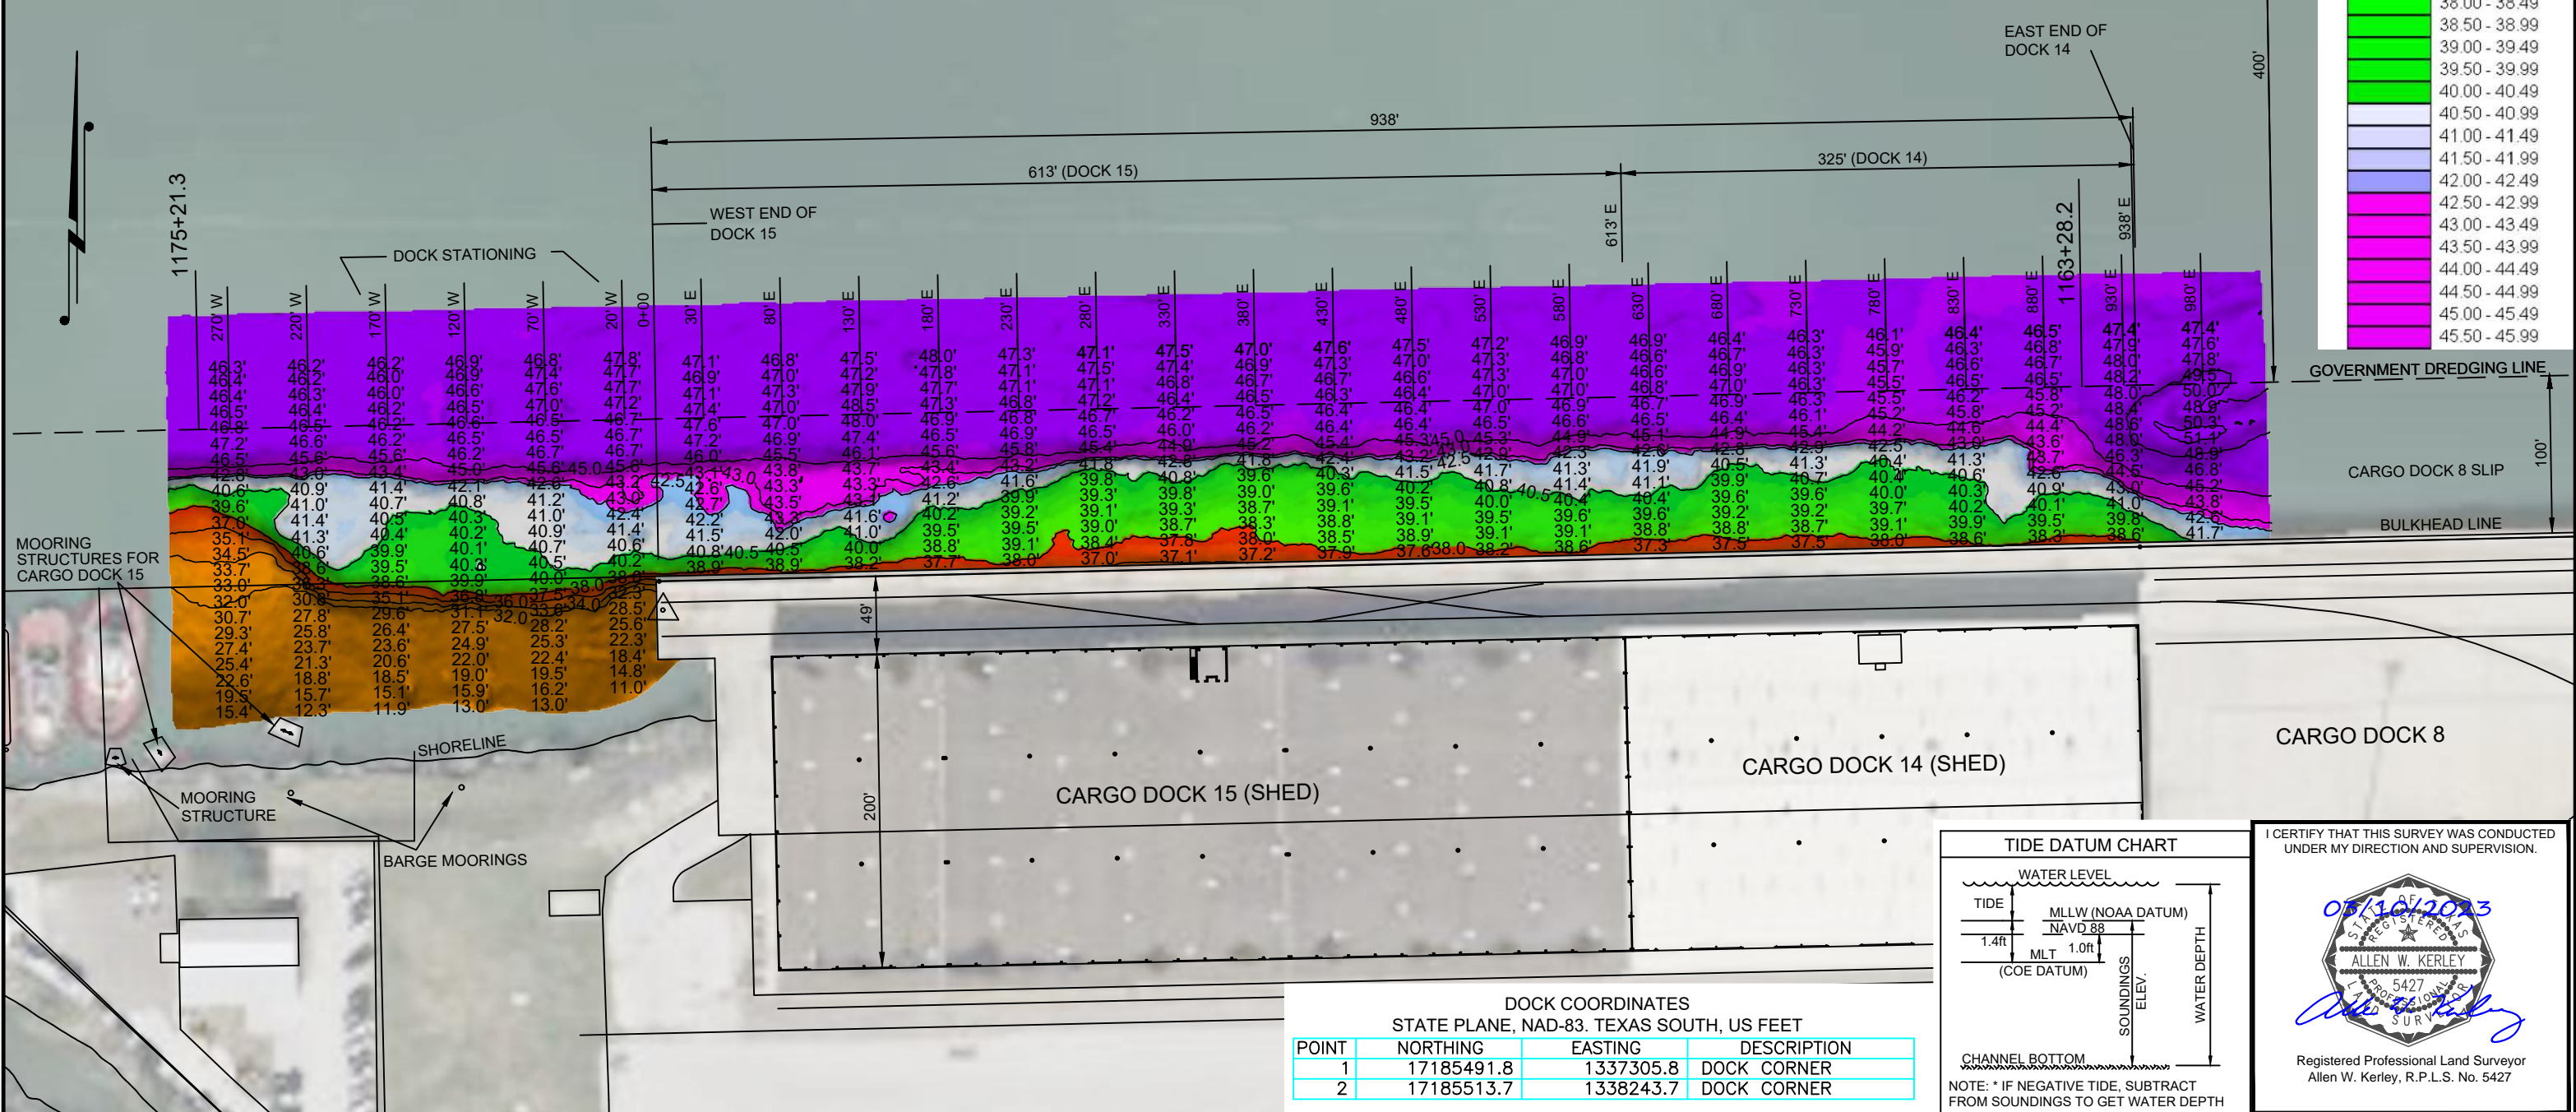
- NOTES:**
- VESSEL LENGTH LIMIT: 1000 FEET OR MORE IF ADJACENT BERTHS ARE UNOCCUPIED.
  - SOUNDINGS WERE RECORDED BY T BAKER SMITH ON 15 FEBRUARY, 2023.  
SEA FLOOR CONDITIONS ARE SUBJECT TO CHANGE.
  - THE PORT OF CORPUS CHRISTI ASSUMES NO LIABILITY FOR THE ACCURACY OF THIS INFORMATION. THE INFORMATION DEPICTED ON THIS MAP REPRESENTS THE RESULTS OF SURVEYS MADE ON THE DATE DEPICTED AND CAN ONLY BE CONSIDERED AS INDICATING THE GENERAL CONDITIONS AT THAT TIME. THESE CONDITIONS ARE SUBJECT TO RAPID CHANGE DUE TO SHOALING EVENTS.
  - ALL READINGS ARE BASED ON THE NATIONAL OCEANIC AND ATMOSPHERIC ADMINISTRATION (NOAA) MEAN LOWER LOW WATER (MLLW) DATUM, (O.O')
  - HORIZONTAL DATUM: NAD-83, STATE PLANE, TEXAS SOUTH ZONE, US FEET.
  - TO GET THE DEPTH OF WATER, ADD THE CURRENT TIDE LEVEL TO THE READINGS SHOWN. (SEE TIDE DATUM CHART).
