DRAWING NAME: CARGO DOCK 14-15 22MAY2023

**PORT OF CORPUS CHRISTI AUTHORITY**

**CARGO DOCK 14-15**  
SOUNDINGS  
AN EXHIBIT OF A  
BATHYMETRIC SURVEY  
LOCATED IN  
CORPUS CHRISTI, TEXAS

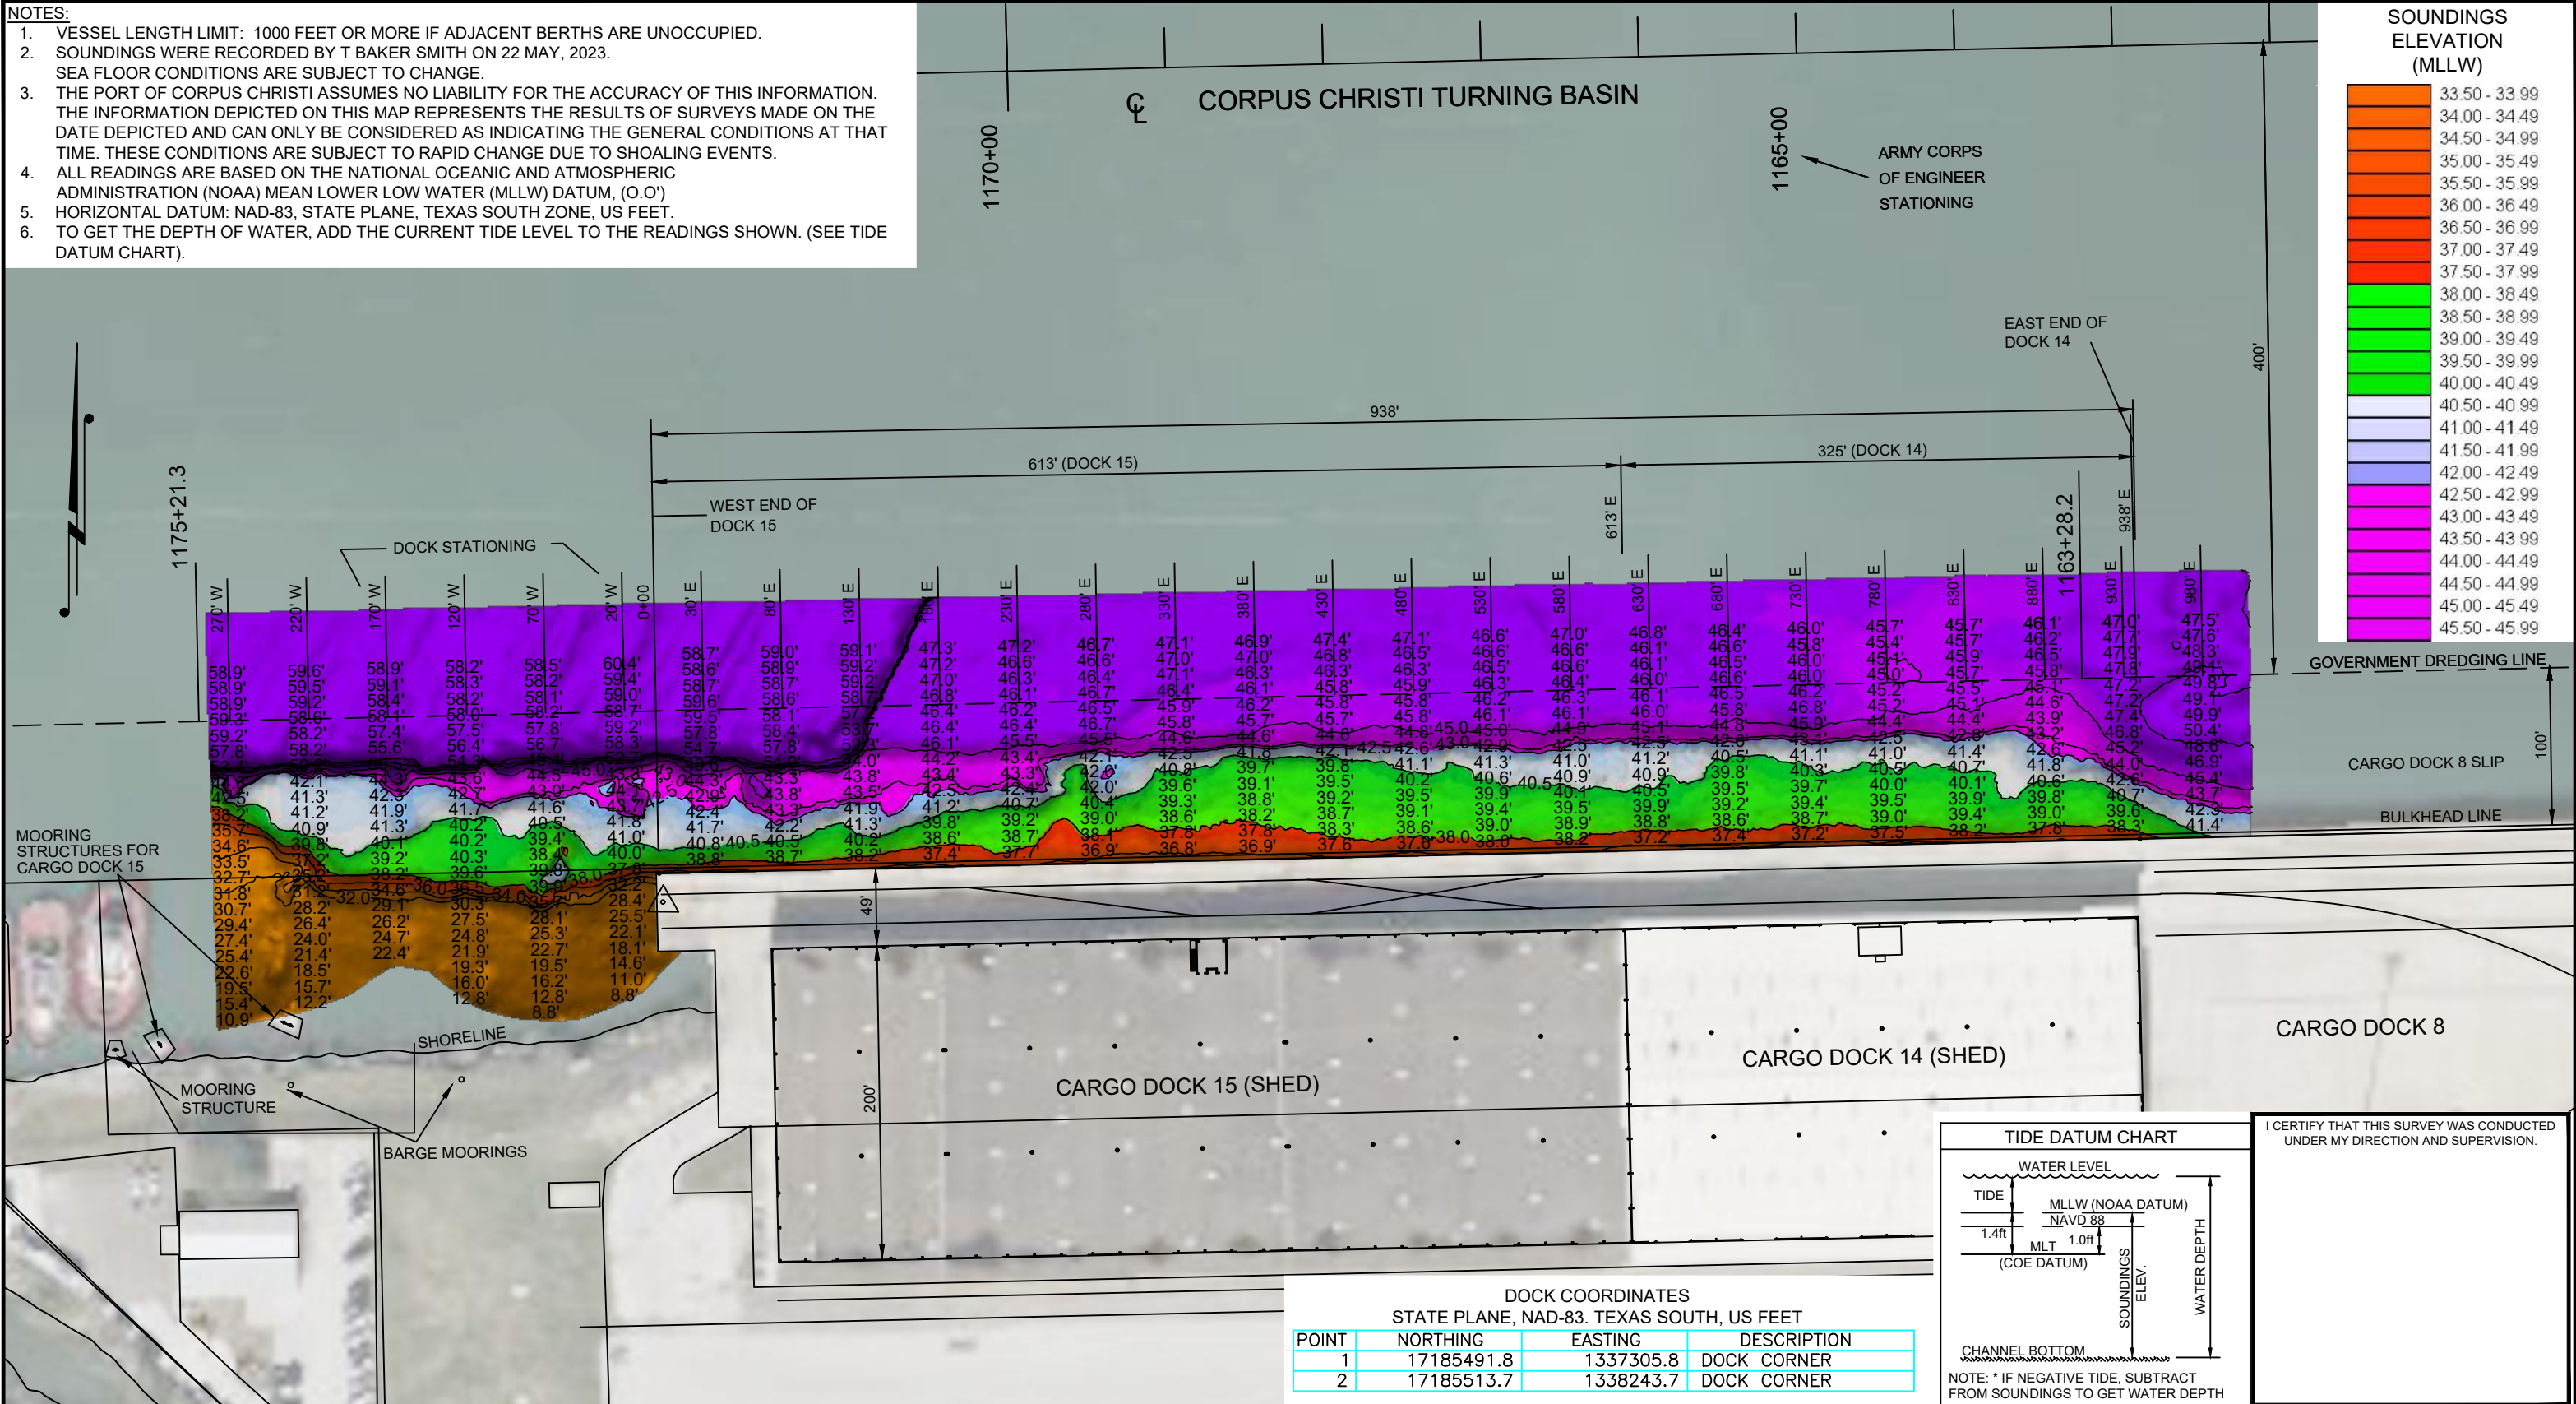
- NOTES:**
1. VESSEL LENGTH LIMIT: 1000 FEET OR MORE IF ADJACENT BERTHS ARE UNOCCUPIED.
  2. SOUNDINGS WERE RECORDED BY T BAKER SMITH ON 22 MAY, 2023. SEA FLOOR CONDITIONS ARE SUBJECT TO CHANGE.

4. ALL READINGS ARE BASED ON THE NATIONAL OCEANIC AND ATMOSPHERIC ADMINISTRATION (NOAA) MEAN LOWER LOW WATER (MLLW) DATUM, (O.O') HORIZONTAL DATUM: NAD-83, STATE PLANE, TEXAS SOUTH ZONE, US FEET.

5. HORIZONTAL DATUM: NAD-83, STATE PLANE, TEXAS SOUTH ZONE, US FEET.
  6. TO GET THE DEPTH OF WATER, ADD THE CURRENT TIDE LEVEL TO THE READINGS SHOWN. (SEE TIDE DATUM CHART).
