DRAWING NAME: CARGO DOCK 14-15 28NOV2023

**PORT OF CORPUS CHRISTI AUTHORITY**

**CARGO DOCK 14-15**  
SOUNDINGS  
AN EXHIBIT OF A  
BATHYMETRIC SURVEY  
LOCATED IN  
CORPUS CHRISTI, TEXAS

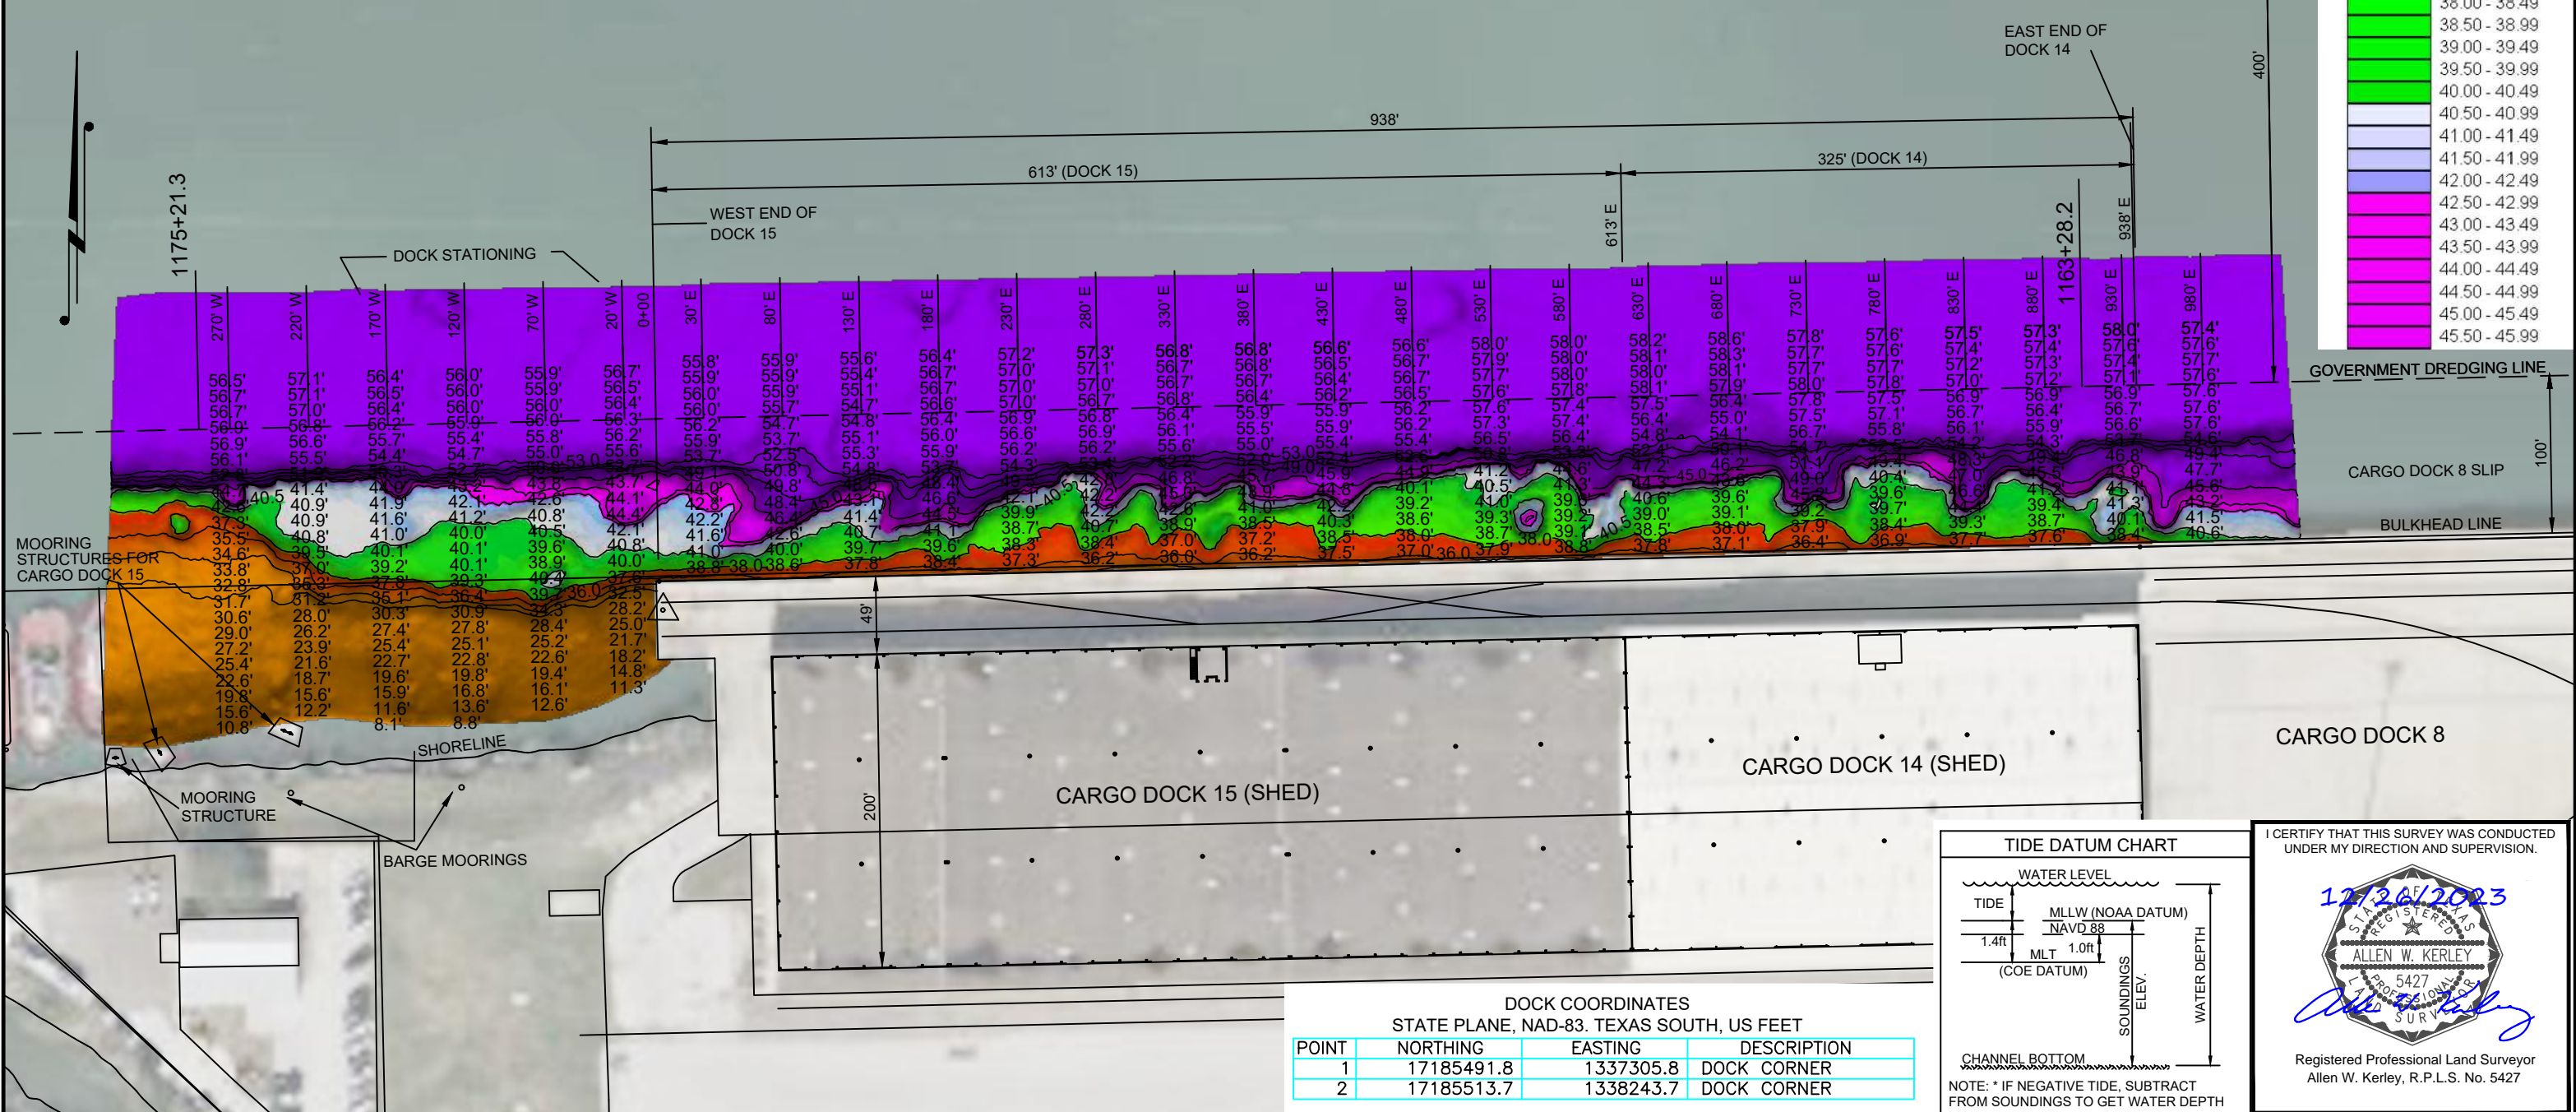
- NOTES:**
1. VESSEL LENGTH LIMIT: 1000 FEET OR MORE IF ADJACENT BERTHS ARE UNOCCUPIED.
  2. SOUNDINGS WERE RECORDED BY T BAKER SMITH ON 28 NOVEMBER, 2023. SEA FLOOR CONDITIONS ARE SUBJECT TO CHANGE.
  3. THE PORT OF CORPUS CHRISTI ASSUMES NO LIABILITY FOR THE ACCURACY OF THIS INFORMATION. THE INFORMATION DEPICTED ON THIS MAP REPRESENTS THE RESULTS OF SURVEYS MADE ON THE DATE DEPICTED AND CAN ONLY BE CONSIDERED AS INDICATING THE GENERAL CONDITIONS AT THAT TIME. THESE CONDITIONS ARE SUBJECT TO RAPID CHANGE DUE TO SHOALING EVENTS.
  4. ALL READINGS ARE BASED ON THE NATIONAL OCEANIC AND ATMOSPHERIC ADMINISTRATION (NOAA) MEAN LOWER LOW WATER (MLLW) DATUM, (O.O')
  5. HORIZONTAL DATUM: NAD-83, STATE PLANE, TEXAS SOUTH ZONE, US FEET.
  6. TO GET THE DEPTH OF WATER, ADD THE CURRENT TIDE LEVEL TO THE READINGS SHOWN. (SEE TIDE DATUM CHART).
