DRAWN BY:	MMC	APPROVED BY:	AWK
DATE:	05/26/2023	JOB NO.:	2023.0091
DRAWING NAME: CARGO DOCK 16 25MAY2023			
PROJECTION: TEXAS STATE PLANE SOUTH ZONE			
GEO. DATUM: NAD83 (2011) VERT. DATUM: NAVD88			
GRID UNITS: US SURVEY FEET			
SHEET NO.:	1	OF	1

PORT OF CORPUS CHRISTI AUTHORITY

CARGO DOCK 16
SOUNDINGS
AN EXHIBIT OF A
BATHYMETRIC SURVEY
LOCATED IN
CORPUS CHRISTI, TEXAS

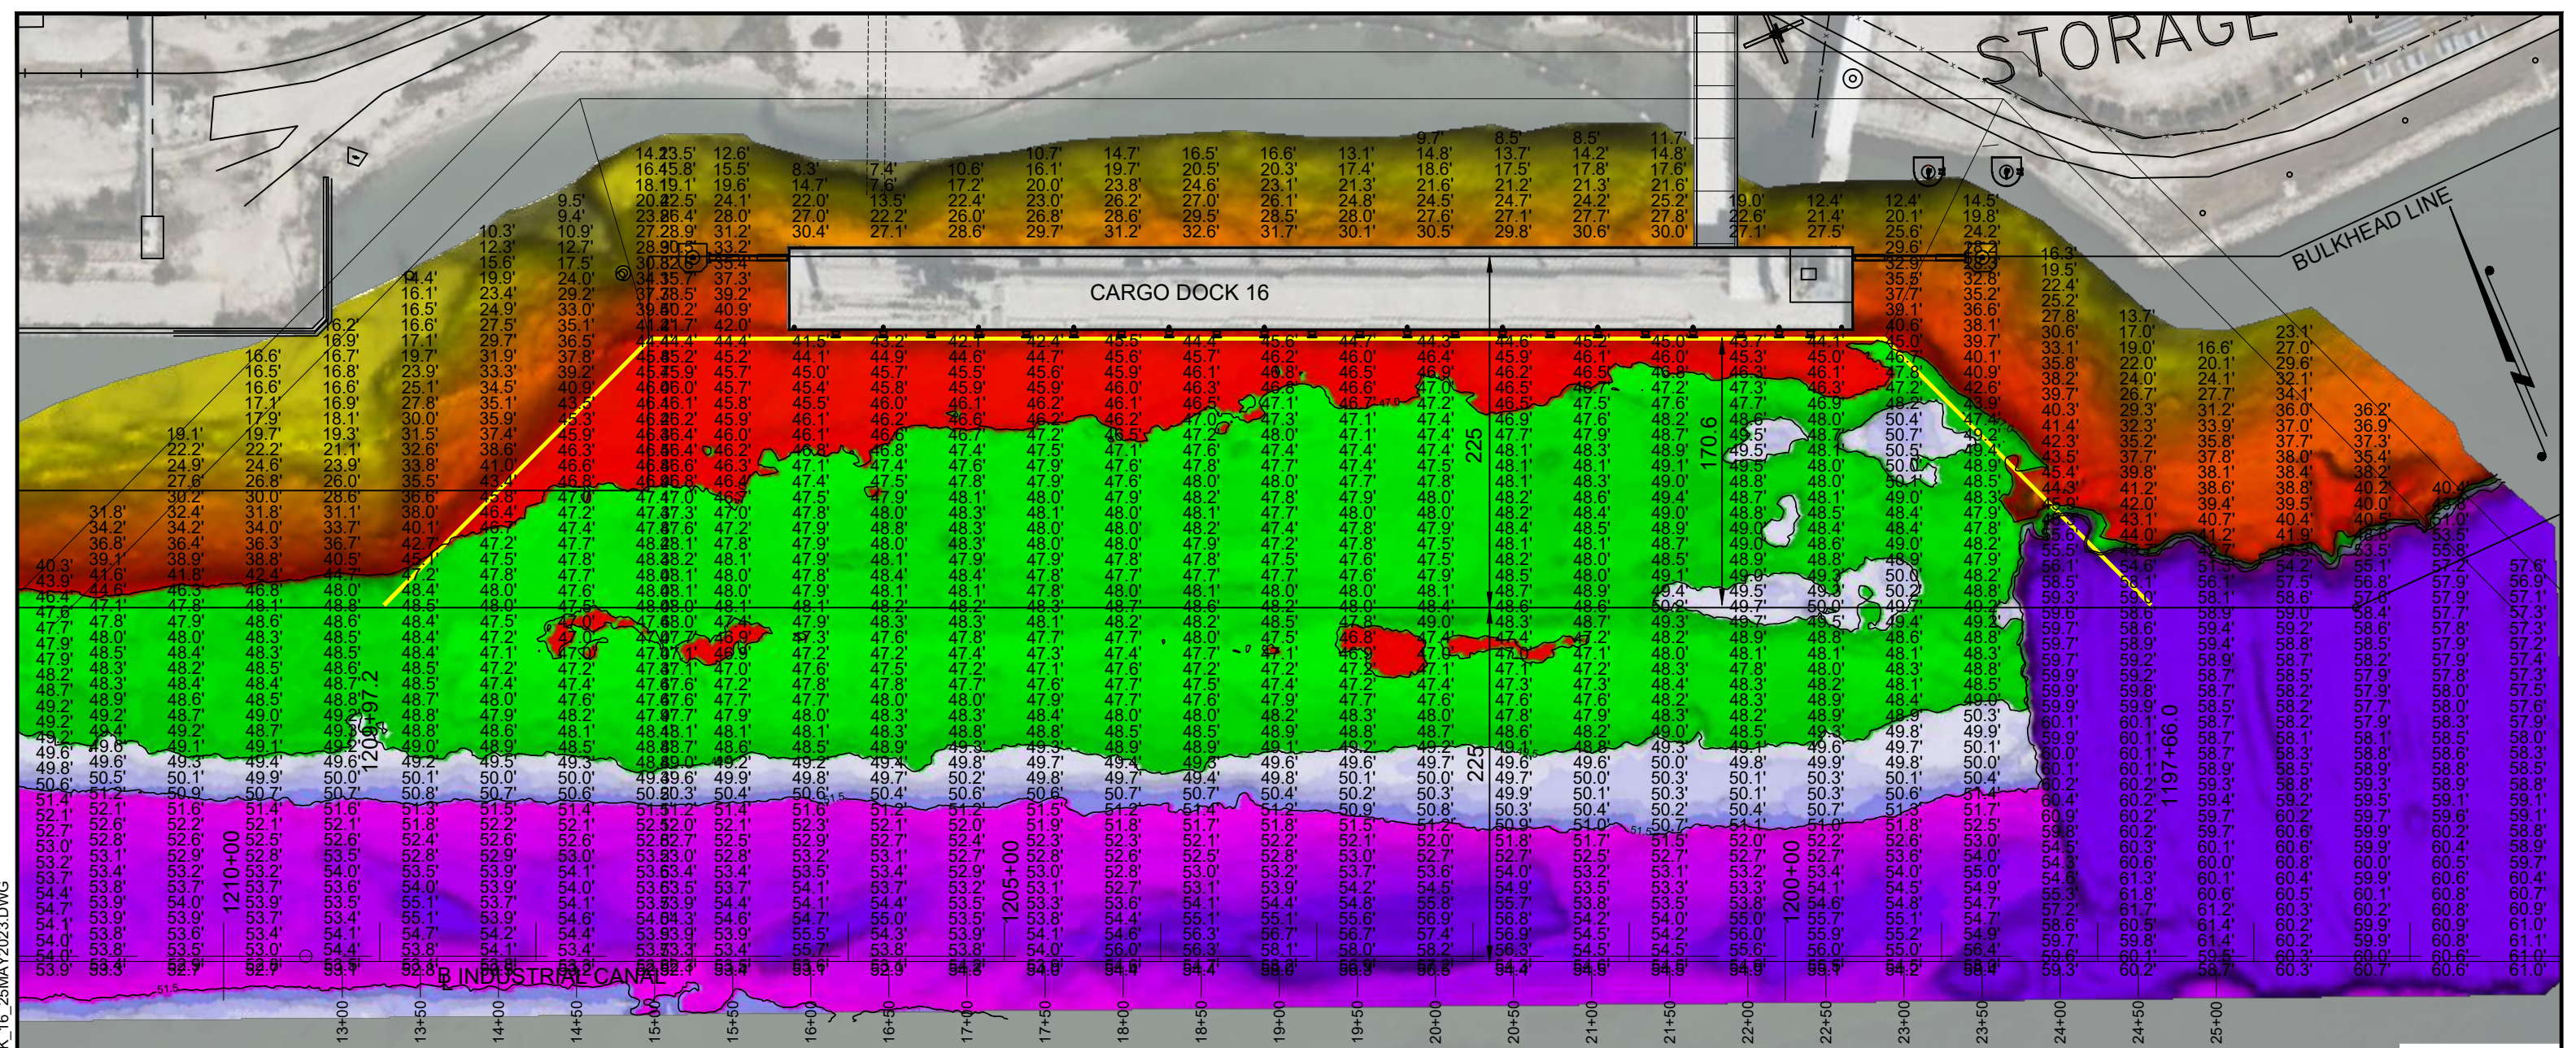
- NOTES:
- SOUNDINGS WERE RECORDED BY T. BAKER SMITH ON 25 MAY, 2023. SEA FLOOR CONDITIONS ARE SUBJECT TO CHANGE.
 - THE PORT OF CORPUS CHRISTI ASSUMES NO LIABILITY FOR THE ACCURACY OF THIS INFORMATION. THE INFORMATION DEPICTED ON THIS MAP REPRESENTS THE RESULTS OF SURVEYS MADE ON THE DATE DEPICTED AND CAN ONLY BE CONSIDERED AS INDICATING THE GENERAL CONDITIONS AT THAT TIME. THESE CONDITIONS ARE SUBJECT TO RAPID CHANGE DUE TO SHOALING EVENTS.
 - ALL READINGS ARE BASED ON THE NATIONAL OCEANIC AND ATMOSPHERIC ADMINISTRATION (NOAA) MEAN LOWER LOW WATER (MLLW) DATUM, (0.0')
 - ORIZONTAL DATUM: NAD-83, STATE PLANE, TEXAS SOUTH ZONE, US FEET.
 - TO GET THE DEPTH OF WATER, ADD THE CURRENT TIDE LEVEL TO THE READINGS SHOWN. (SEE TIDE DATUM CHART).
