#### PORT OF CORPUS CHRISTI AUTHORITY

CARGO DOCK 16  
SOUNDINGS  
AN EXHIBIT OF A  
BATHYMETRIC SURVEY  
LOCATED IN  
CORPUS CHRISTI, TEXAS

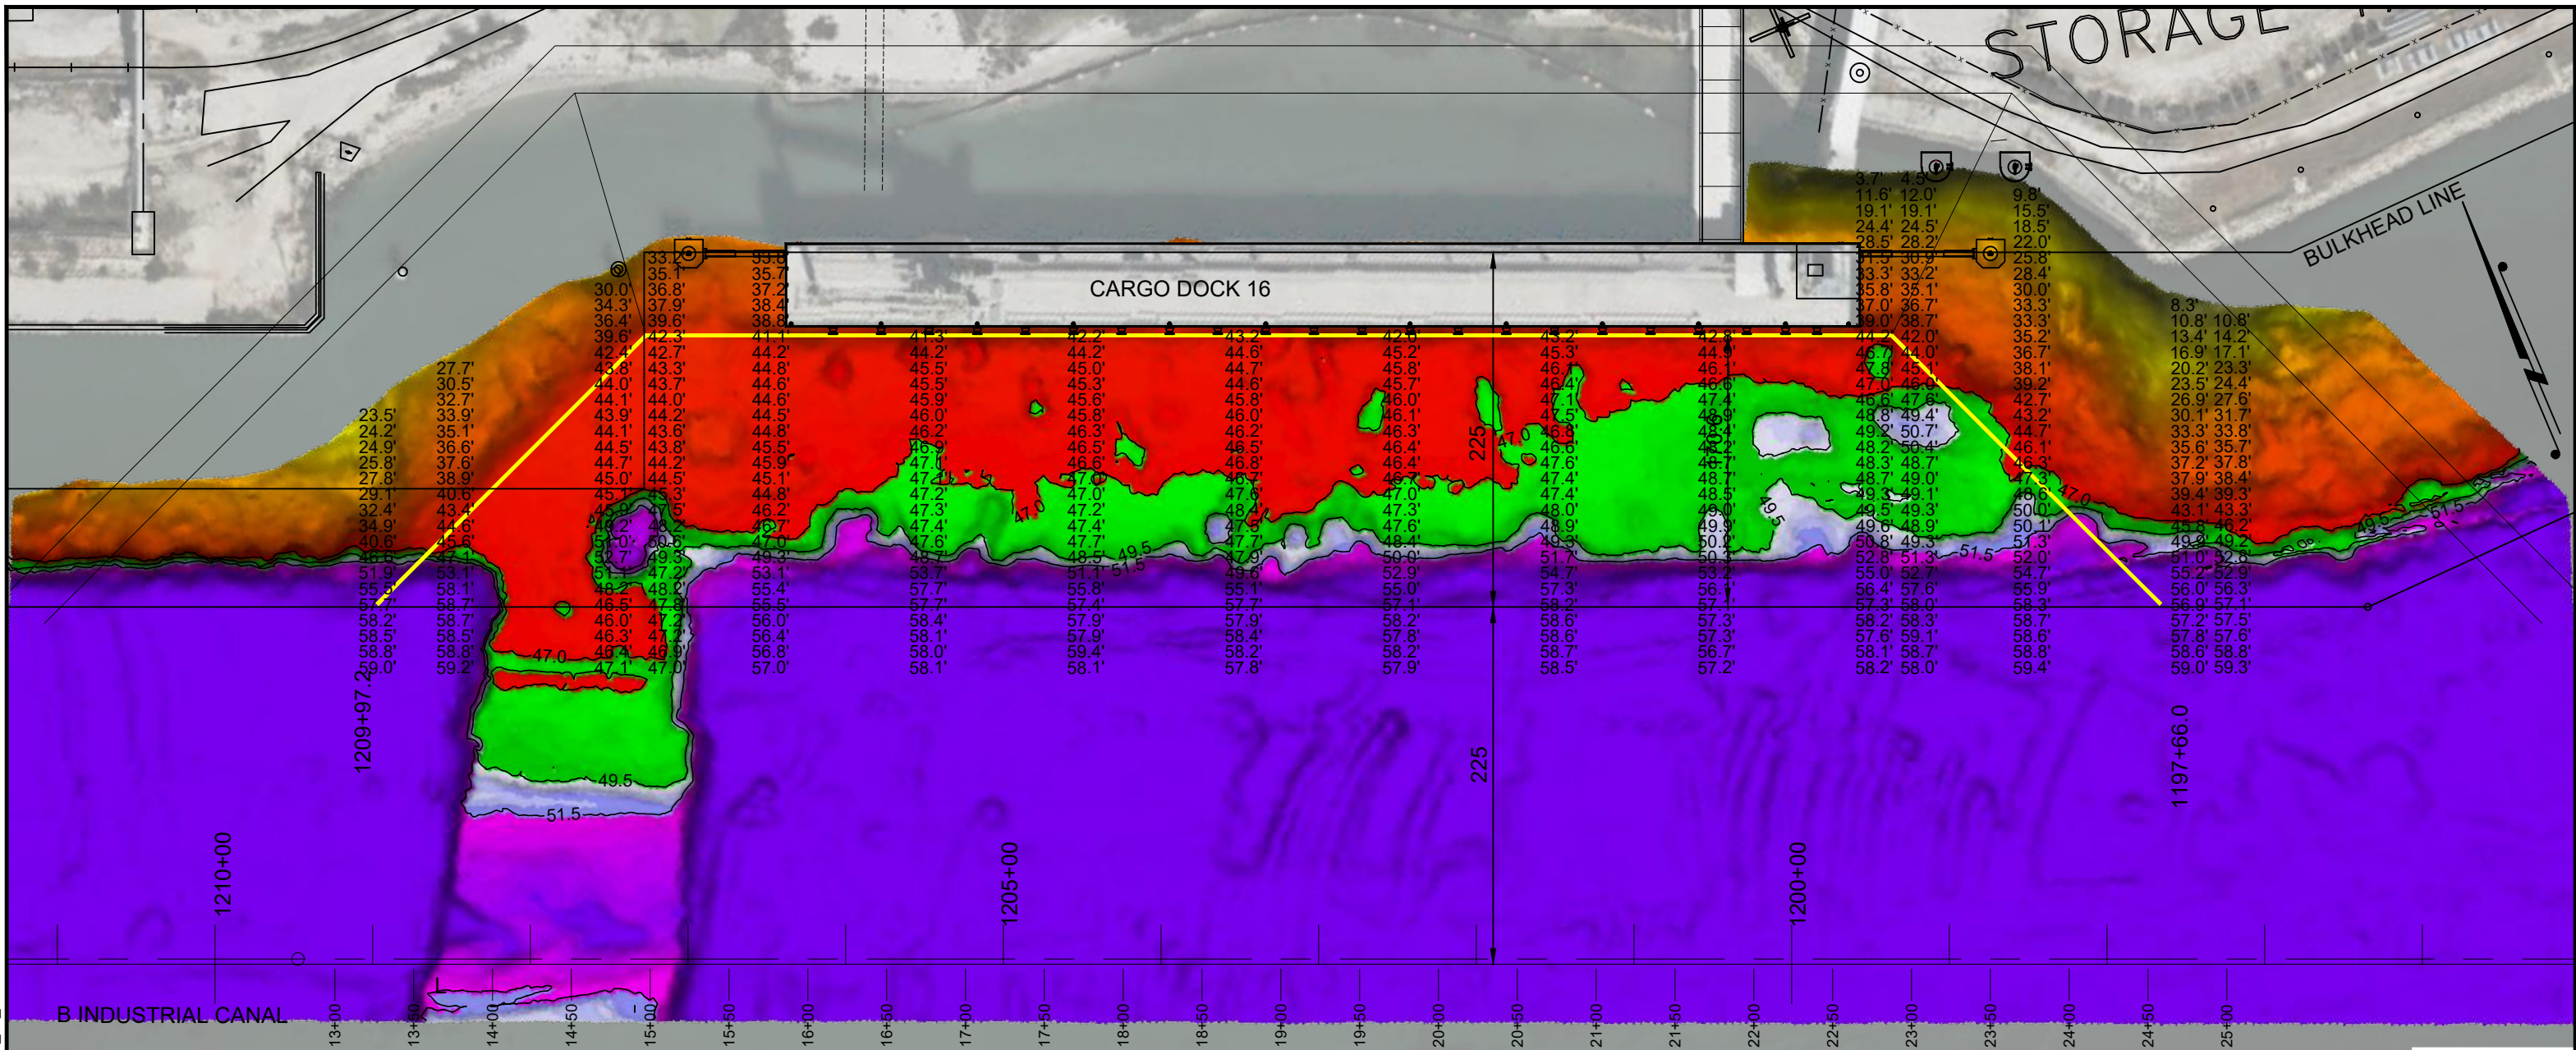
1. SOUNDINGS WERE RECORDED BY T. BAKER SMITH ON 26 DECEMBER, 2023. SEA FLOOR CONDITIONS ARE SUBJECT TO CHANGE.
2. THE PORT OF CORPUS CHRISTI ASSUMES NO LIABILITY FOR THE ACCURACY OF THIS INFORMATION. THE INFORMATION DEPICTED ON THIS MAP REPRESENTS THE RESULTS OF SURVEYS MADE ON THE DATE DEPICTED AND CAN ONLY BE CONSIDERED AS INDICATING THE GENERAL CONDITIONS AT THAT TIME. THESE CONDITIONS ARE SUBJECT TO RAPID CHANGE DUE TO SHOALING EVENTS.
3. ALL READINGS ARE BASED ON THE NATIONAL OCEANIC AND ATMOSPHERIC ADMINISTRATION (NOAA) MEAN LOWER LOW WATER (MLLW) DATUM, (0.0')
4. HORIZONTAL DATUM: NAD-83, STATE PLANE, TEXAS SOUTH ZONE, US FEET.
5. TO GET THE DEPTH OF WATER, ADD THE CURRENT TIDE LEVEL TO THE READINGS SHOWN. (SEE TIDE DATUM CHART).
