DRAWN BY:	CDW	APPROVED BY:	AWK
DATE:	02/06/2026	JOB NO.:	2025.0225
DRAWING NAME: CARGO DOCK 16 28OCT2025			
PROJECTION: TEXAS STATE PLANE SOUTH ZONE GEO. DATUM: NAD83 (2011)   VERT. DATUM: MLLW GRID UNITS: US SURVEY FEET			
SHEET NO.:	1	OF	1

**PORT OF CORPUS CHRISTI AUTHORITY**

**CARGO DOCK 16**  
SOUNDINGS  
AN EXHIBIT OF A  
BATHYMETRIC SURVEY  
LOCATED IN  
CORPUS CHRISTI, TEXAS

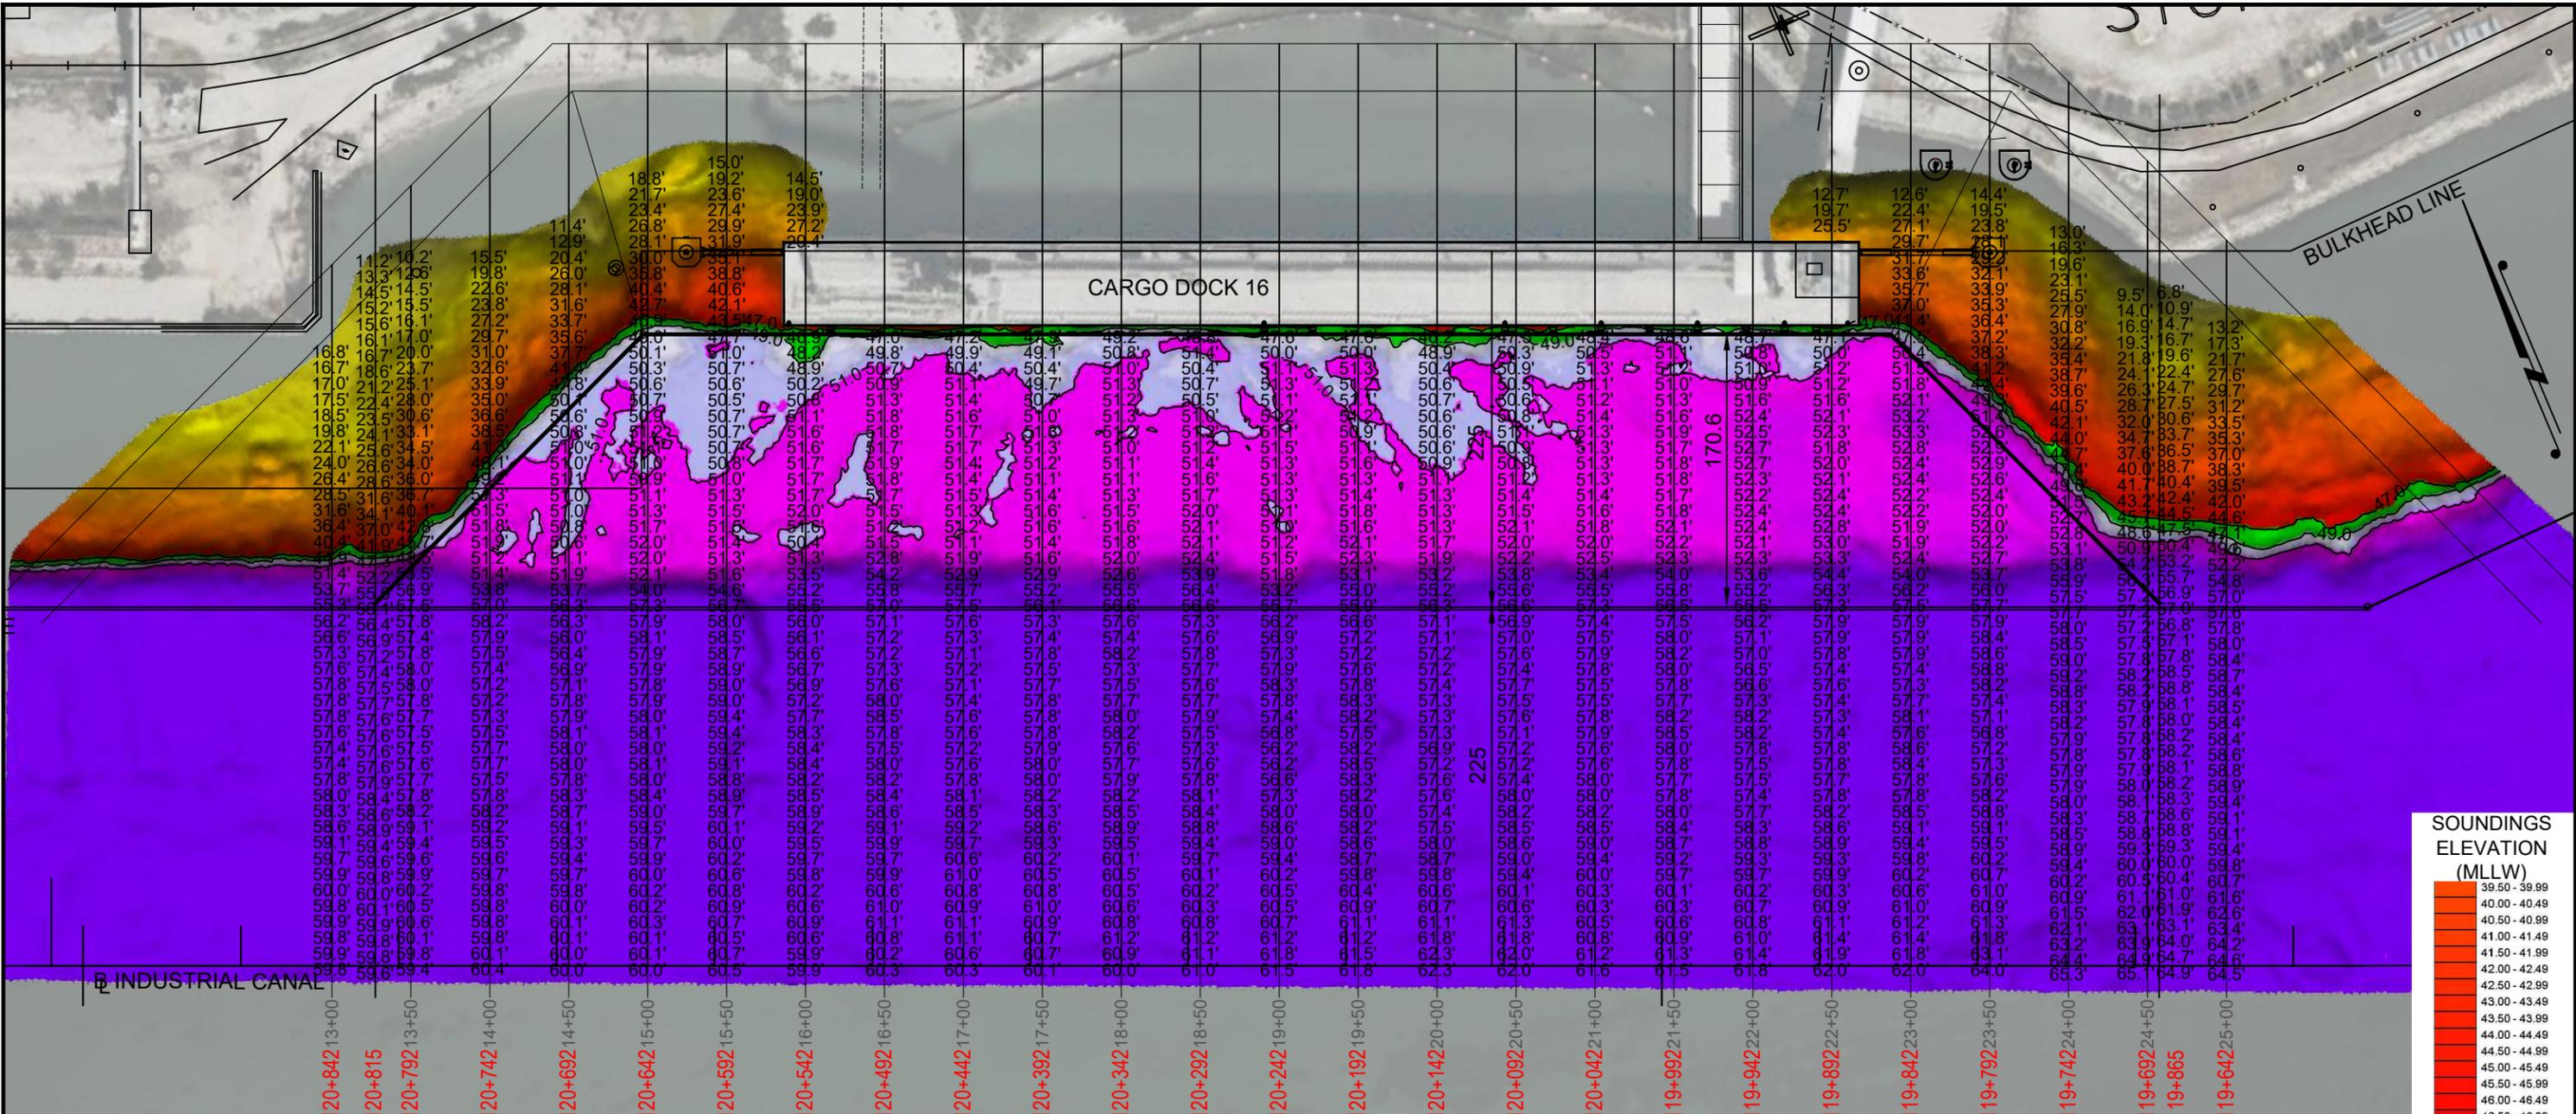
- NOTES:**
- SOUNDINGS WERE RECORDED BY T. BAKER SMITH ON 28 OCTOBER, 2025. SEA FLOOR CONDITIONS ARE SUBJECT TO CHANGE.
  - THE PORT OF CORPUS CHRISTI ASSUMES NO LIABILITY FOR THE ACCURACY OF THIS INFORMATION. THE INFORMATION DEPICTED ON THIS MAP REPRESENTS THE RESULTS OF SURVEYS MADE ON THE DATE DEPICTED AND CAN ONLY BE CONSIDERED AS INDICATING THE GENERAL CONDITIONS AT THAT TIME. THESE CONDITIONS ARE SUBJECT TO RAPID CHANGE DUE TO SHOALING EVENTS.
  - ALL READINGS ARE BASED ON THE NATIONAL OCEANIC AND ATMOSPHERIC ADMINISTRATION (NOAA) MEAN LOWER LOW WATER (MLLW) DATUM, (0.0')
  - ORIZONTAL DATUM: NAD-83, STATE PLANE, TEXAS SOUTH ZONE, US FEET.
  - TO GET THE DEPTH OF WATER, ADD THE CURRENT TIDE LEVEL TO THE READINGS SHOWN. (SEE TIDE DATUM CHART).
