**PORT CORPUS CHRISTI**

**PORT OF CORPUS CHRISTI AUTHORITY**

**CARGO DOCK 16**  
SOUNDINGS  
AN EXHIBIT OF A  
BATHYMETRIC SURVEY  
LOCATED IN  
CORPUS CHRISTI, TEXAS

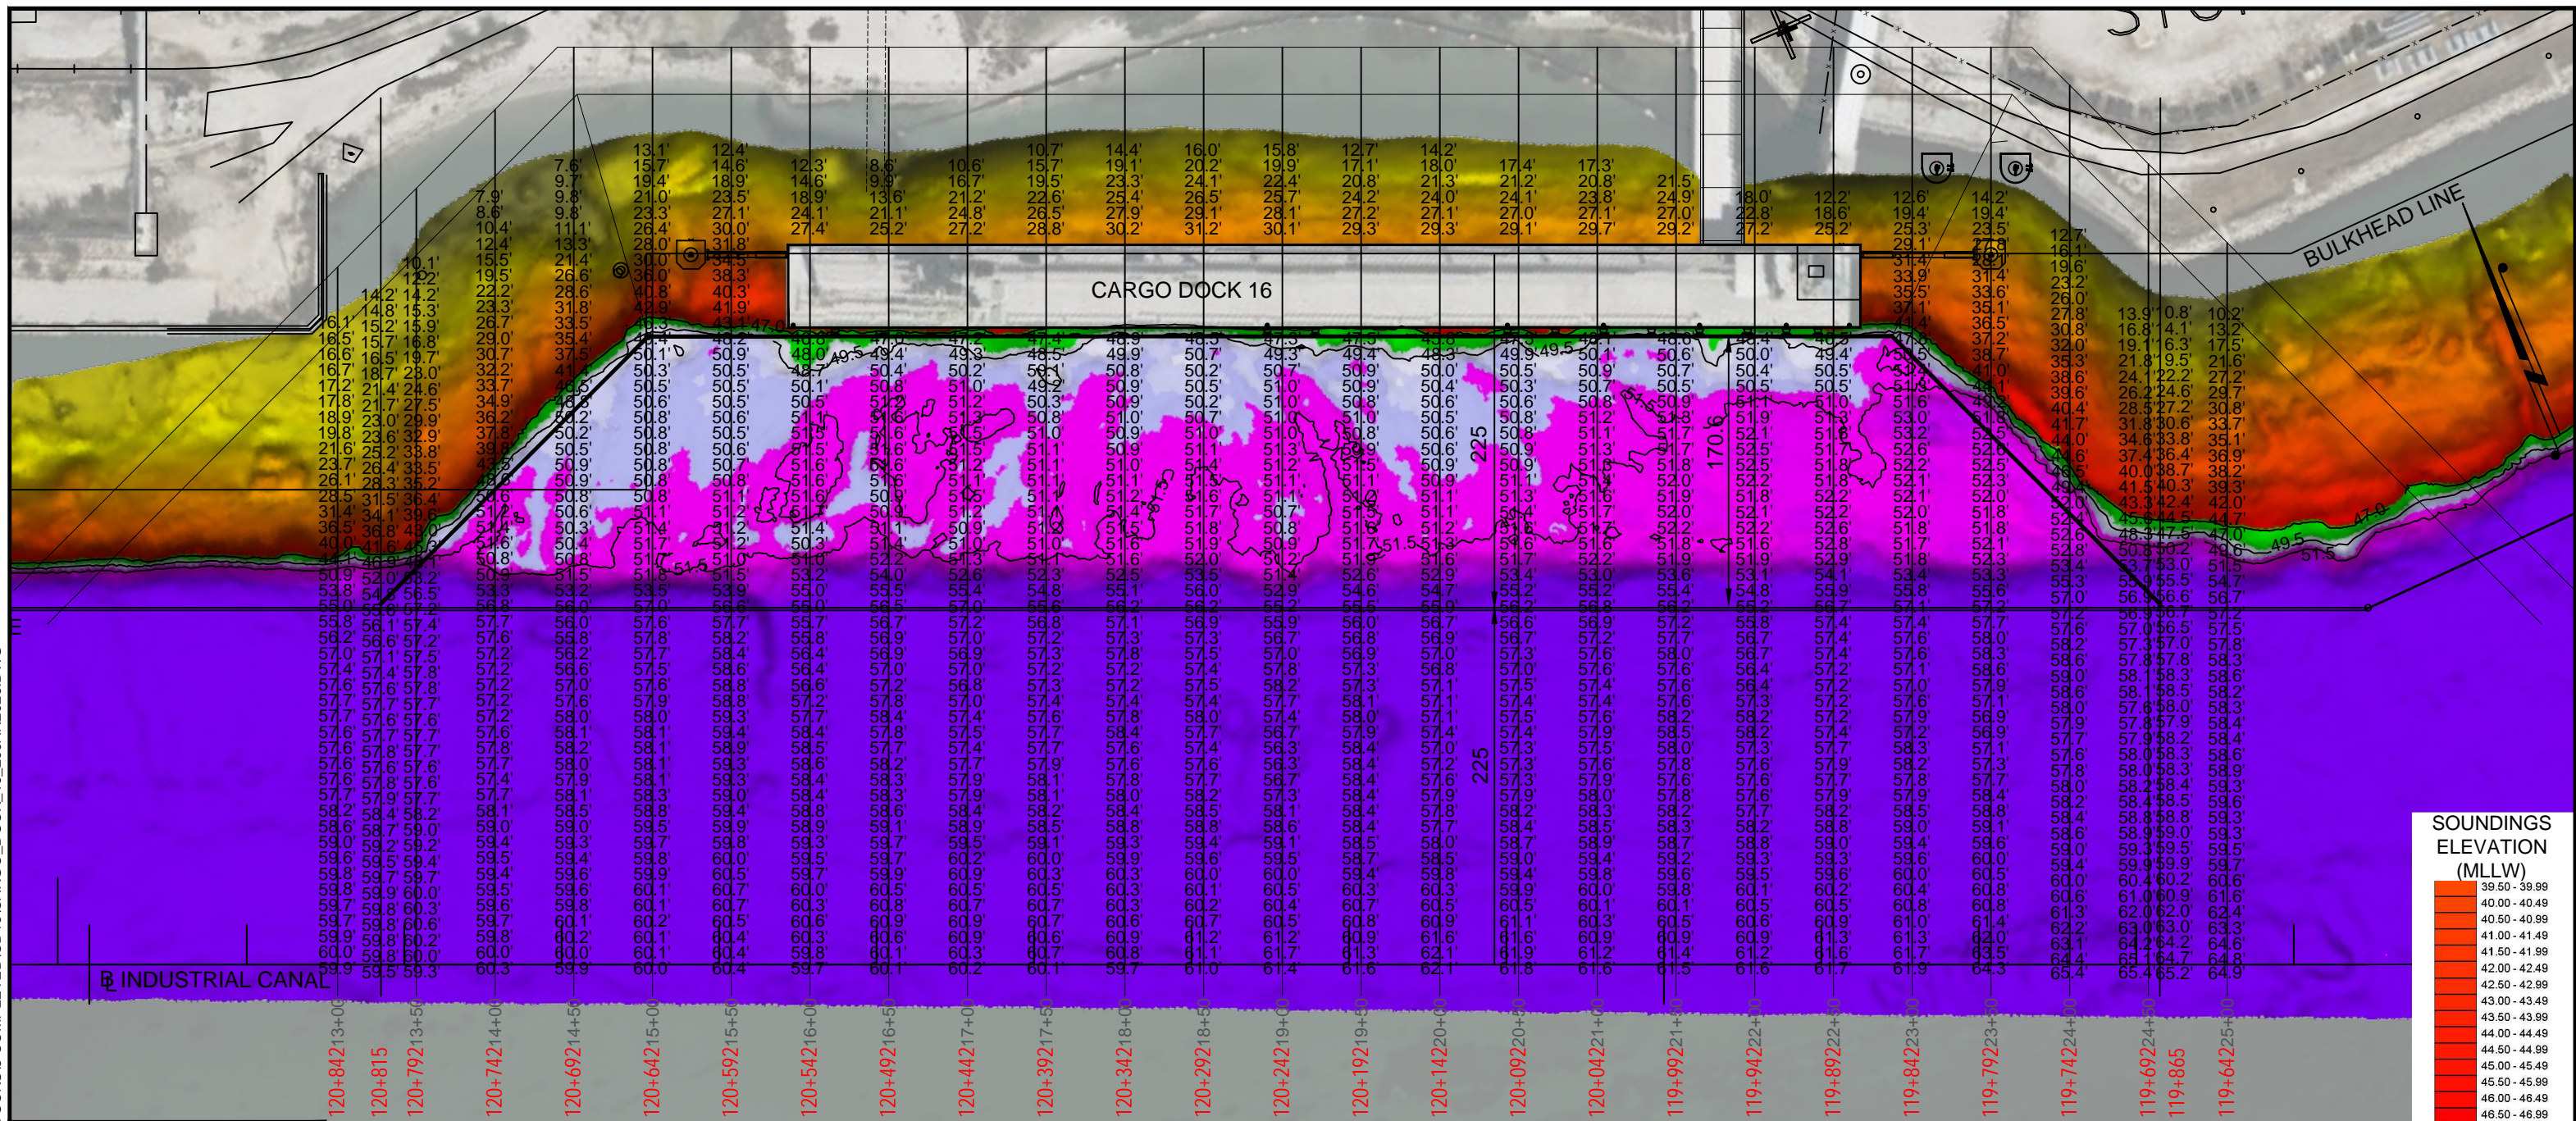
- NOTES:**
- SOUNDINGS WERE RECORDED BY T. BAKER SMITH ON 29 JANUARY, 2026. SEA FLOOR CONDITIONS ARE SUBJECT TO CHANGE.
  - THE PORT OF CORPUS CHRISTI ASSUMES NO LIABILITY FOR THE ACCURACY OF THIS INFORMATION. THE INFORMATION DEPICTED ON THIS MAP REPRESENTS THE RESULTS OF SURVEYS MADE ON THE DATE DEPICTED AND CAN ONLY BE CONSIDERED AS INDICATING THE GENERAL CONDITIONS AT THAT TIME. THESE CONDITIONS ARE SUBJECT TO RAPID CHANGE DUE TO SHOALING EVENTS.
  - ALL READINGS ARE BASED ON THE NATIONAL OCEANIC AND ATMOSPHERIC ADMINISTRATION (NOAA) MEAN LOWER LOW WATER (MLLW) DATUM, (0.0')
  - ORIZONTAL DATUM: NAD-83, STATE PLANE, TEXAS SOUTH ZONE, US FEET.
  - TO GET THE DEPTH OF WATER, ADD THE CURRENT TIDE LEVEL TO THE READINGS SHOWN. (SEE TIDE DATUM CHART).
