DRAWN BY: CDW APPROVED BY: AWK
DATE: 03/27/2025 JOB NO: 2025.0225
DRAWING NAME: CARGO DOCK 16 5MAR2025
PROJECTION: TEXAS STATE PLANE SOUTH ZONE
GEO. DATUM: NAD83 (2011) | VERT. DATUM: NAVD88
GRID UNITS: US SURVEY FEET
SHEET NO: 1 OF 1

PORT OF CORPUS CHRISTI AUTHORITY
CARGO DOCK 16
SOUNDINGS
AN EXHIBIT OF A
BATHYMETRIC SURVEY
LOCATED IN
CORPUS CHRISTI, TEXAS

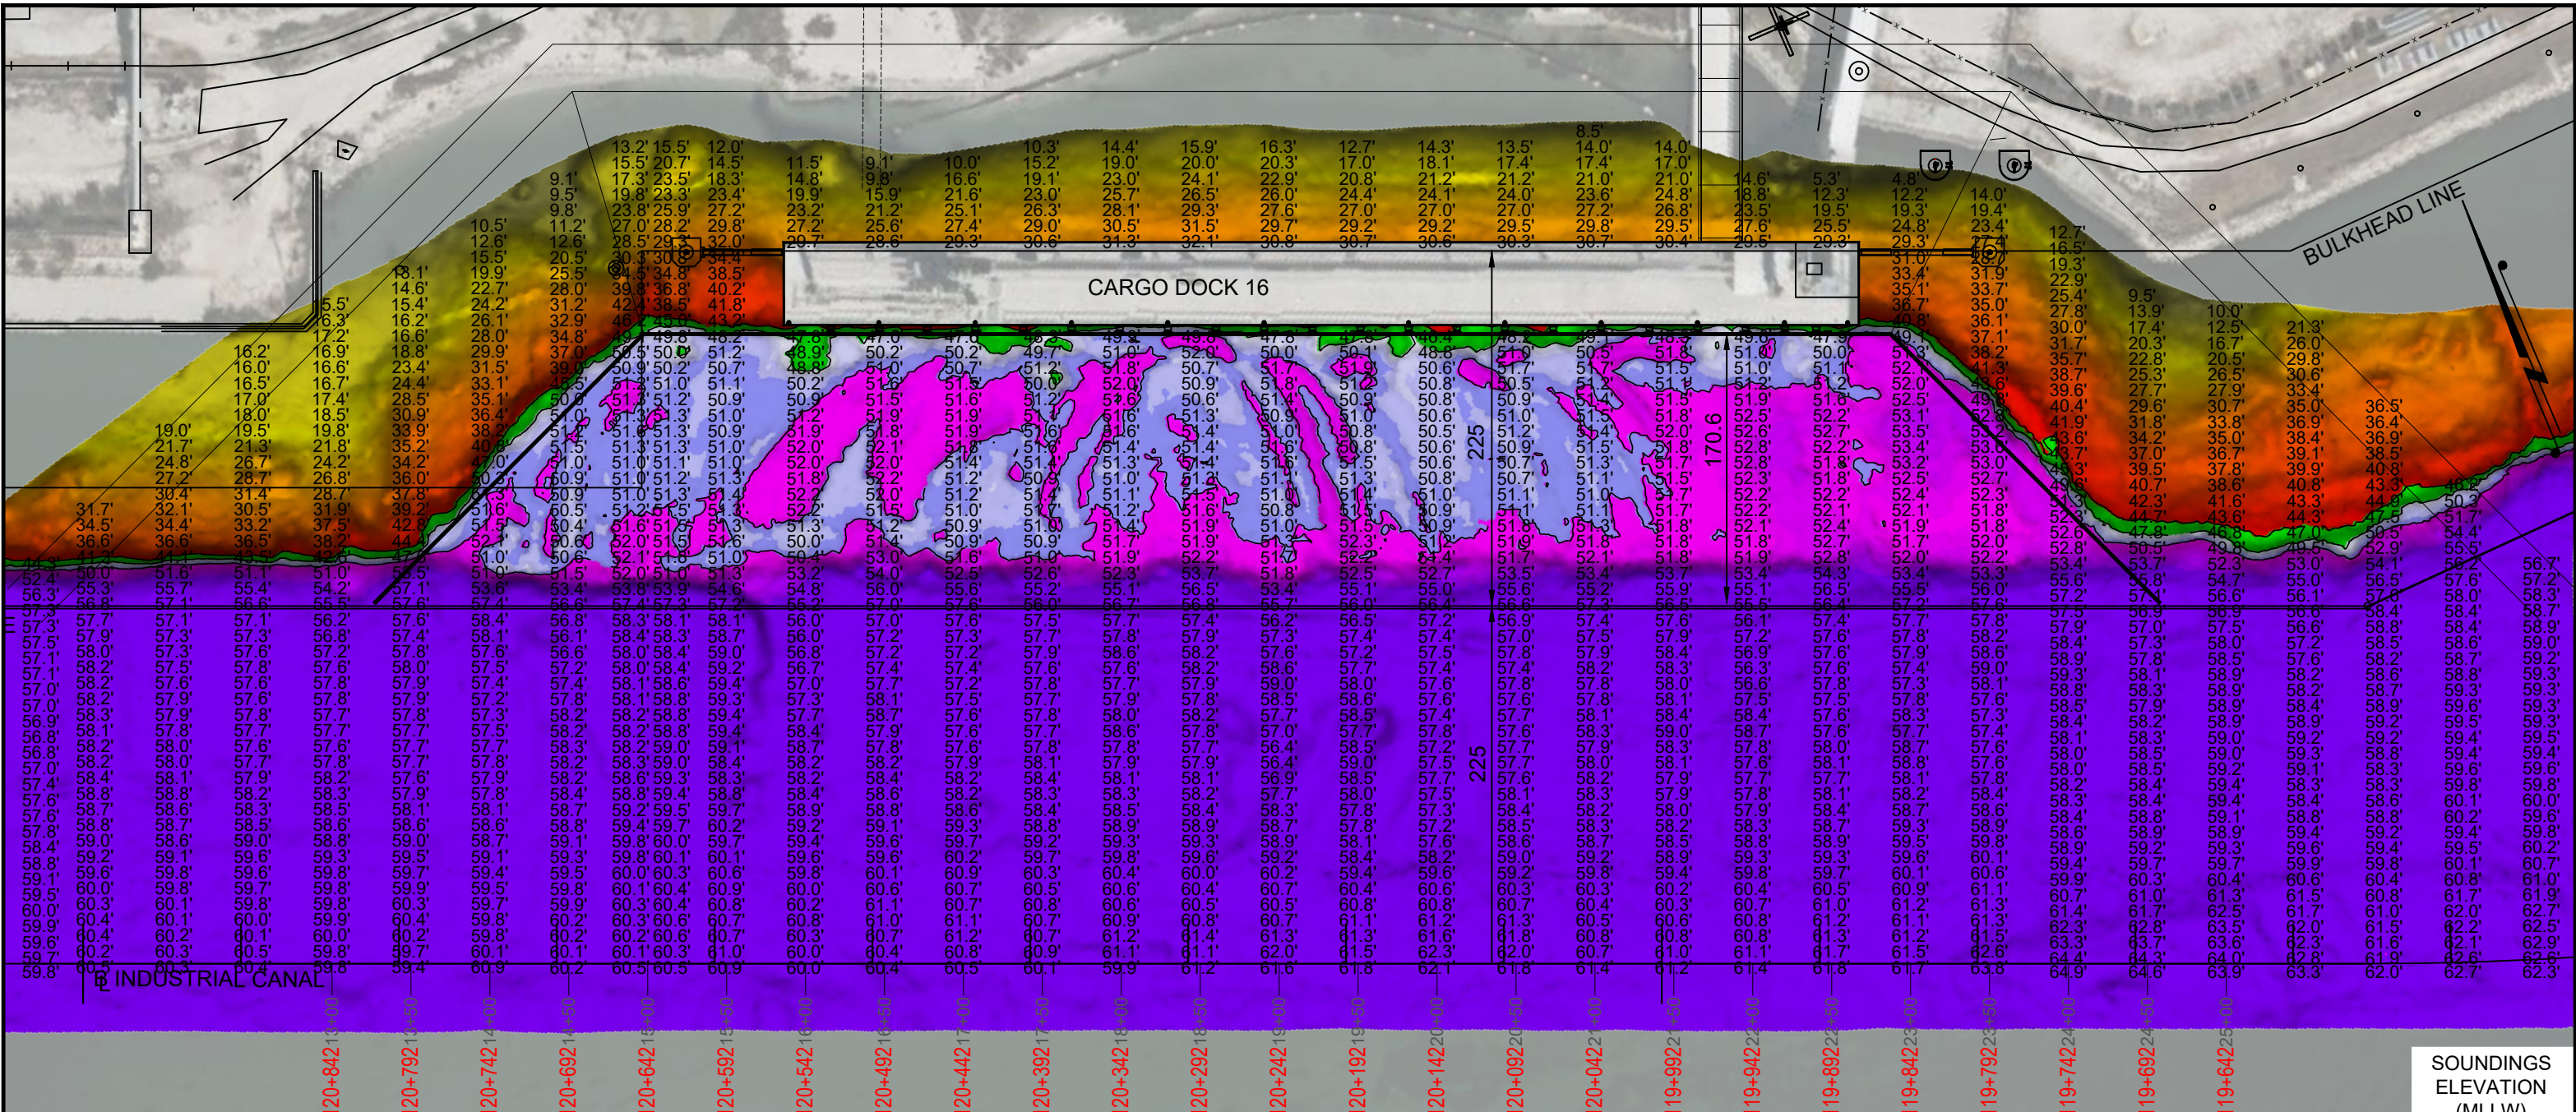
- SOUNDINGS WERE RECORDED BY T. BAKER SMITH ON 5 MARCH, 2025. SEA FLOOR CONDITIONS ARE SUBJECT TO CHANGE.
- THE PORT OF CORPUS CHRISTI ASSUMES NO LIABILITY FOR THE ACCURACY OF THIS INFORMATION. THE INFORMATION DEPICTED ON THIS MAP REPRESENTS THE RESULTS OF SURVEYS MADE ON THE DATE DEPICTED AND CAN ONLY BE CONSIDERED AS INDICATING THE GENERAL CONDITIONS AT THAT TIME. THESE CONDITIONS ARE SUBJECT TO RAPID CHANGE DUE TO SHOALING EVENTS.
- ALL READINGS ARE BASED ON THE NATIONAL OCEANIC AND ATMOSPHERIC ADMINISTRATION (NOAA) MEAN LOWER LOW WATER (MLLW) DATUM, (0.0')
- ORIZONTAL DATUM: NAD-83, STATE PLANE, TEXAS SOUTH ZONE, US FEET.
- TO GET THE DEPTH OF WATER, ADD THE CURRENT TIDE LEVEL TO THE READINGS SHOWN. (SEE TIDE DATUM CHART).
