DRAWING NAME: OIL\_DOCK\_12\_2DEC2025

PORT OF CORPUS CHRISTI AUTHORITY

OIL DOCK 12  
SOUNDINGS  
AN EXHIBIT OF A  
BATHYMETRIC SURVEY  
LOCATED IN  
CORPUS CHRISTI, TEXAS

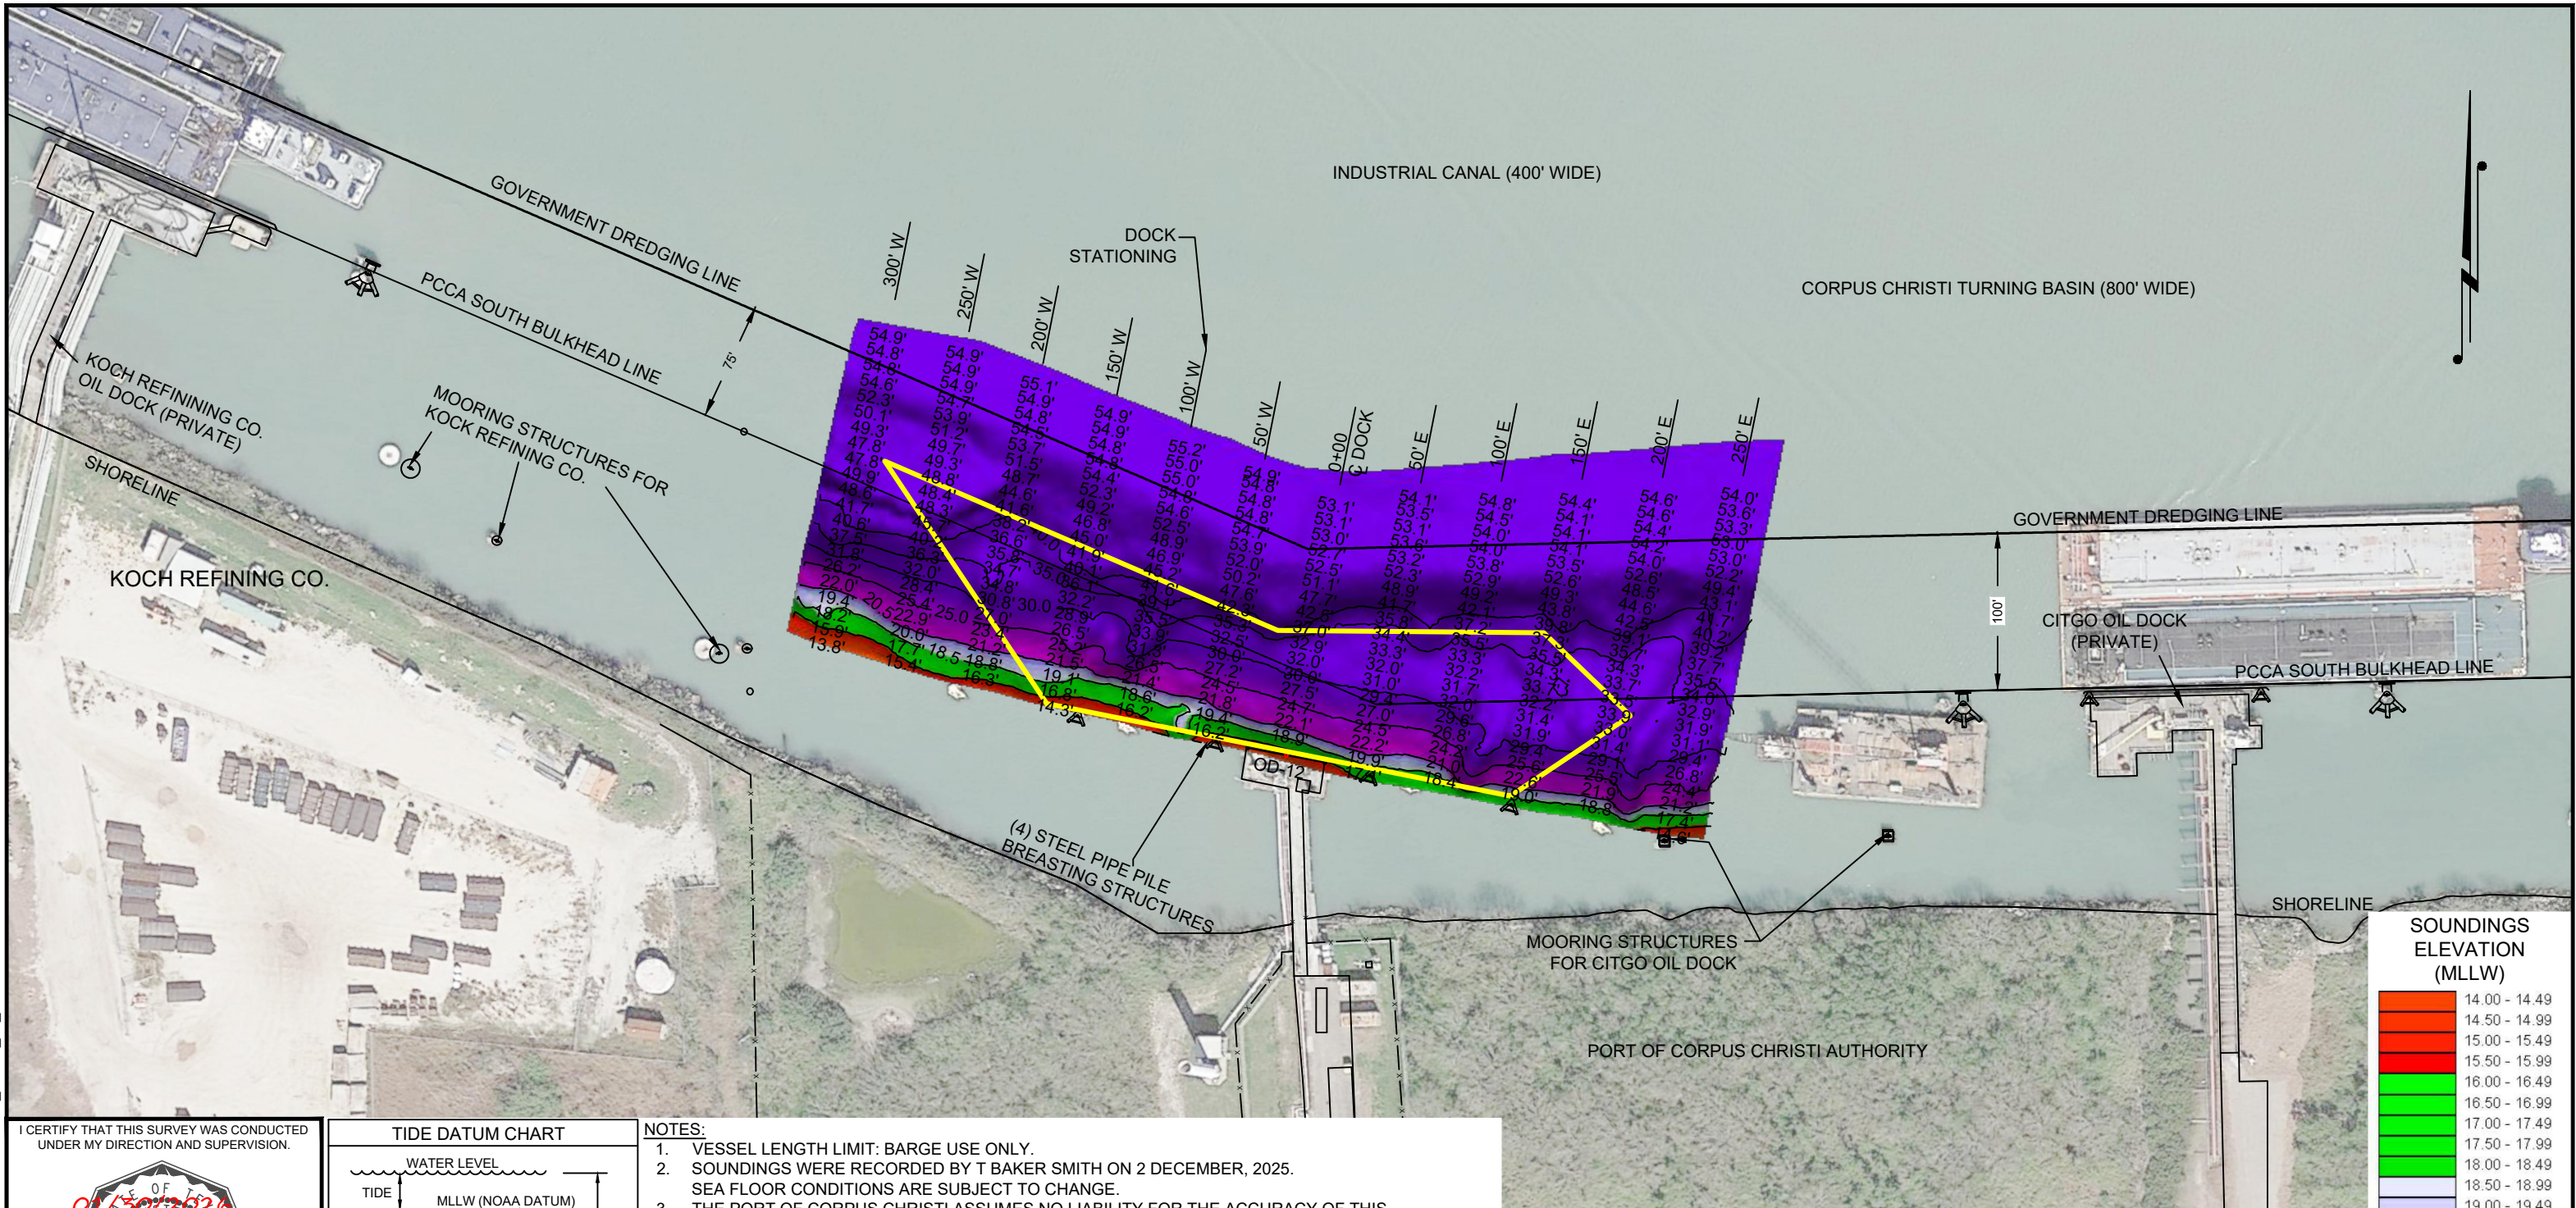
- NOTES:
1. VESSEL LENGTH LIMIT: BARGE USE ONLY.
  2. SOUNDINGS WERE RECORDED BY T BAKER SMITH ON 2 DECEMBER, 2025. SEA FLOOR CONDITIONS ARE SUBJECT TO CHANGE. THE PORT OF CORPUS CHRISTI ASSUMES NO LIABILITY FOR THE ACCURACY OF THIS INFORMATION. THE INFORMATION DEPICTED ON THIS MAP REPRESENTS THE RESULTS OF SURVEYS MADE ON THE DATE DEPICTED AND CAN ONLY BE CONSIDERED AS INDICATING THE GENERAL CONDITIONS AT THAT TIME. THESE CONDITIONS ARE SUBJECT TO RAPID CHANGE DUE TO SHOALING EVENTS.
  3. ALL READINGS ARE BASED ON THE NATIONAL OCEANIC AND ATMOSPHERIC ADMINISTRATION (NOAA) MEAN LOWER LOW WATER (MLLW) DATUM, (O.O').
  4. HORIZONTAL DATUM: NAD-83, STATE PLANE, TEXAS SOUTH ZONE, US FEET.
  5. TO GET THE DEPTH OF WATER, ADD THE CURRENT TIDE LEVEL TO THE READINGS SHOWN. (SEE TIDE DATUM CHART).

DOCK & BREASTING STRUCTURE COORDINATES  
STATE PLANE, NAD-83, TEXAS SOUTH, US FEET

BENCHMARK: PCCA "OD-12"  
PCCA BRASS DISK NE COR.  
STRUCTURE, ELEV. +7.58 (MLT) +6.28 (MLLW)  
N: 17185425.73  
E: 1335829.73
