SHEET NO: 1 OF 1

PORT OF CORPUS CHRISTI AUTHORITY

OIL DOCK 14  
2026-Q2  
AN EXHIBIT OF A  
BATHYMETRIC SURVEY  
LOCATED IN  
CORPUS CHRISTI, TEXAS

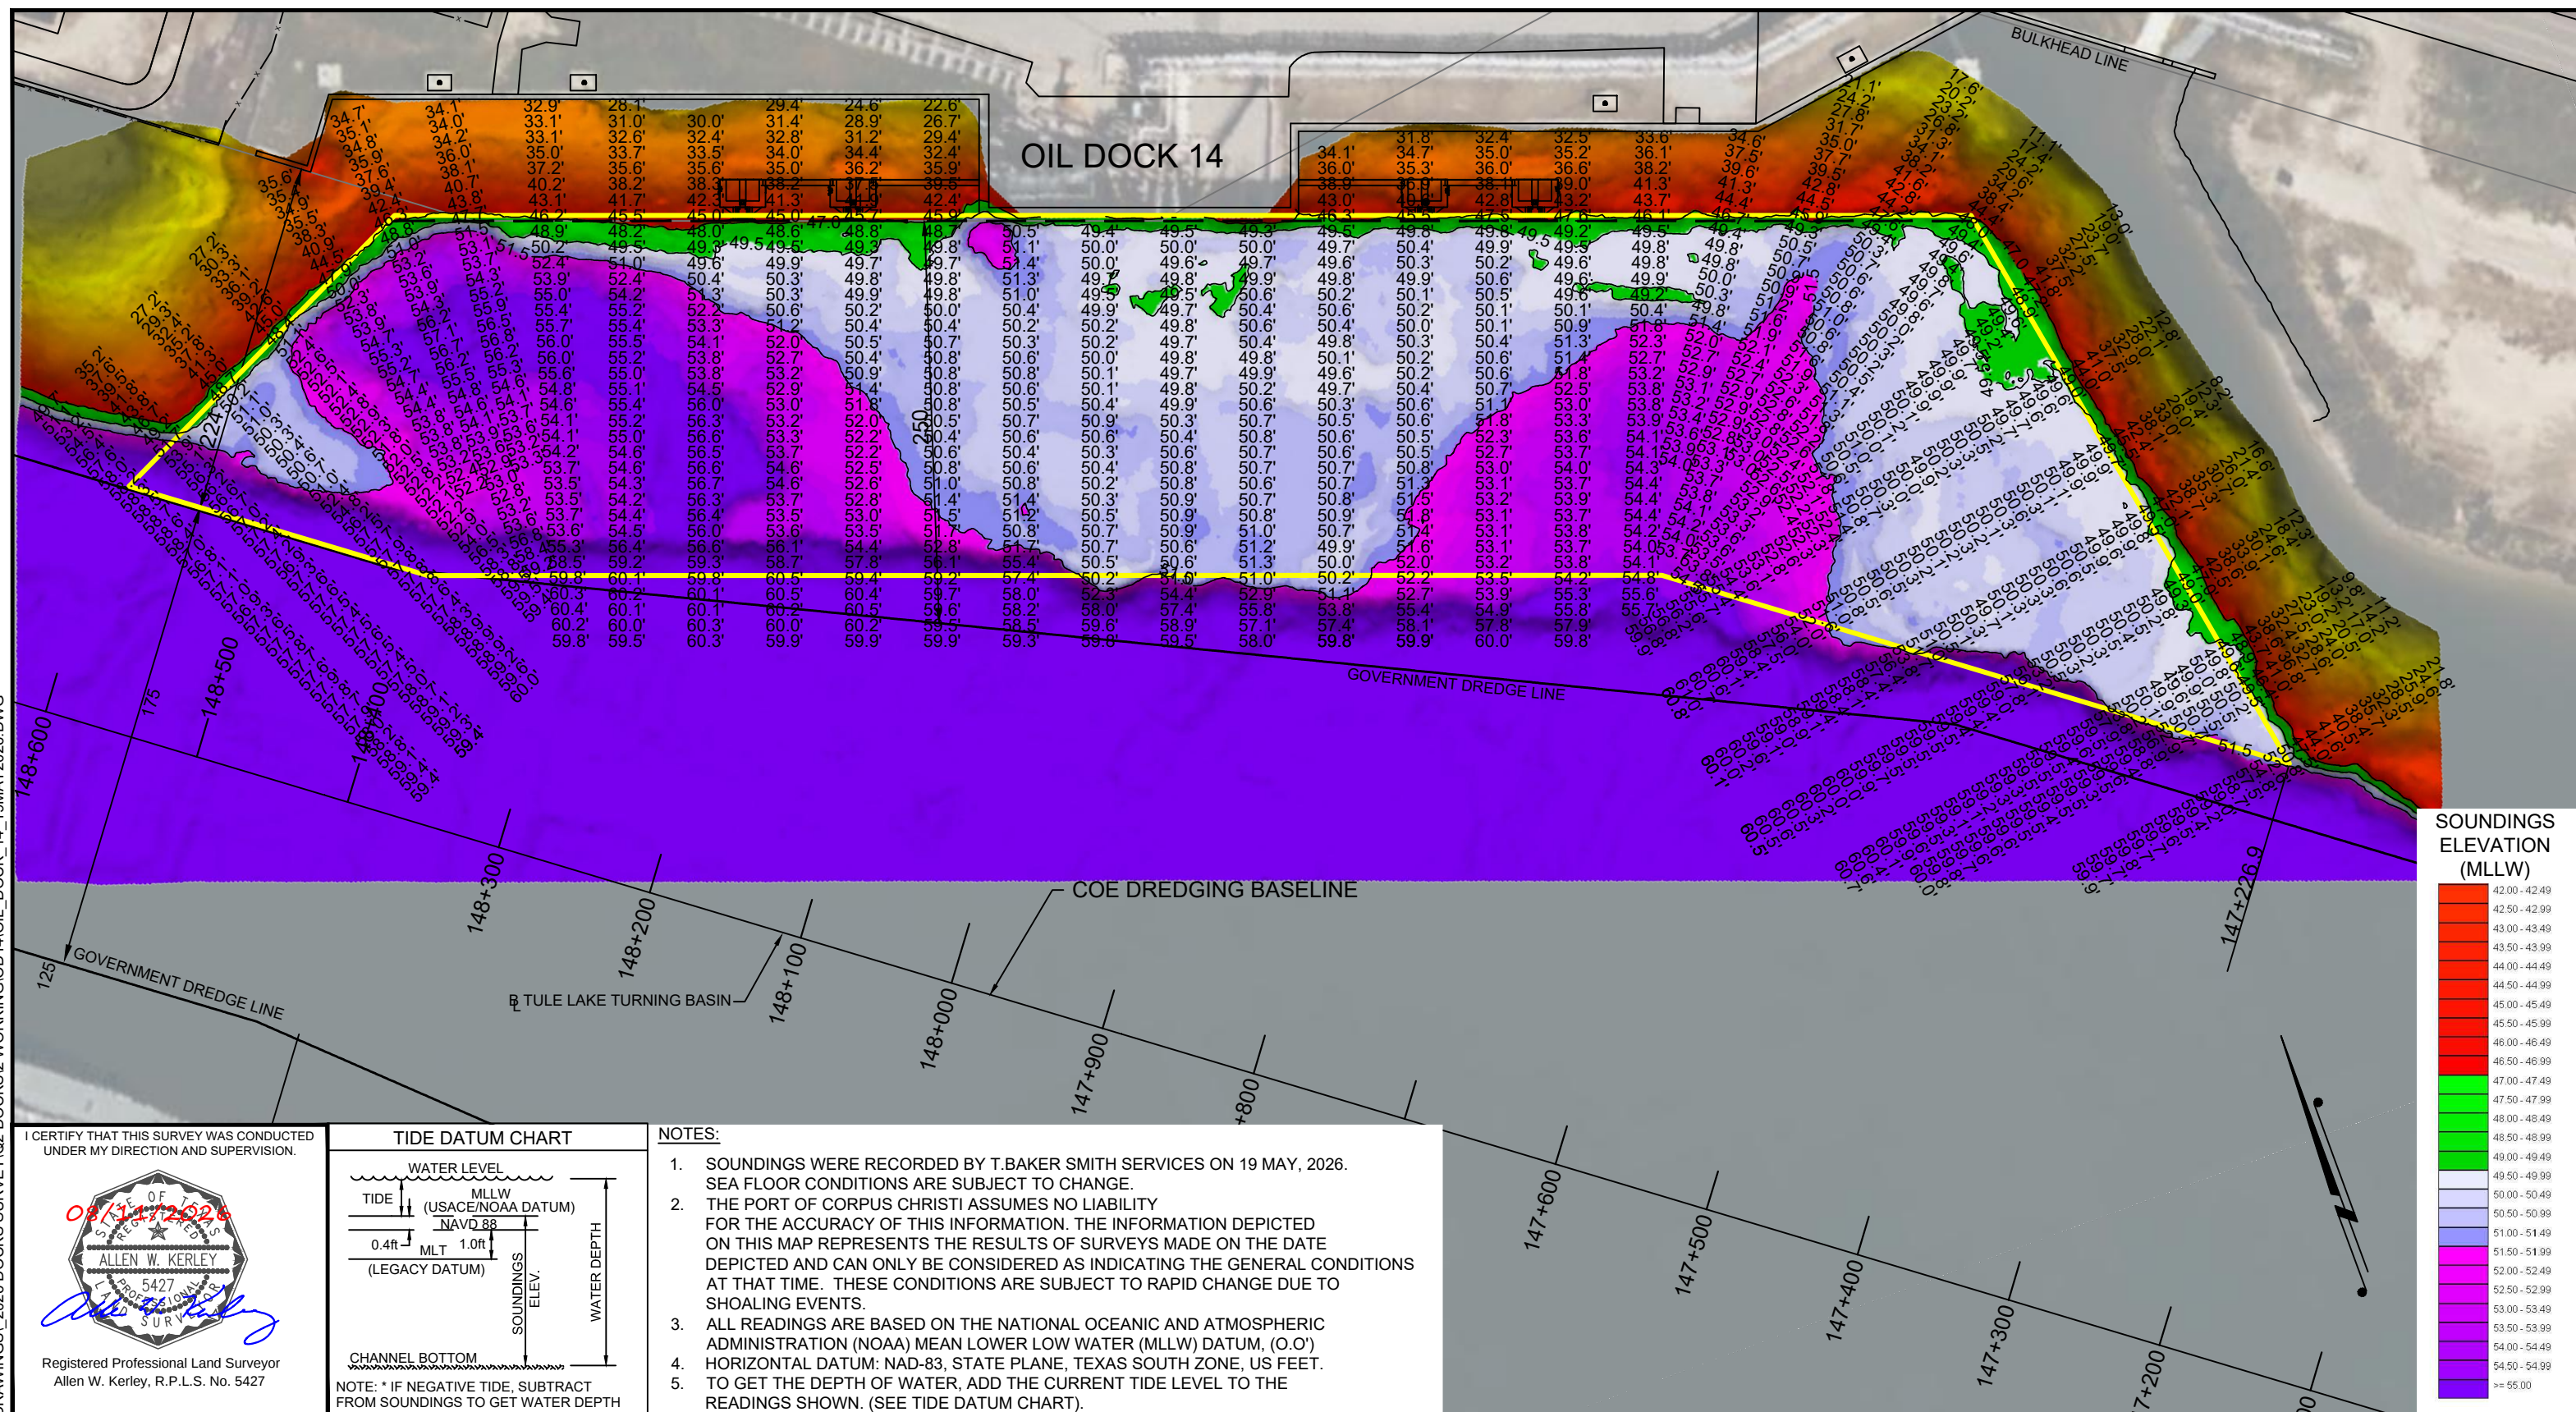
NOTE: \* IF NEGATIVE TIDE, SUBTRACT FROM SOUNDINGS TO GET WATER DEPTH

1. SOUNDINGS WERE RECORDED BY T.BAKER SMITH SERVICES ON 19 MAY, 2026. SEA FLOOR CONDITIONS ARE SUBJECT TO CHANGE.
2. THE PORT OF CORPUS CHRISTI ASSUMES NO LIABILITY FOR THE ACCURACY OF THIS INFORMATION. THE INFORMATION DEPICTED ON THIS MAP REPRESENTS THE RESULTS OF SURVEYS MADE ON THE DATE DEPICTED AND CAN ONLY BE CONSIDERED AS INDICATING THE GENERAL CONDITIONS AT THAT TIME. THESE CONDITIONS ARE SUBJECT TO RAPID CHANGE DUE TO SHOALING EVENTS.
3. ALL READINGS ARE BASED ON THE NATIONAL OCEANIC AND ATMOSPHERIC ADMINISTRATION (NOAA) MEAN LOWER LOW WATER (MLLW) DATUM, (O.O')
4. HORIZONTAL DATUM: NAD-83, STATE PLANE, TEXAS SOUTH ZONE, US FEET.
5. TO GET THE DEPTH OF WATER, ADD THE CURRENT TIDE LEVEL TO THE READINGS SHOWN. (SEE TIDE DATUM CHART).
