PORT OF CORPUS CHRISTI AUTHORITY

SOUNDINGS
OIL DOCK 3

PLAN

DATE: NOV. 2022

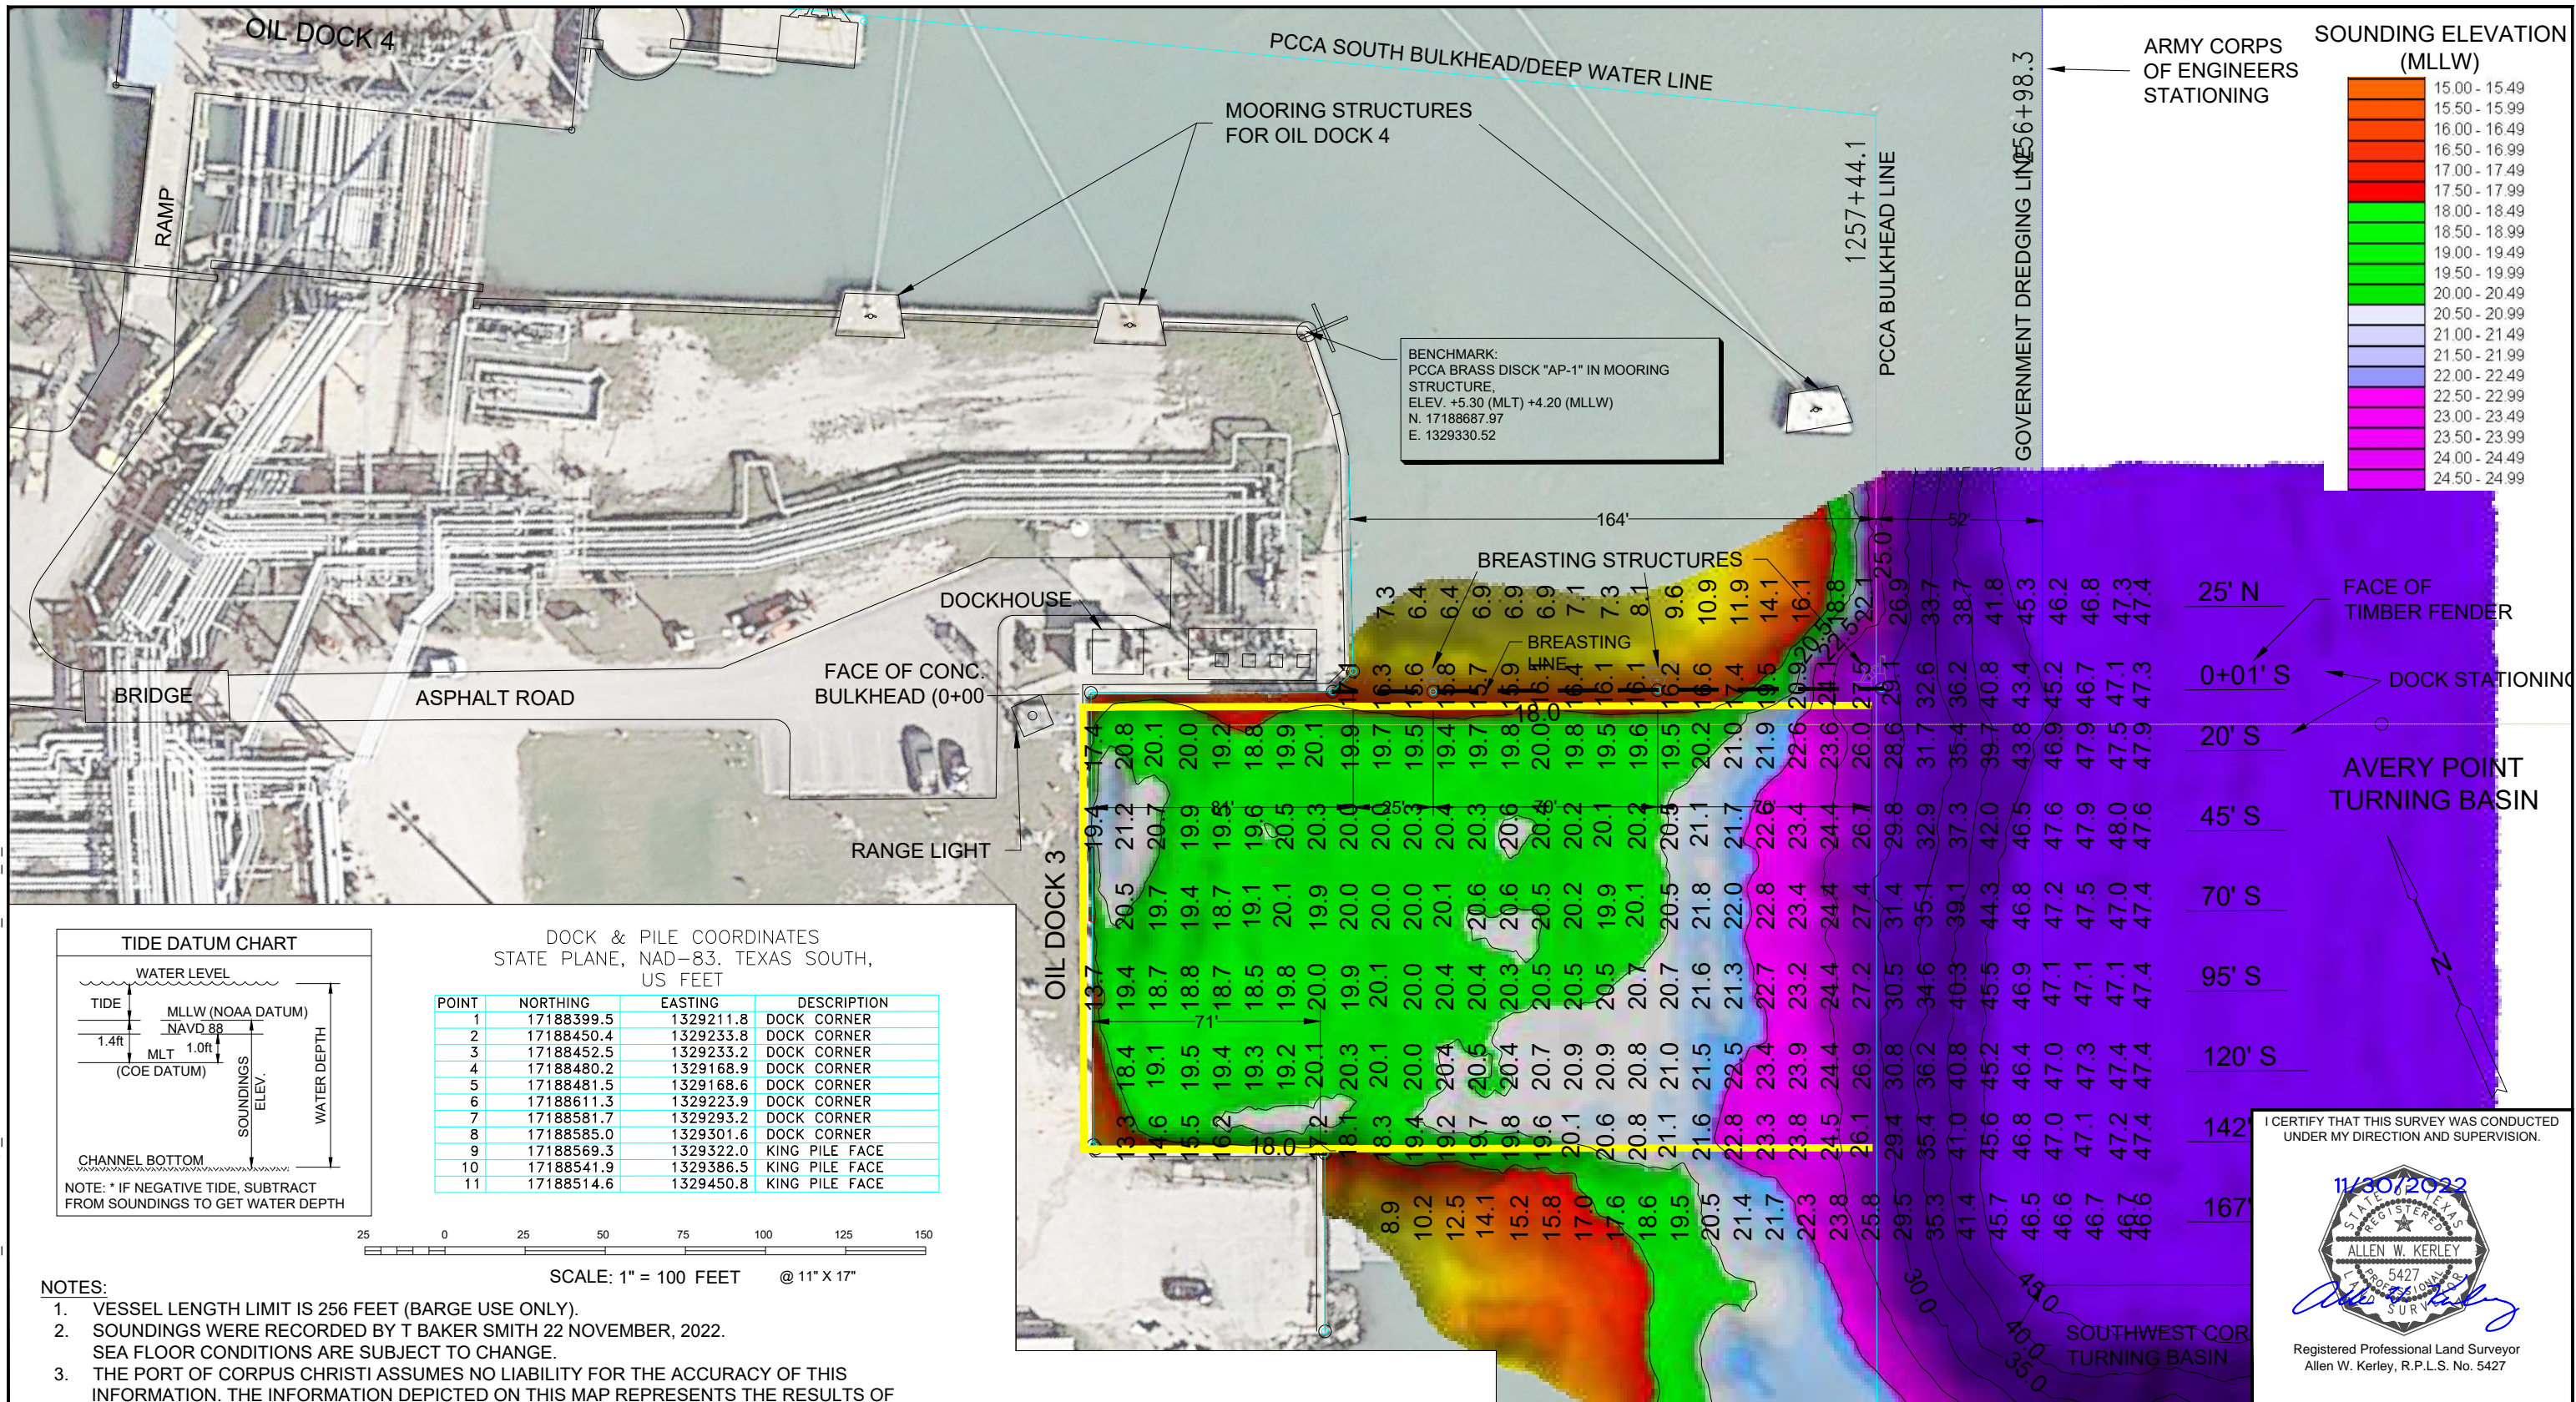
- NOTES:**
- VESSEL LENGTH LIMIT IS 256 FEET (BARGE USE ONLY).
 - SOUNDINGS WERE RECORDED BY T BAKER SMITH 22 NOVEMBER, 2022. SEA FLOOR CONDITIONS ARE SUBJECT TO CHANGE.
 - THE PORT OF CORPUS CHRISTI ASSUMES NO LIABILITY FOR THE ACCURACY OF THIS INFORMATION. THE INFORMATION DEPICTED ON THIS MAP REPRESENTS THE RESULTS OF SURVEYS MADE ON THE DATE DEPICTED AND CAN ONLY BE CONSIDERED AS INDICATING THE GENERAL CONDITIONS AT THAT TIME. THESE CONDITIONS ARE SUBJECT TO RAPID CHANGE DUE TO SHOALING EVENTS.
 - ALL READINGS ARE BASED ON THE NATIONAL OCEANIC AND ATMOSPHERIC ADMINISTRATION (NOAA) MEAN LOWER LOW WATER (MLLW) DATUM, (O.O')
 - HORIZONTAL DATUM: NAD-83, STATE PLANE, TEXAS SOUTH ZONE, US FEET.
 - TO GET THE DEPTH OF WATER, ADD THE CURRENT TIDE LEVEL TO THE READINGS SHOWN. (SEE TIDE DATUM CHART).
