DATE: 03/28/2025 JOB NO: 2025.0225

DRAWING NAME: OIL DOCK 6 12MAR2025

PORT OF CORPUS CHRISTI AUTHORITY

OIL DOCK 6
SOUNDINGS
AN EXHIBIT OF A
BATHYMETRIC SURVEY
LOCATED IN
CORPUS CHRISTI, TEXAS

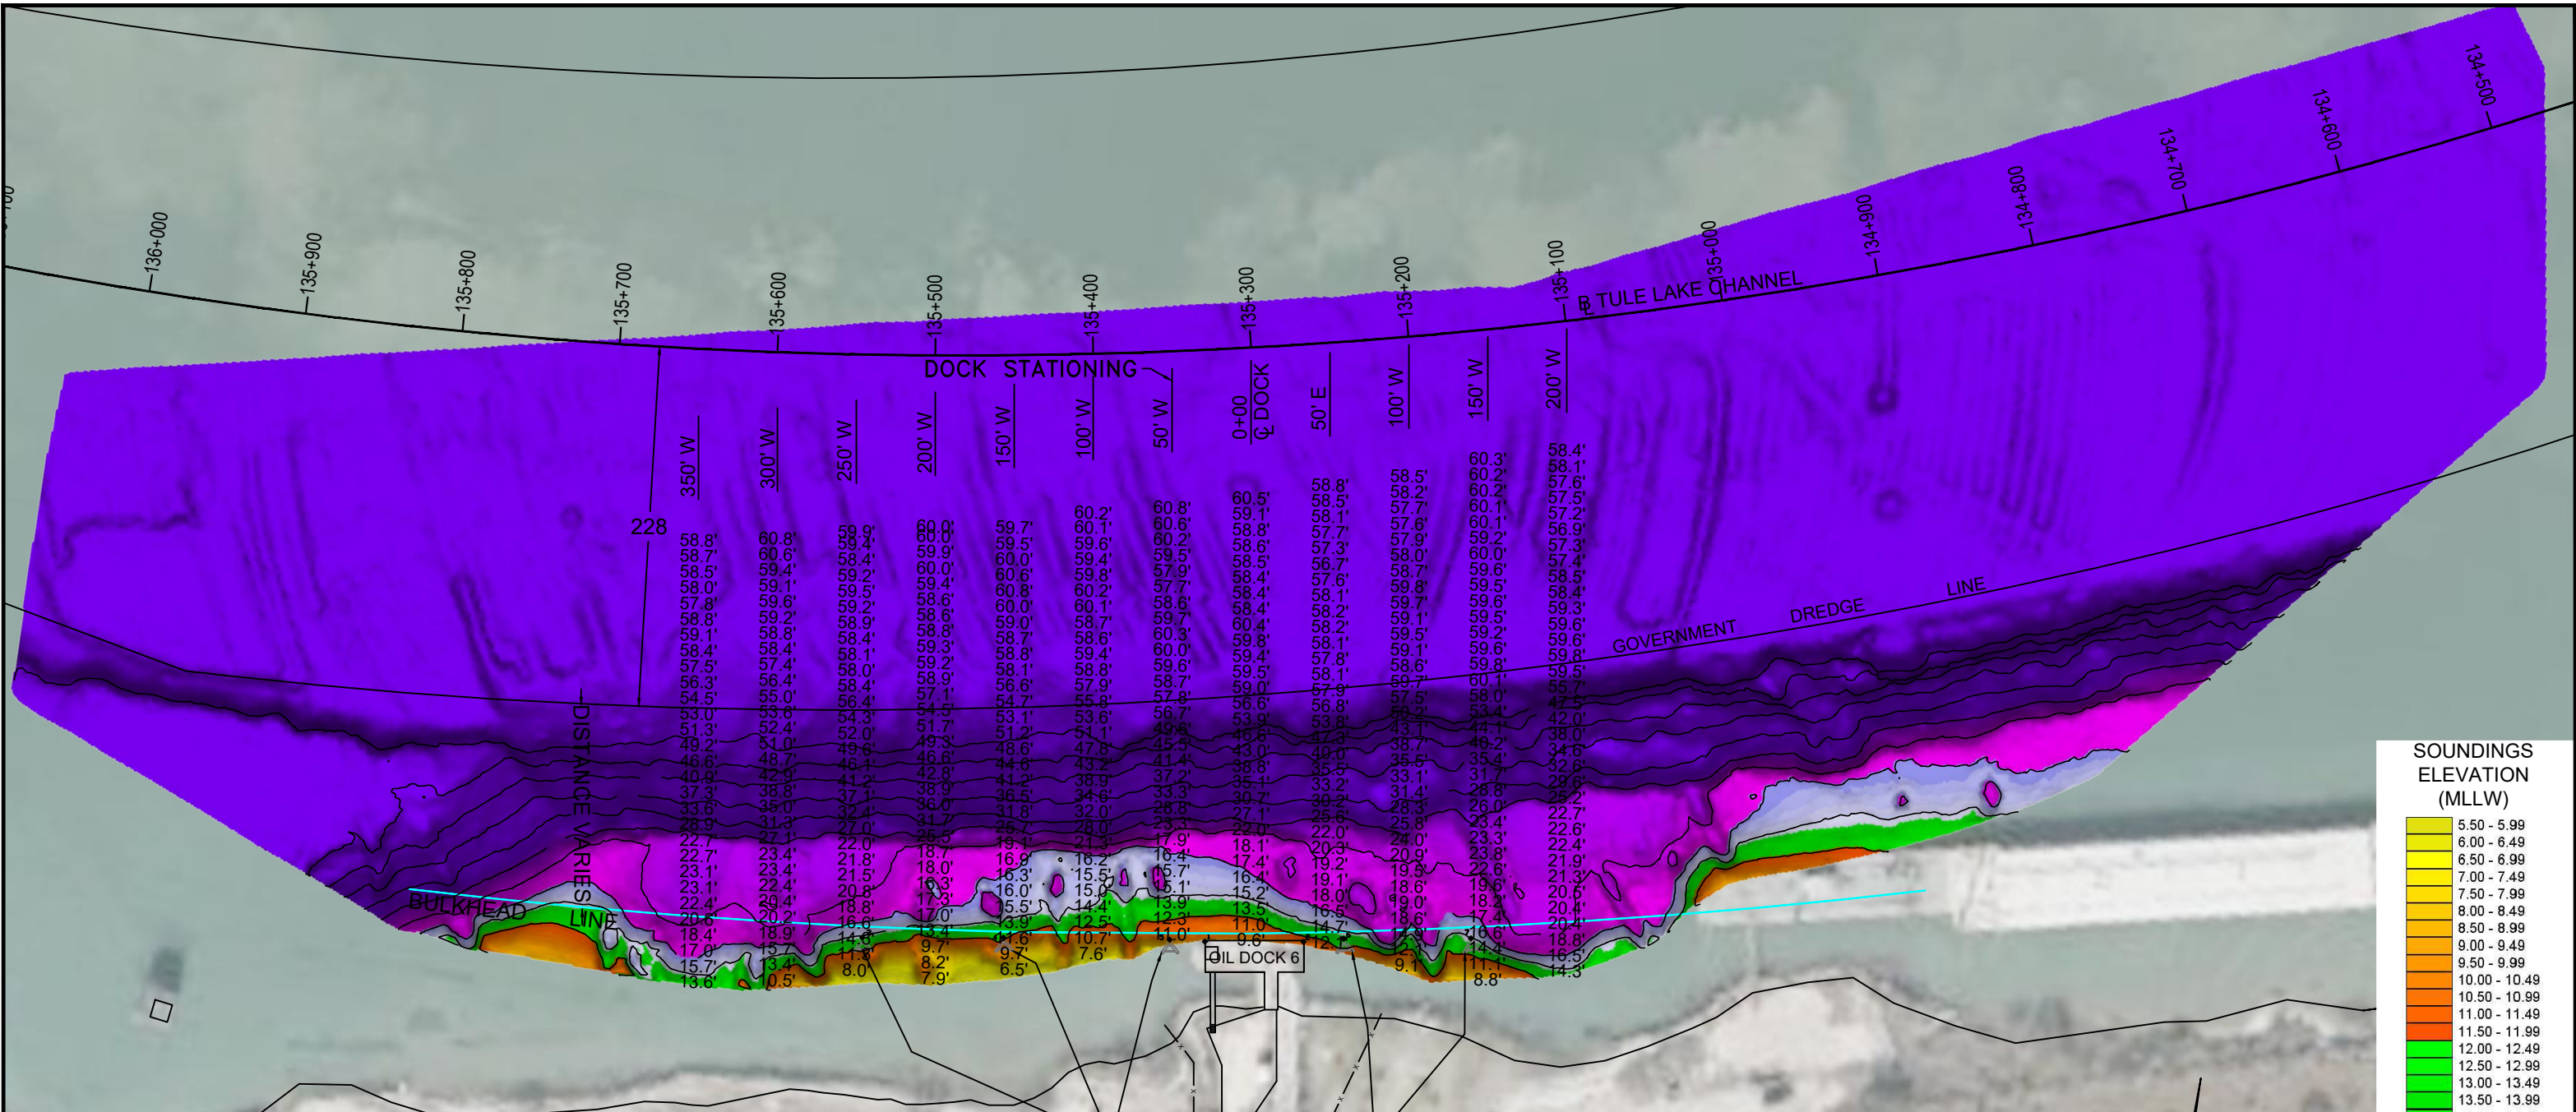
SHEET NO: 1 OF 1

- NOTES:**
- VESSEL LENGTH LIMIT: BARGE USE ONLY.
 - SOUNDINGS WERE RECORDED BY T BAKER SMITH ON 12 MARCH, 2025. SEA FLOOR CONDITIONS ARE SUBJECT TO CHANGE.
 - THE PORT OF CORPUS CHRISTI ASSUMES NO LIABILITY FOR THE ACCURACY OF THIS INFORMATION. THE INFORMATION DEPICTED ON THIS MAP REPRESENTS THE RESULTS OF SURVEYS MADE ON THE DATE DEPICTED AND CAN ONLY BE CONSIDERED AS INDICATING THE GENERAL CONDITIONS AT THAT TIME. THESE CONDITIONS ARE SUBJECT TO RAPID CHANGE DUE TO SHOALING EVENTS.
 - ALL READINGS ARE BASED ON THE NATIONAL OCEANIC AND ATMOSPHERIC ADMINISTRATION (NOAA) MEAN LOWER LOW WATER (MLLW) DATUM, (0.0')
 - HORIZONTAL DATUM: NAD-83, STATE PLANE, TEXAS SOUTH ZONE, US FEET.
 - TO GET THE DEPTH OF WATER, ADD THE CURRENT TIDE LEVEL TO THE READINGS SHOWN. (SEE TIDE DATUM CHART).
