PORT OF CORPUS CHRISTI AUTHORITY

OIL DOCK 6
SOUNDINGS
AN EXHIBIT OF A
BATHYMETRIC SURVEY
LOCATED IN
CORPUS CHRISTI, TEXAS

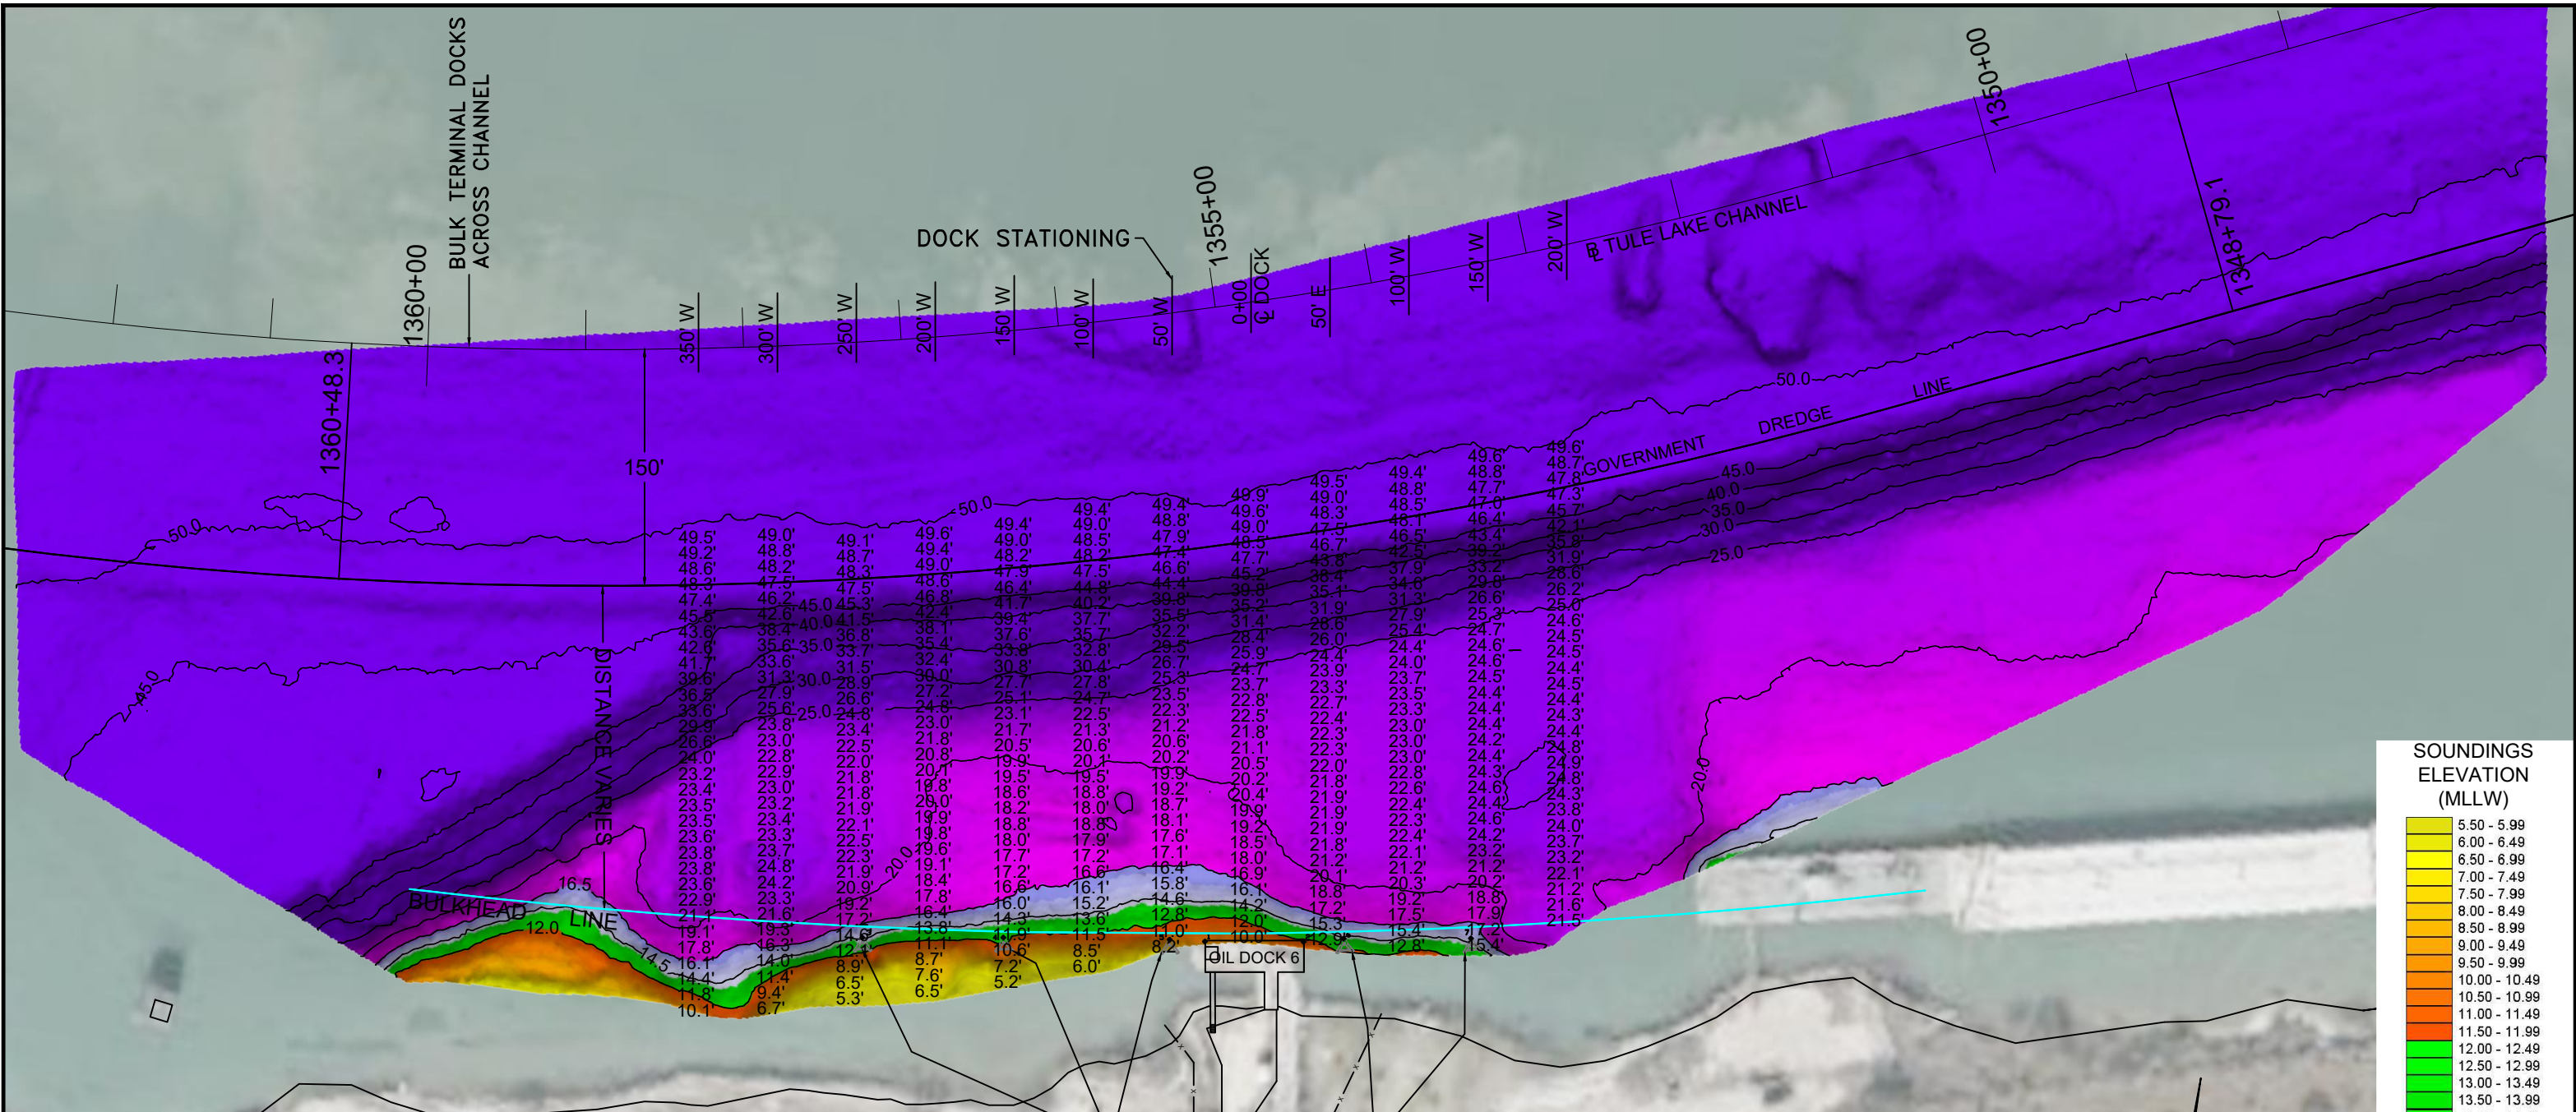
- NOTES:**
- VESSEL LENGTH LIMIT: BARGE USE ONLY.
 - SOUNDINGS WERE RECORDED BY T BAKER SMITH ON 13 MARCH, 2024. SEA FLOOR CONDITIONS ARE SUBJECT TO CHANGE.
 - THE PORT OF CORPUS CHRISTI ASSUMES NO LIABILITY FOR THE ACCURACY OF THIS INFORMATION. THE INFORMATION DEPICTED ON THIS MAP REPRESENTS THE RESULTS OF SURVEYS MADE ON THE DATE DEPICTED AND CAN ONLY BE CONSIDERED AS INDICATING THE GENERAL CONDITIONS AT THAT TIME. THESE CONDITIONS ARE SUBJECT TO RAPID CHANGE DUE TO SHOALING EVENTS.
 - ALL READINGS ARE BASED ON THE NATIONAL OCEANIC AND ATMOSPHERIC ADMINISTRATION (NOAA) MEAN LOWER LOW WATER (MLLW) DATUM, (0.0')
 - HORIZONTAL DATUM: NAD-83, STATE PLANE, TEXAS SOUTH ZONE, US FEET.
 - TO GET THE DEPTH OF WATER, ADD THE CURRENT TIDE LEVEL TO THE READINGS SHOWN. (SEE TIDE DATUM CHART).

DOCK & BREASTING STRUCTURE COORDINATES
STATE PLANE, NAD-83. TEXAS SOUTH, US FEET

POINT	NORTHING	EASTING	DESCRIPTION
1	17186636.9	1320846.3	dock corner
2	17186645.6	1320708.1	dock corner
3	17186608.6	1320431.0	pile face
4	17186621.3	1320519.6	pile face
5	17186634.9	1320624.0	pile face
6	17186651.2	1320732.9	pile face
7	17186662.9	1320812.8	pile face
