DRAWN BY:	MMC	APPROVED BY:	AWK
DATE:	07/11/2024	JOB NO:	2024.0287
DRAWING NAME:	OIL DOCK 6 1JULY2024		
PROJECTION:	TEXAS STATE PLANE SOUTH ZONE		
GEO. DATUM:	NAD83 (2011)   VERT. DATUM: NAVD88		
GRID UNITS:	US SURVEY FEET		
SHEET NO:	1	OF	1

**PORT OF CORPUS CHRISTI AUTHORITY**

**OIL DOCK 6**  
 SOUNDINGS  
 AN EXHIBIT OF A  
 BATHYMETRIC SURVEY  
 LOCATED IN  
 CORPUS CHRISTI, TEXAS

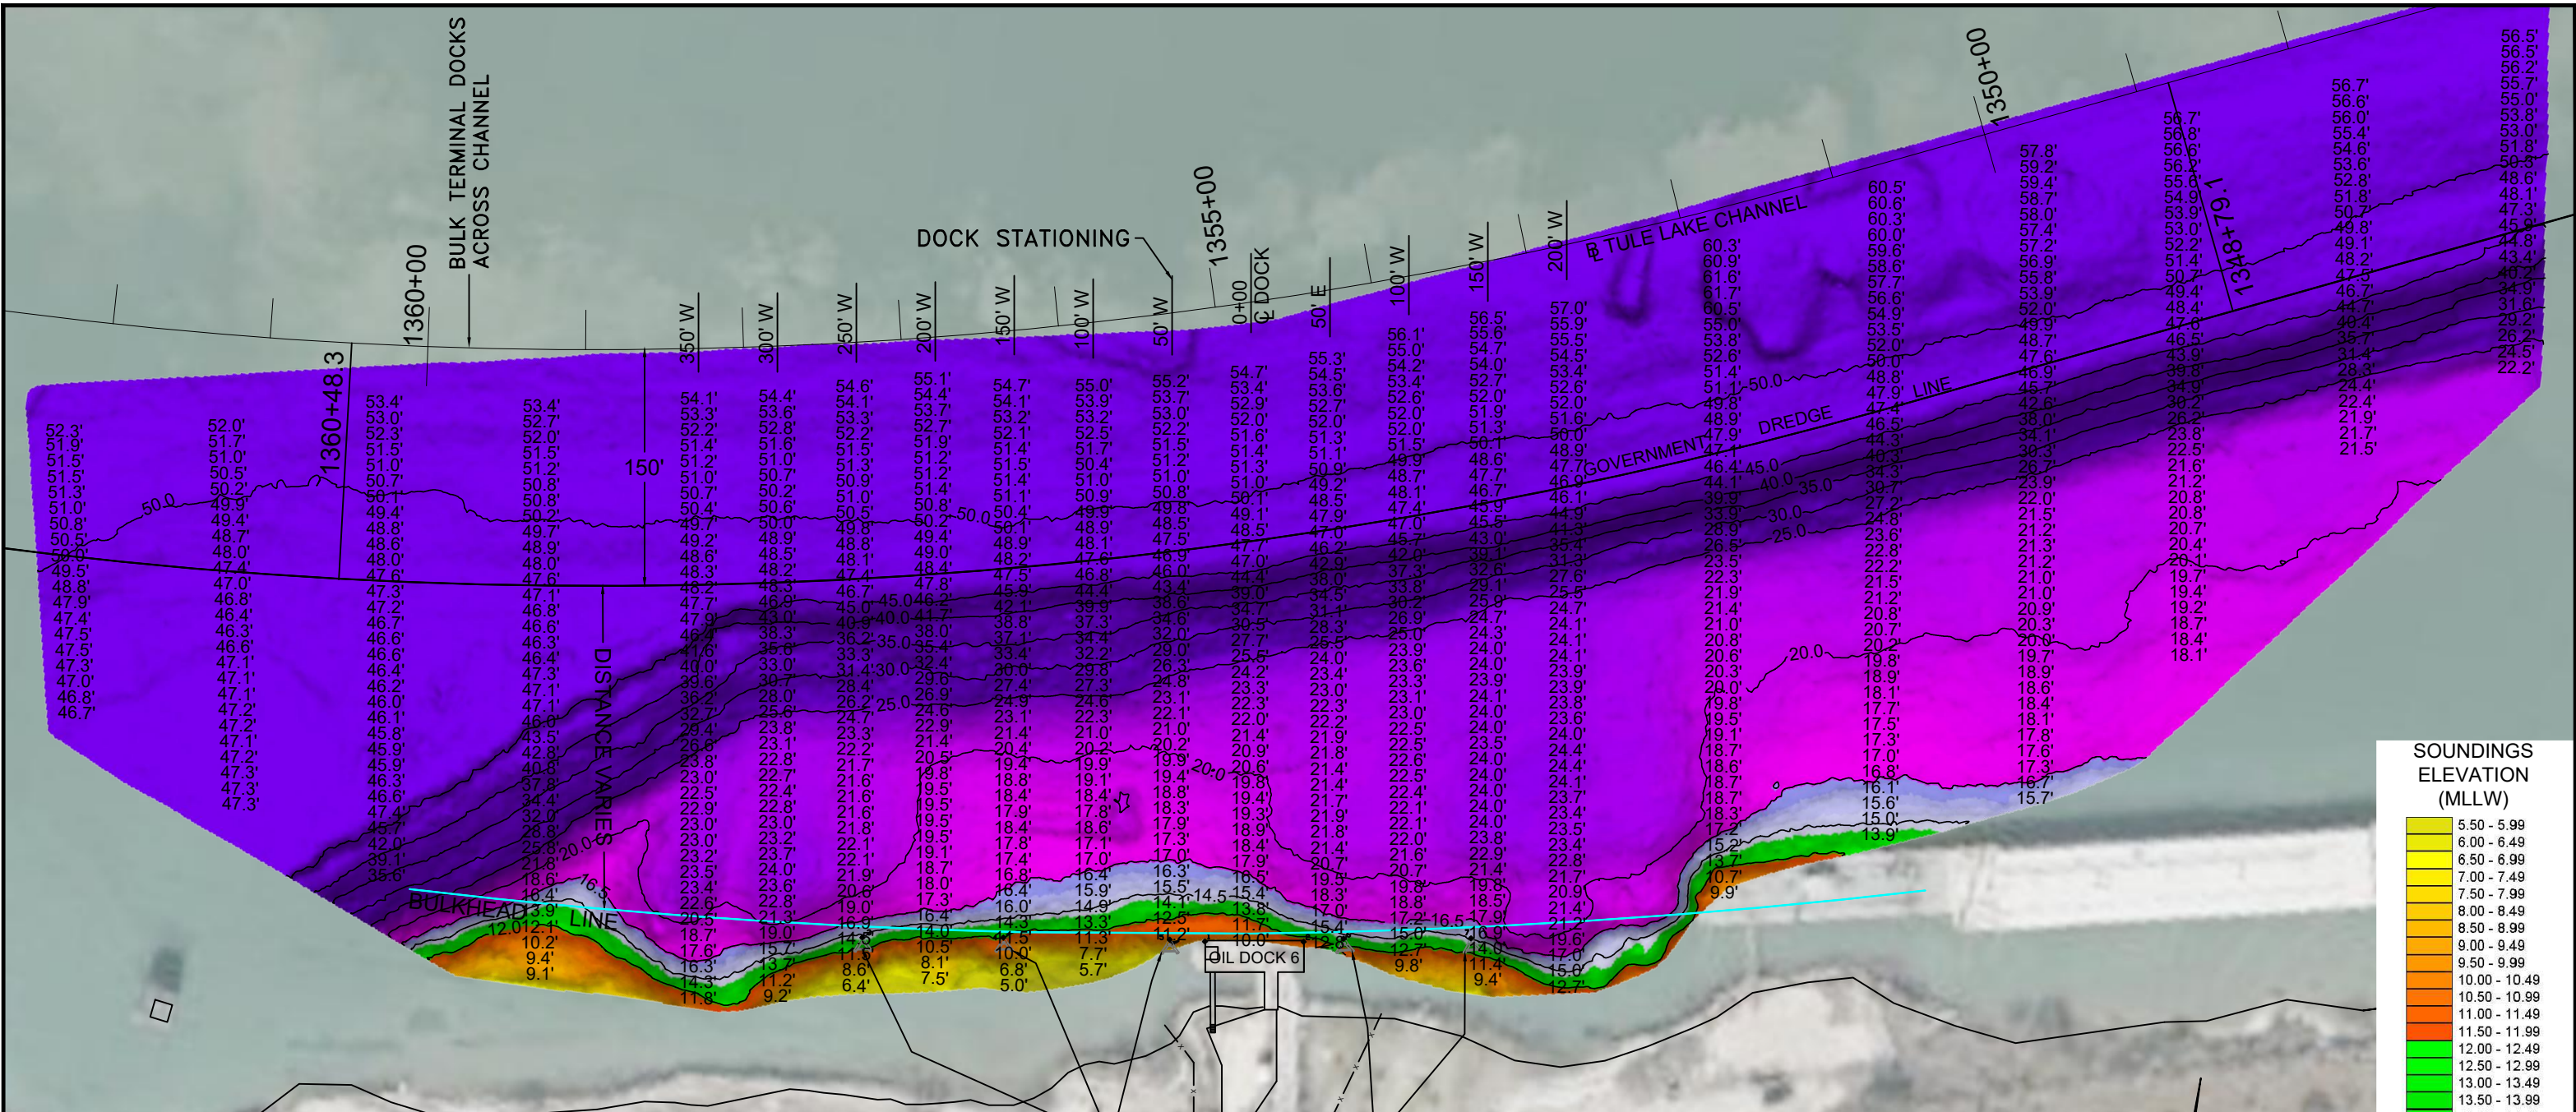
- NOTES:**
1. VESSEL LENGTH LIMIT: BARGE USE ONLY.
  2. SOUNDINGS WERE RECORDED BY T BAKER SMITH ON 1 JULY, 2024. SEA FLOOR CONDITIONS ARE SUBJECT TO CHANGE.
  3. THE PORT OF CORPUS CHRISTI ASSUMES NO LIABILITY FOR THE ACCURACY OF THIS INFORMATION. THE INFORMATION DEPICTED ON THIS MAP REPRESENTS THE RESULTS OF SURVEYS MADE ON THE DATE DEPICTED AND CAN ONLY BE CONSIDERED AS INDICATING THE GENERAL CONDITIONS AT THAT TIME. THESE CONDITIONS ARE SUBJECT TO RAPID CHANGE DUE TO SHOALING EVENTS.
  4. ALL READINGS ARE BASED ON THE NATIONAL OCEANIC AND ATMOSPHERIC ADMINISTRATION (NOAA) MEAN LOWER LOW WATER (MLLW) DATUM, (0.0').
  5. HORIZONTAL DATUM: NAD-83, STATE PLANE, TEXAS SOUTH ZONE, US FEET.
  6. TO GET THE DEPTH OF WATER, ADD THE CURRENT TIDE LEVEL TO THE READINGS SHOWN. (SEE TIDE DATUM CHART).
