PORT OF CORPUS CHRISTI AUTHORITY

OIL DOCK 6  
SOUNDINGS  
AN EXHIBIT OF A  
BATHYMETRIC SURVEY  
LOCATED IN  
CORPUS CHRISTI, TEXAS

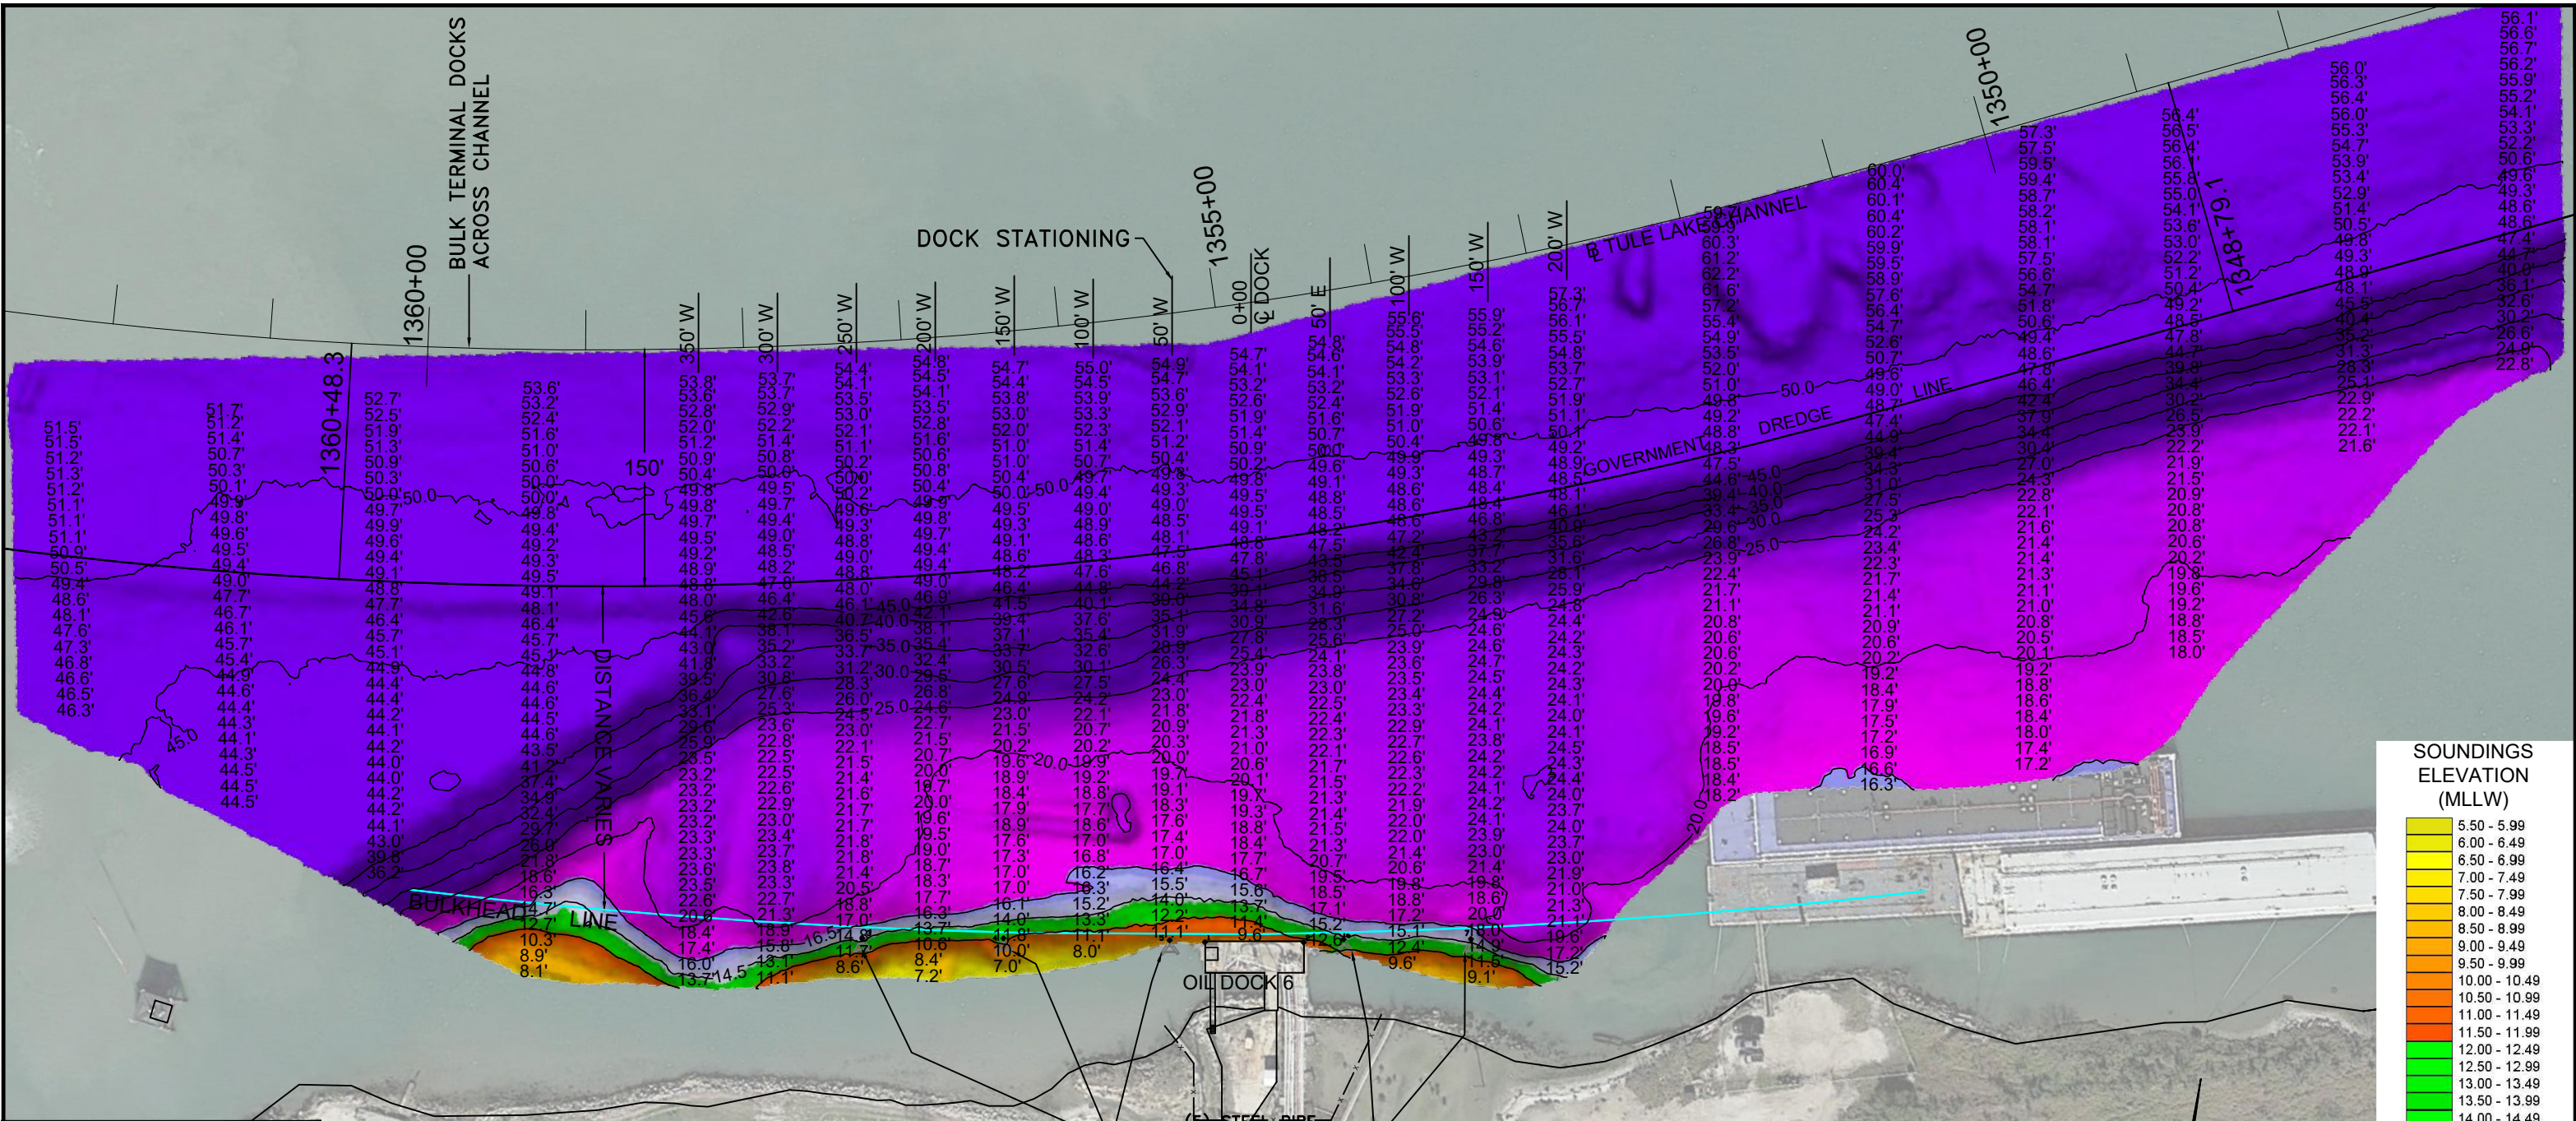
- NOTES:**
1. VESSEL LENGTH LIMIT: BARGE USE ONLY.
  2. SOUNDINGS WERE RECORDED BY T BAKER SMITH ON 21 MARCH, 2023. SEA FLOOR CONDITIONS ARE SUBJECT TO CHANGE.
  3. THE PORT OF CORPUS CHRISTI ASSUMES NO LIABILITY FOR THE ACCURACY OF THIS INFORMATION. THE INFORMATION DEPICTED ON THIS MAP REPRESENTS THE RESULTS OF SURVEYS MADE ON THE DATE DEPICTED AND CAN ONLY BE CONSIDERED AS INDICATING THE GENERAL CONDITIONS AT THAT TIME. THESE CONDITIONS ARE SUBJECT TO RAPID CHANGE DUE TO SHOALING EVENTS.
  4. ALL READINGS ARE BASED ON THE NATIONAL OCEANIC AND ATMOSPHERIC ADMINISTRATION (NOAA) MEAN LOWER LOW WATER (MLLW) DATUM, (0.0')
  5. HORIZONTAL DATUM: NAD-83, STATE PLANE, TEXAS SOUTH ZONE, US FEET.
  6. TO GET THE DEPTH OF WATER, ADD THE CURRENT TIDE LEVEL TO THE READINGS SHOWN. (SEE TIDE DATUM CHART).
