**PORT OF CORPUS CHRISTI AUTHORITY**

**OIL DOCK 6**  
 2026 Q1  
 AN EXHIBIT OF A  
 BATHYMETRIC SURVEY  
 LOCATED IN  
 CORPUS CHRISTI, TEXAS

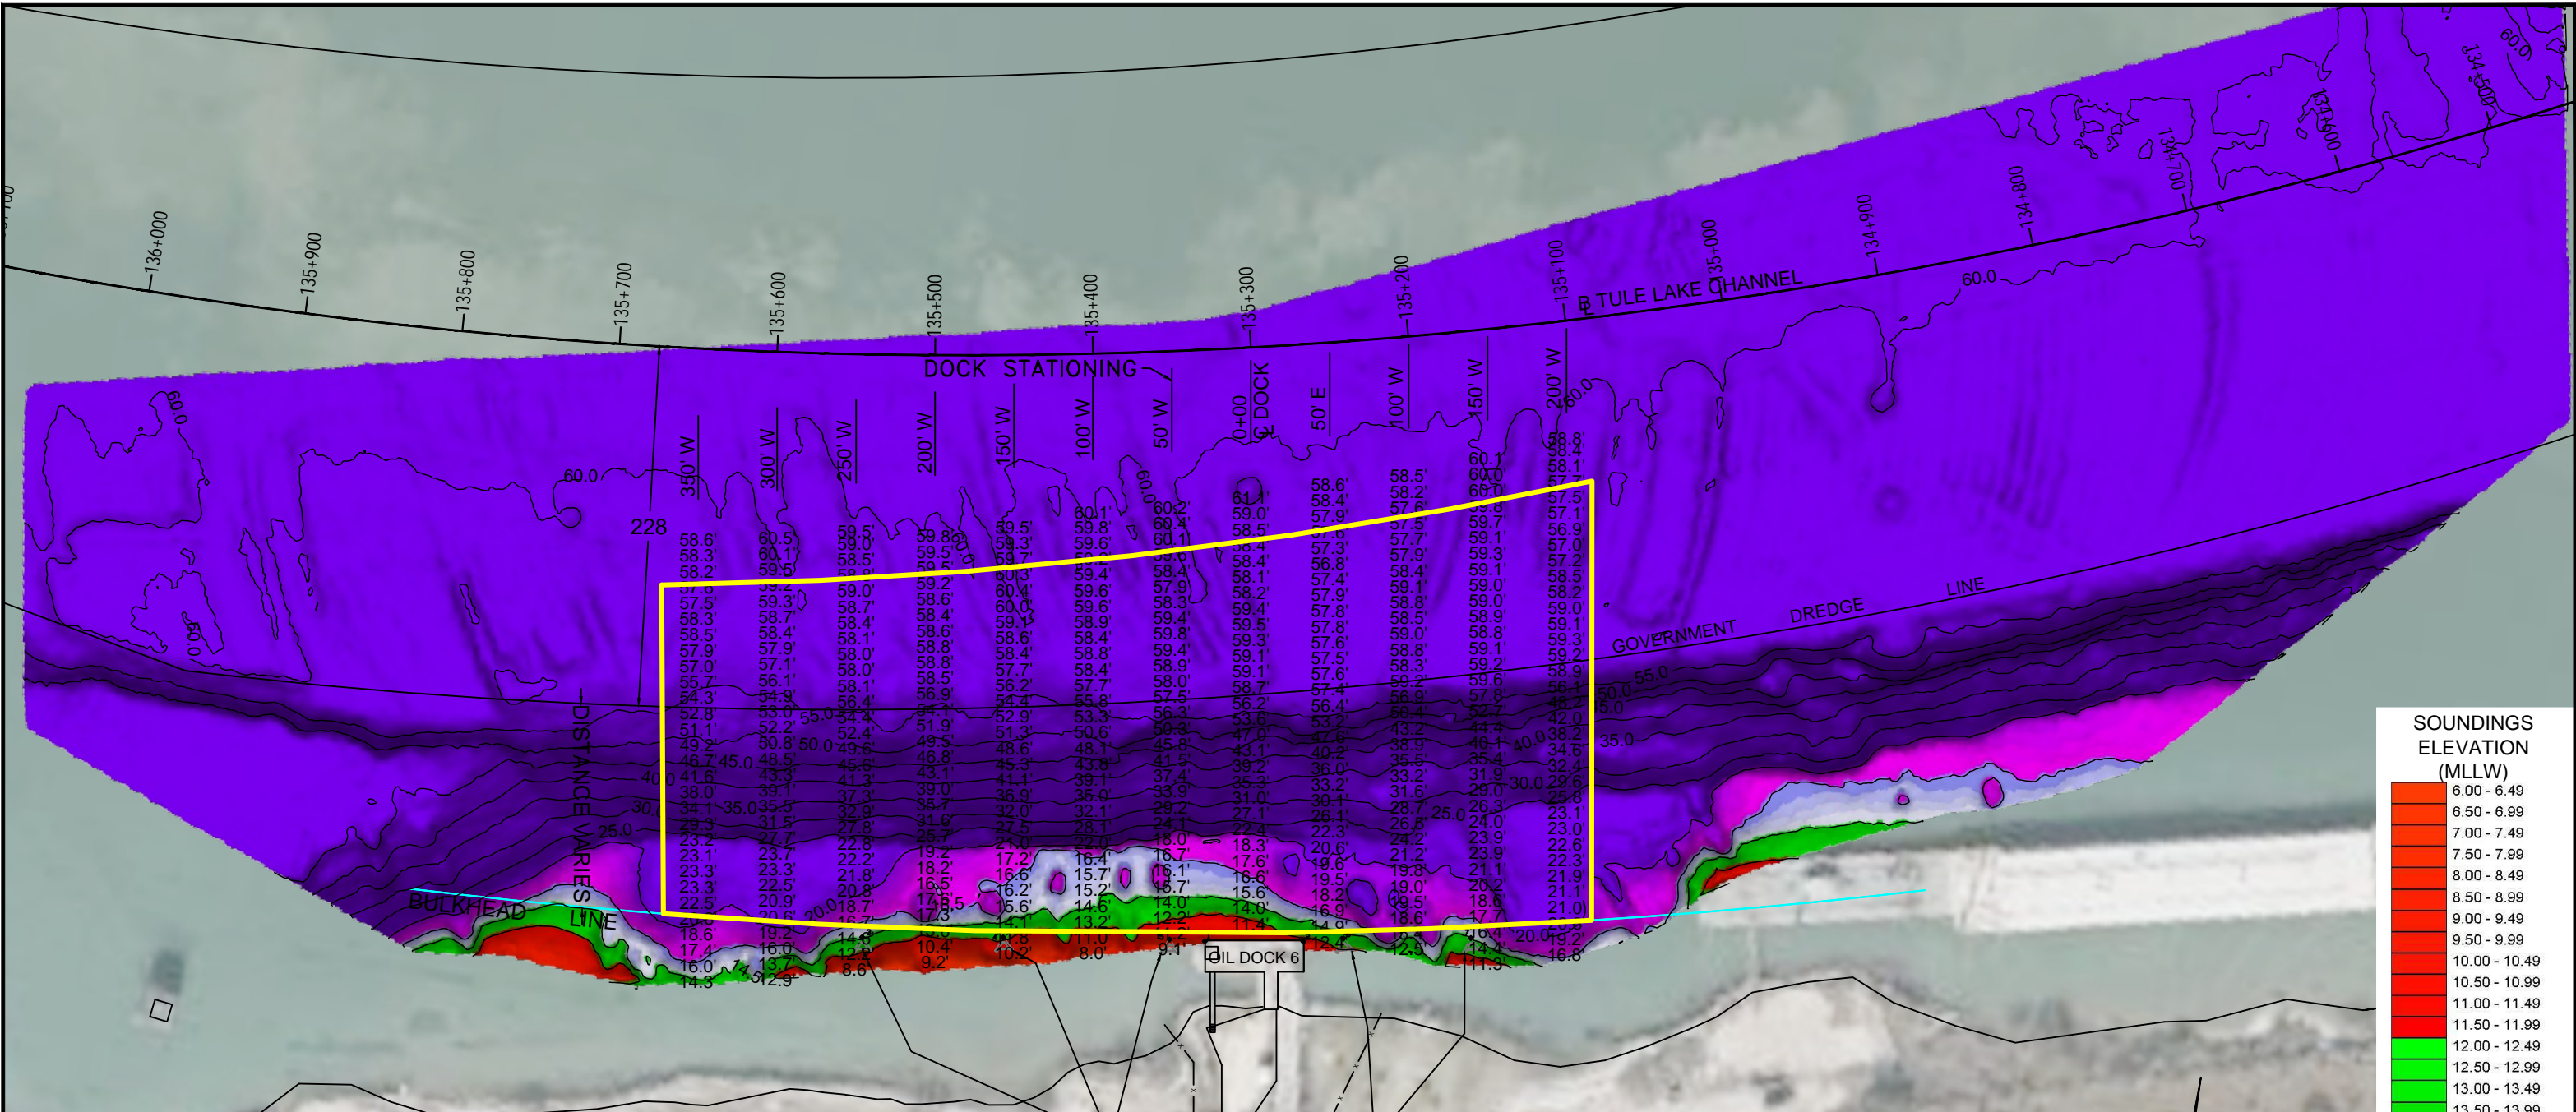
- NOTES:**
- VESSEL LENGTH LIMIT: BARGE USE ONLY.
  - SOUNDINGS WERE RECORDED BY T BAKER SMITH ON 23 FEBRUARY, 2026. SEA FLOOR CONDITIONS ARE SUBJECT TO CHANGE.
  - THE PORT OF CORPUS CHRISTI ASSUMES NO LIABILITY FOR THE ACCURACY OF THIS INFORMATION. THE INFORMATION DEPICTED ON THIS MAP REPRESENTS THE RESULTS OF SURVEYS MADE ON THE DATE DEPICTED AND CAN ONLY BE CONSIDERED AS INDICATING THE GENERAL CONDITIONS AT THAT TIME. THESE CONDITIONS ARE SUBJECT TO RAPID CHANGE DUE TO SHOALING EVENTS.
  - ALL READINGS ARE BASED ON THE NATIONAL OCEANIC AND ATMOSPHERIC ADMINISTRATION (NOAA) MEAN LOWER LOW WATER (MLLW) DATUM, (0.0')
  - HORIZONTAL DATUM: NAD-83, STATE PLANE, TEXAS SOUTH ZONE, US FEET.
  - TO GET THE DEPTH OF WATER, ADD THE CURRENT TIDE LEVEL TO THE READINGS SHOWN. (SEE TIDE DATUM CHART).
