PORT OF CORPUS CHRISTI AUTHORITY

SOUNDINGS
OIL DOCK 6

PLAN

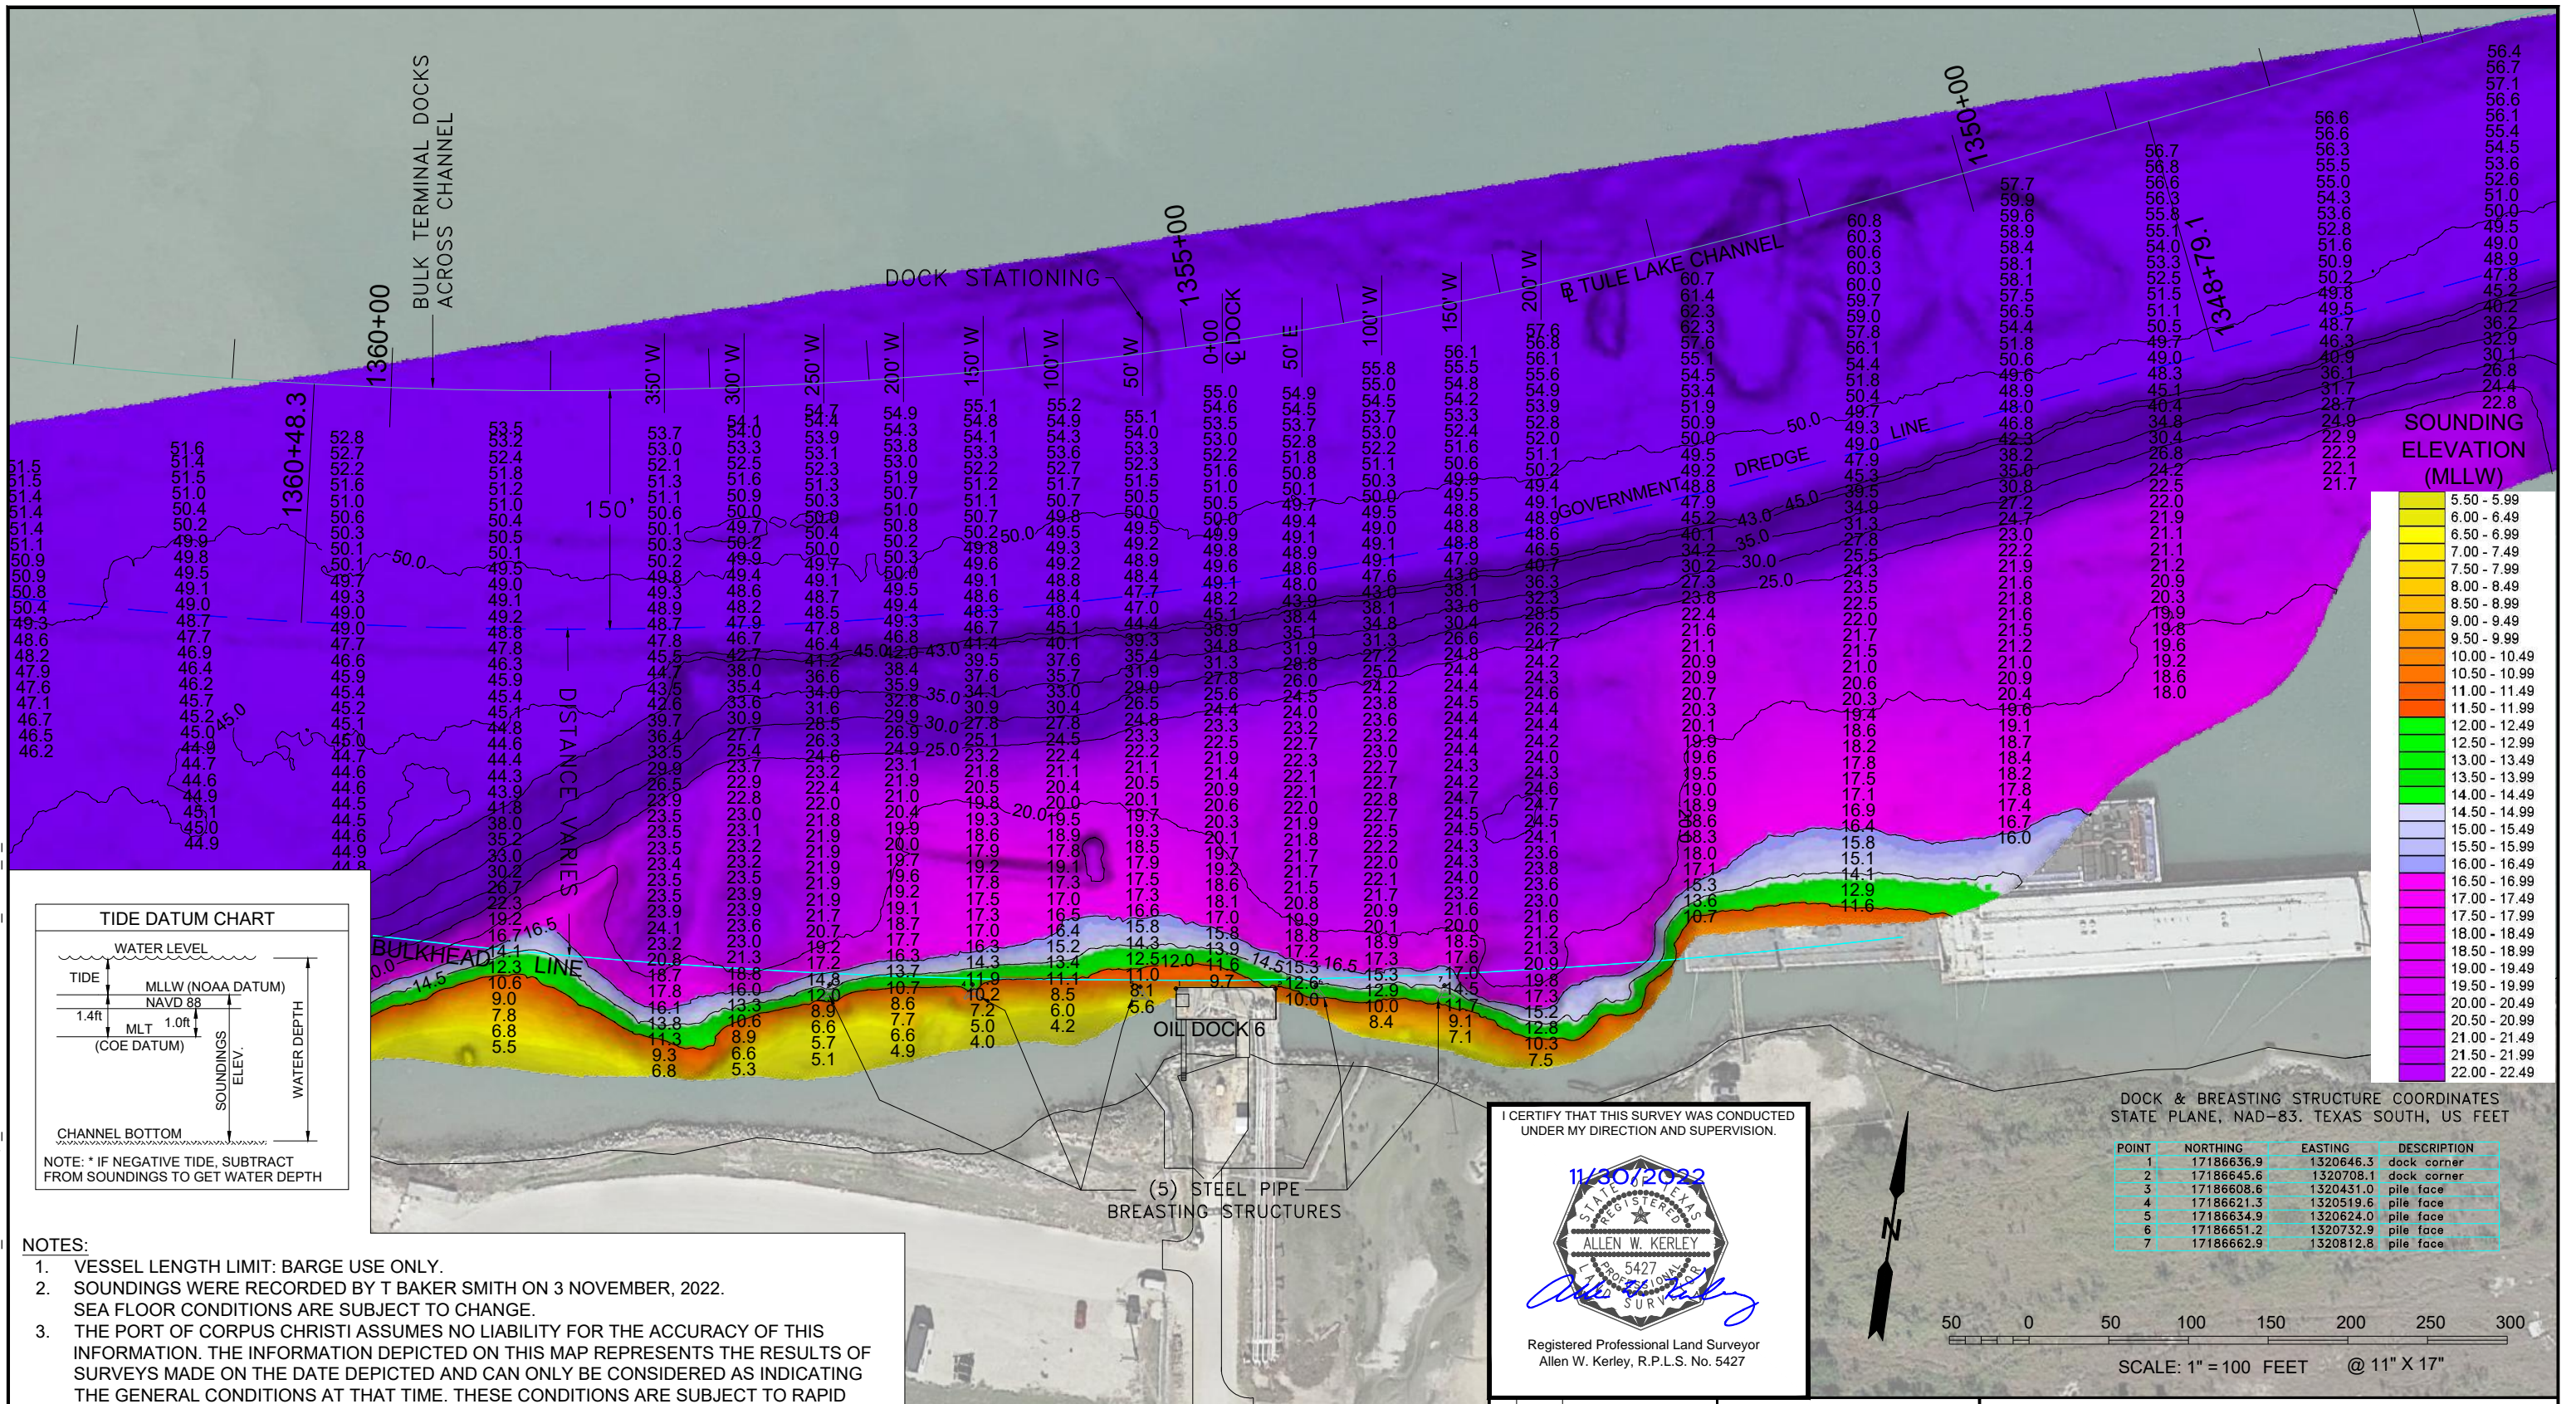
- NOTES:**
1. VESSEL LENGTH LIMIT: BARGE USE ONLY.
 2. SOUNDINGS WERE RECORDED BY T BAKER SMITH ON 3 NOVEMBER, 2022. SEA FLOOR CONDITIONS ARE SUBJECT TO CHANGE.
 3. THE PORT OF CORPUS CHRISTI ASSUMES NO LIABILITY FOR THE ACCURACY OF THIS INFORMATION. THE INFORMATION DEPICTED ON THIS MAP REPRESENTS THE RESULTS OF SURVEYS MADE ON THE DATE DEPICTED AND CAN ONLY BE CONSIDERED AS INDICATING THE GENERAL CONDITIONS AT THAT TIME. THESE CONDITIONS ARE SUBJECT TO RAPID CHANGE DUE TO SHOALING EVENTS.
 4. ALL READINGS ARE BASED ON THE NATIONAL OCEANIC AND ATMOSPHERIC ADMINISTRATION (NOAA) MEAN LOWER LOW WATER (MLLW) DATUM. (O.O')
 5. HORIZONTAL DATUM: NAD-83, STATE PLANE, TEXAS SOUTH ZONE, US FEET.
 6. TO GET THE DEPTH OF WATER, ADD THE CURRENT TIDE LEVEL TO THE READINGS SHOWN. (SEE TIDE DATUM CHART).
