**RINCON CANAL SINGLE BEAM SURVEY**  
**PORT OF CORPUS CHRISTI AUTHORITY**  
RINCON CANAL  
AN EXHIBIT OF A  
SINGLE BEAM SURVEY  
SITUATED IN  
CORPUS CHRISTI, TEXAS

**RINCON CANAL SINGLE BEAM SURVEY**  
**PORT OF CORPUS CHRISTI AUTHORITY**  
**RINCON CANAL**  
AN EXHIBIT OF A  
SINGLE BEAM SURVEY  
SITUATED IN  
CORPUS CHRISTI, TEXAS

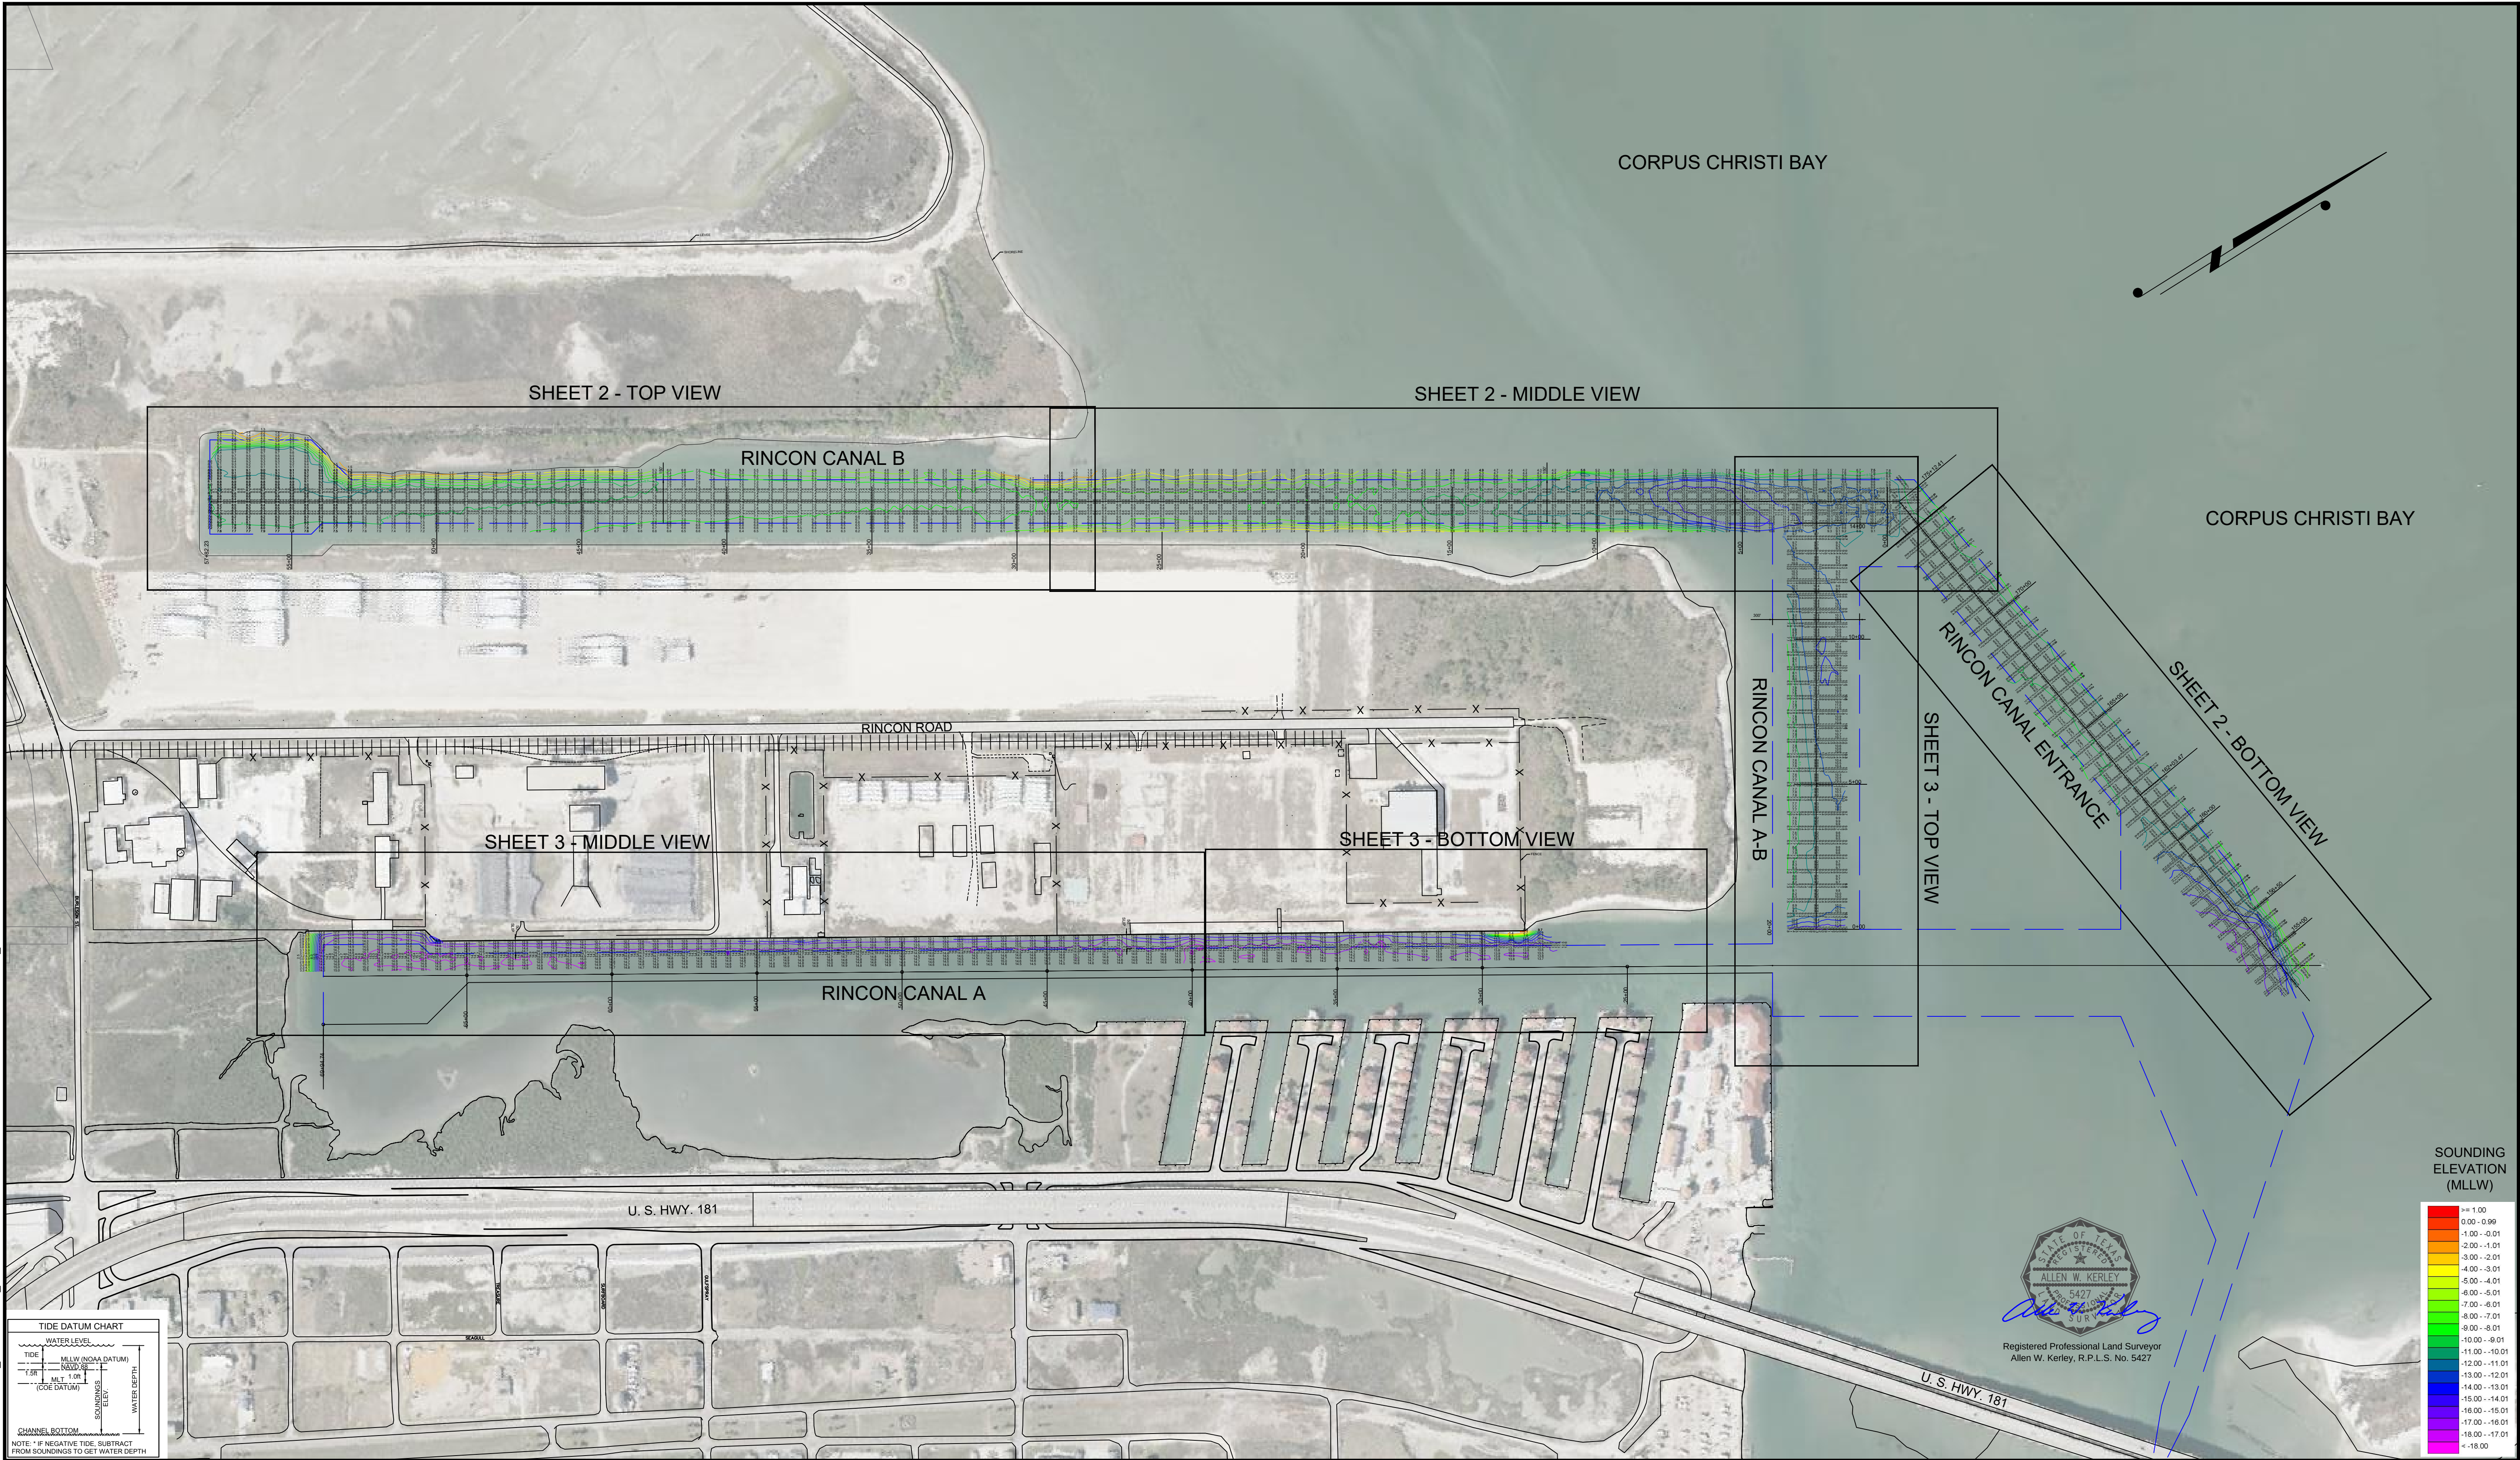
| SHEET NO: | 1 | OF | 3 |

COVERPAGE  
NOT TO SCALE

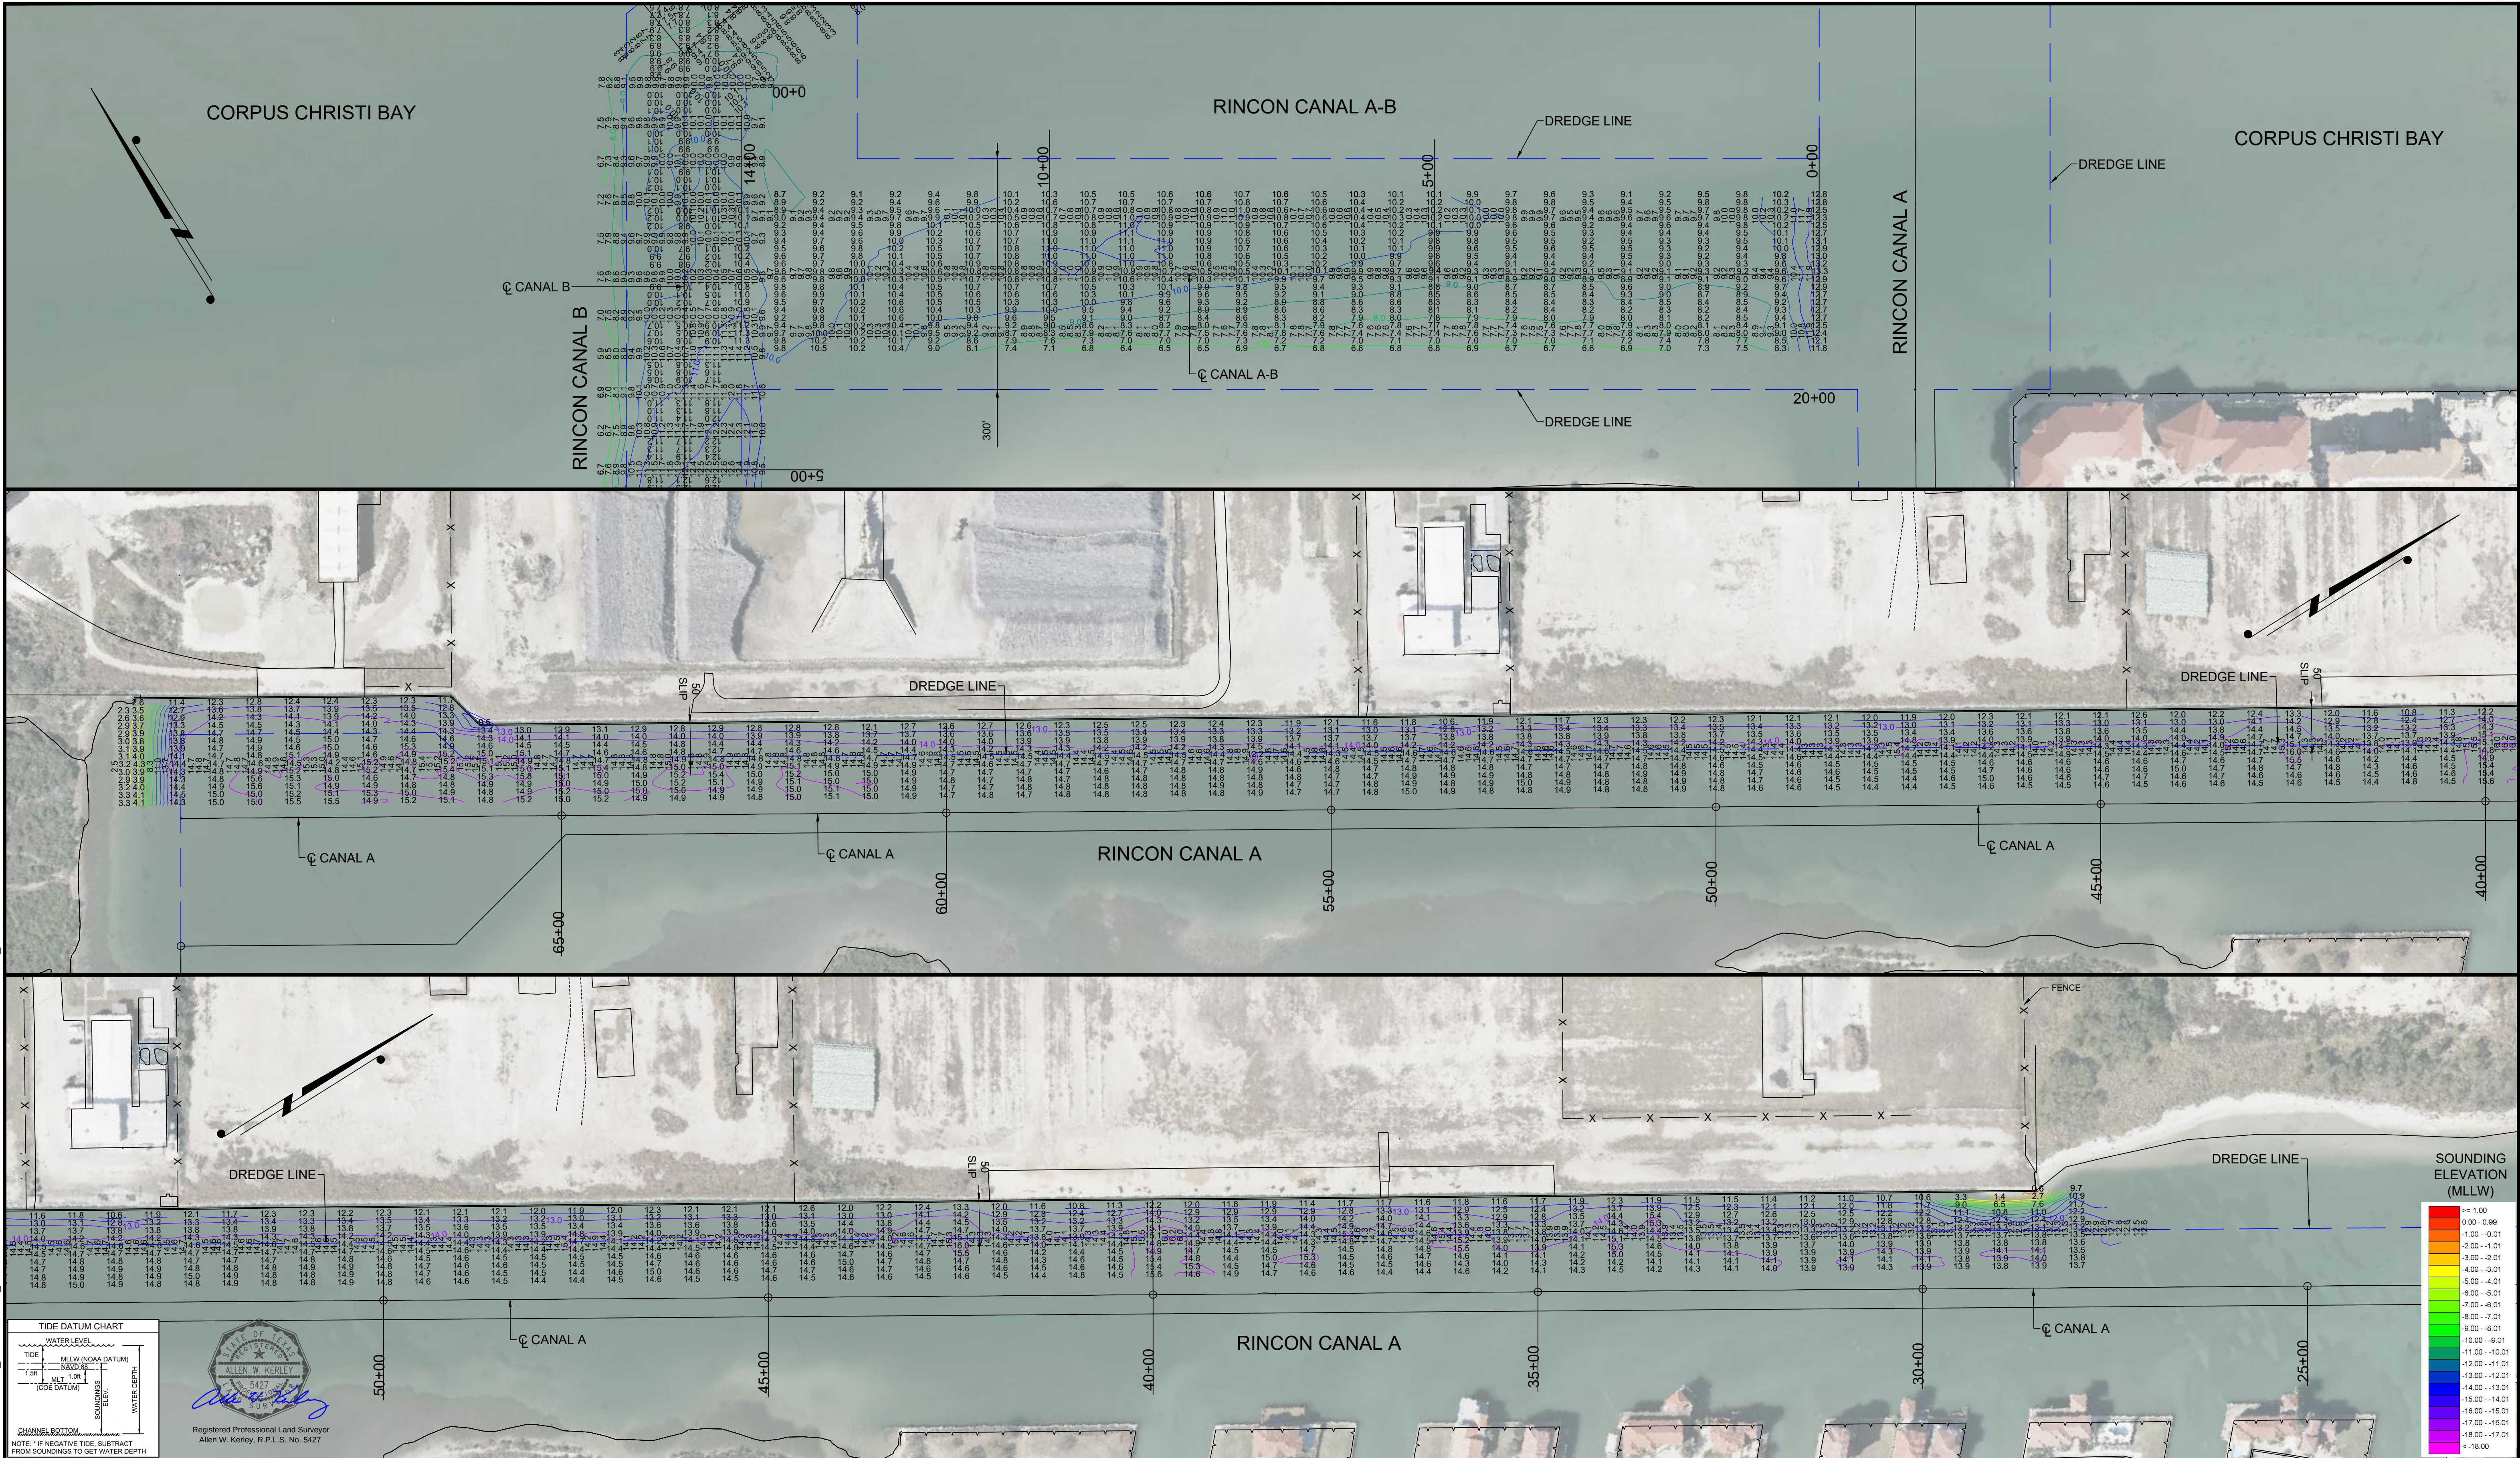
| SHEET NO.: | 3 | OF | 3 |

**RINCON CANAL SINGLE BEAM SURVEY**  
**PORT OF CORPUS CHRISTI AUTHORITY**  
**RINCON CANAL**  
AN EXHIBIT OF A  
SINGLE BEAM SURVEY  
SITUATED IN  
CORPUS CHRISTI, TEXAS
