**RINCON CANAL SINGLE BEAM SURVEY**  
**PORT OF CORPUS CHRISTI AUTHORITY**  
RINCON CANAL  
AN EXHIBIT OF A  
SINGLE BEAM SURVEY  
SITUATED IN  
CORPUS CHRISTI, TEXAS

**RINCON CANAL SINGLE BEAM SURVEY**

**AN EXHIBIT OF A SINGLE BEAM SURVEY SITUATED IN CORPUS CHRISTI, TEXAS**

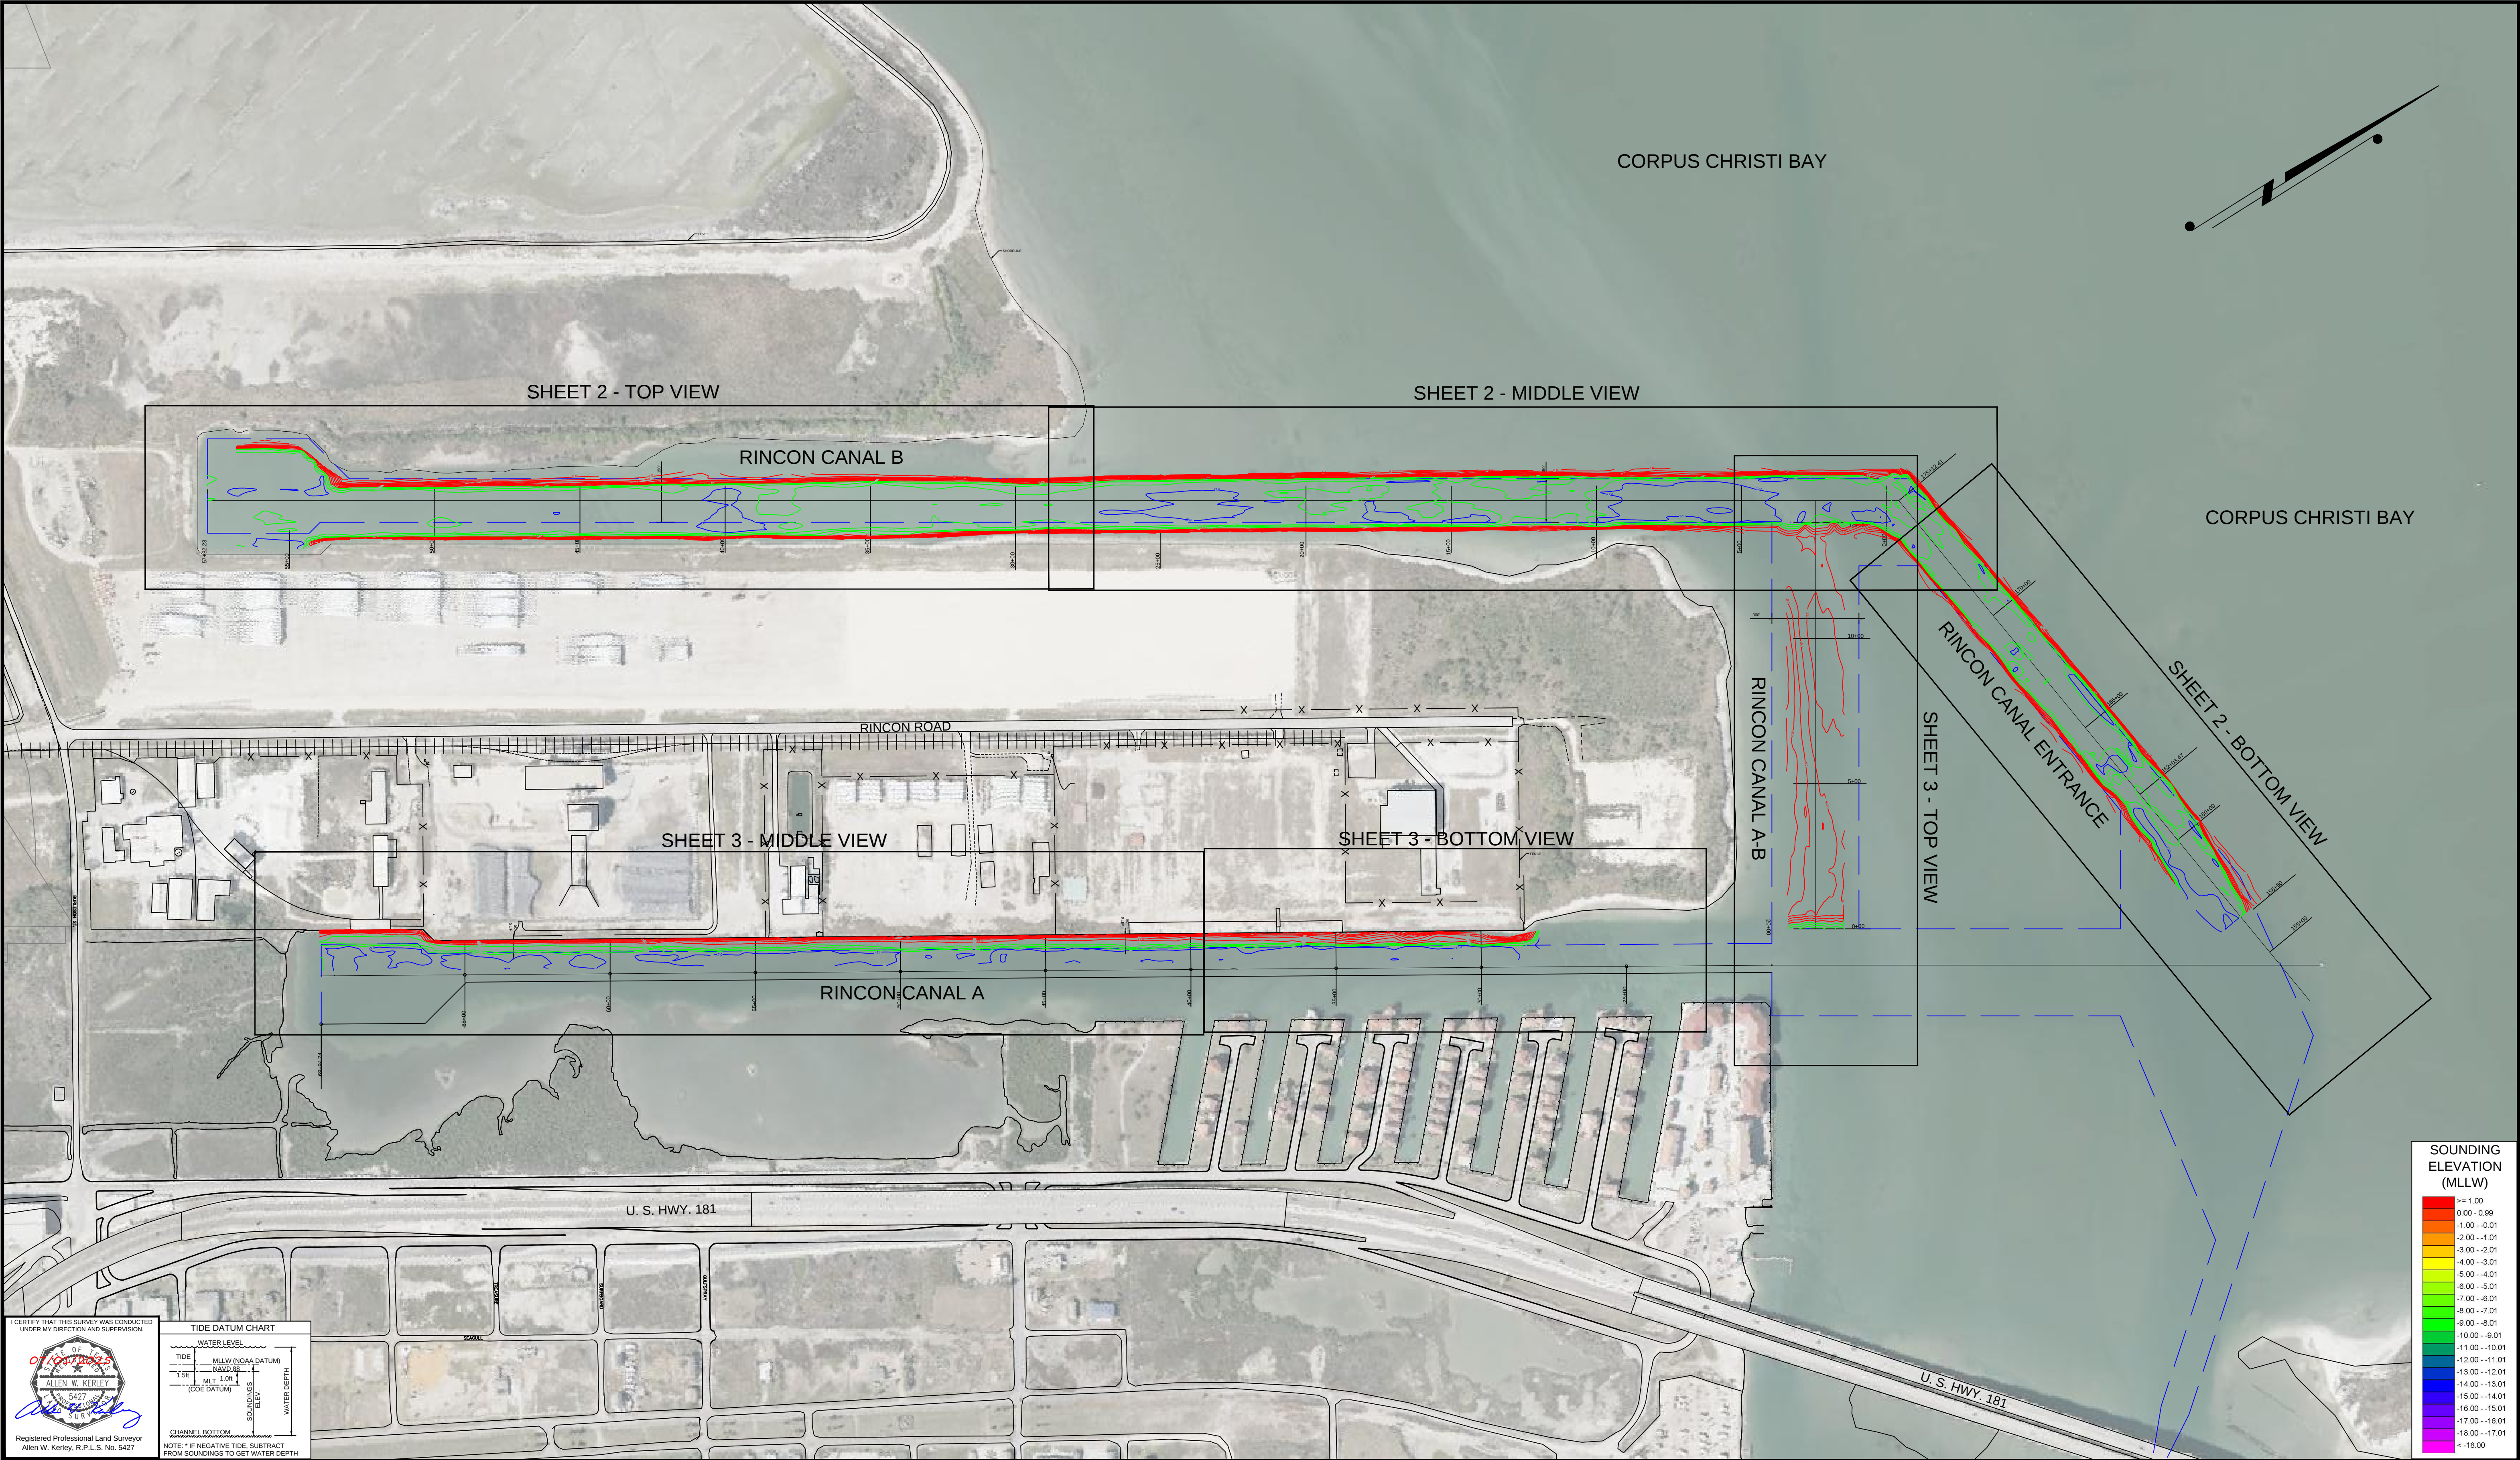
| SHEET NO: 1 | OF 3 |

| 1. SOUNDING DATA WAS RECORDED BY T. BAKER SMITH ON 2 JUNE, 2025 SEA FLOOR CONDITIONS ARE SUBJECT TO CHANGE. | | |
| 5. TO GET THE DEPTH OF WATER, ADD THE CURRENT TIDE LEVEL TO THE READINGS SHOWN. (SEE TIDE DATUM CHART). | | |

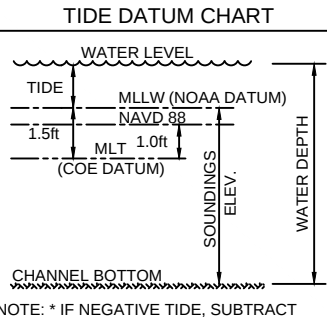
**TIDE DATUM CHART**

NOTE: \* IF NEGATIVE TIDE, SUBTRACT FROM SOUNDINGS TO GET WATER DEPTH

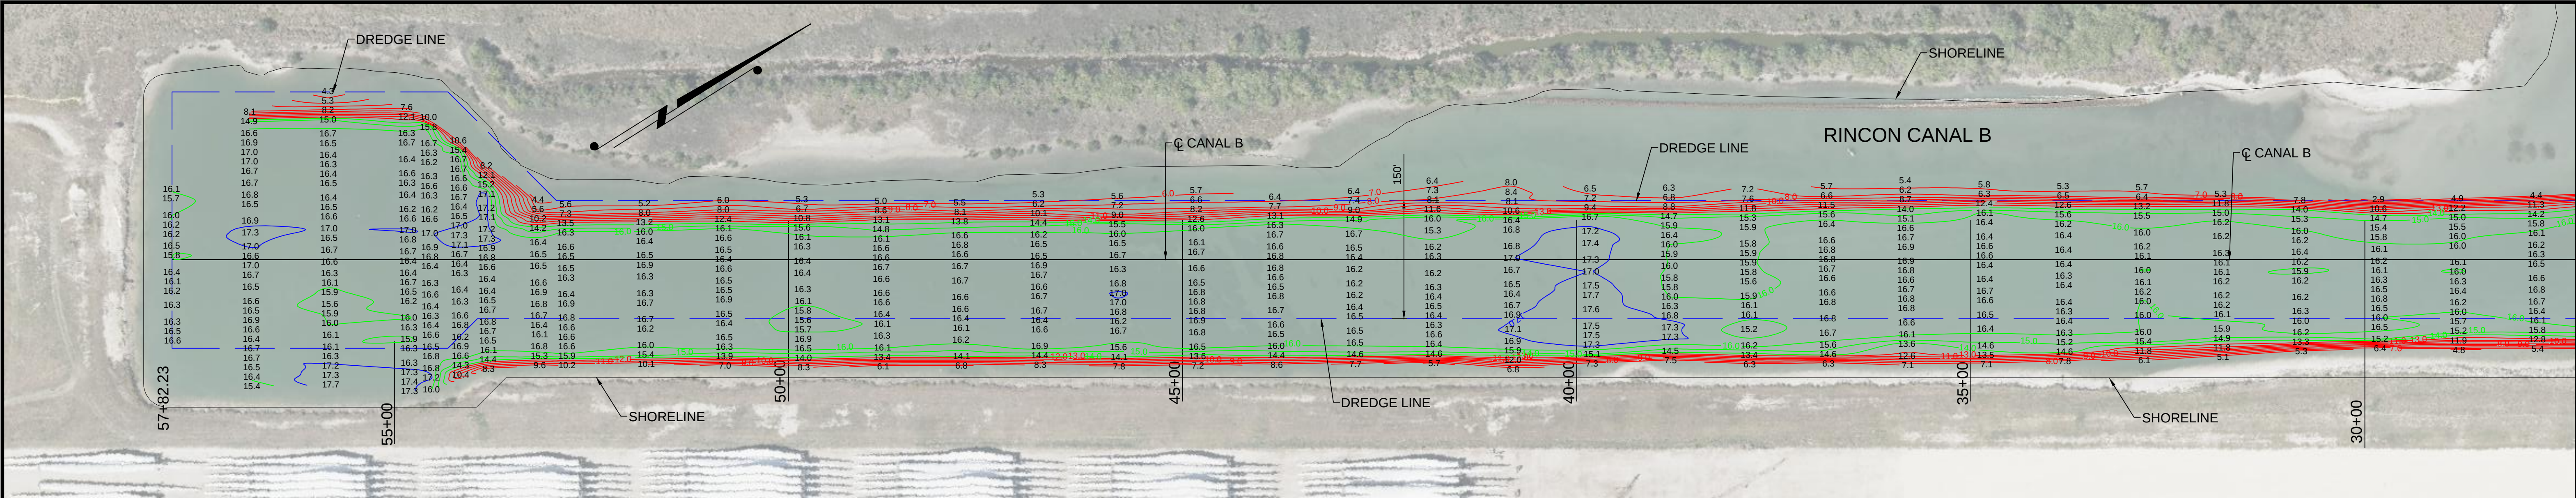
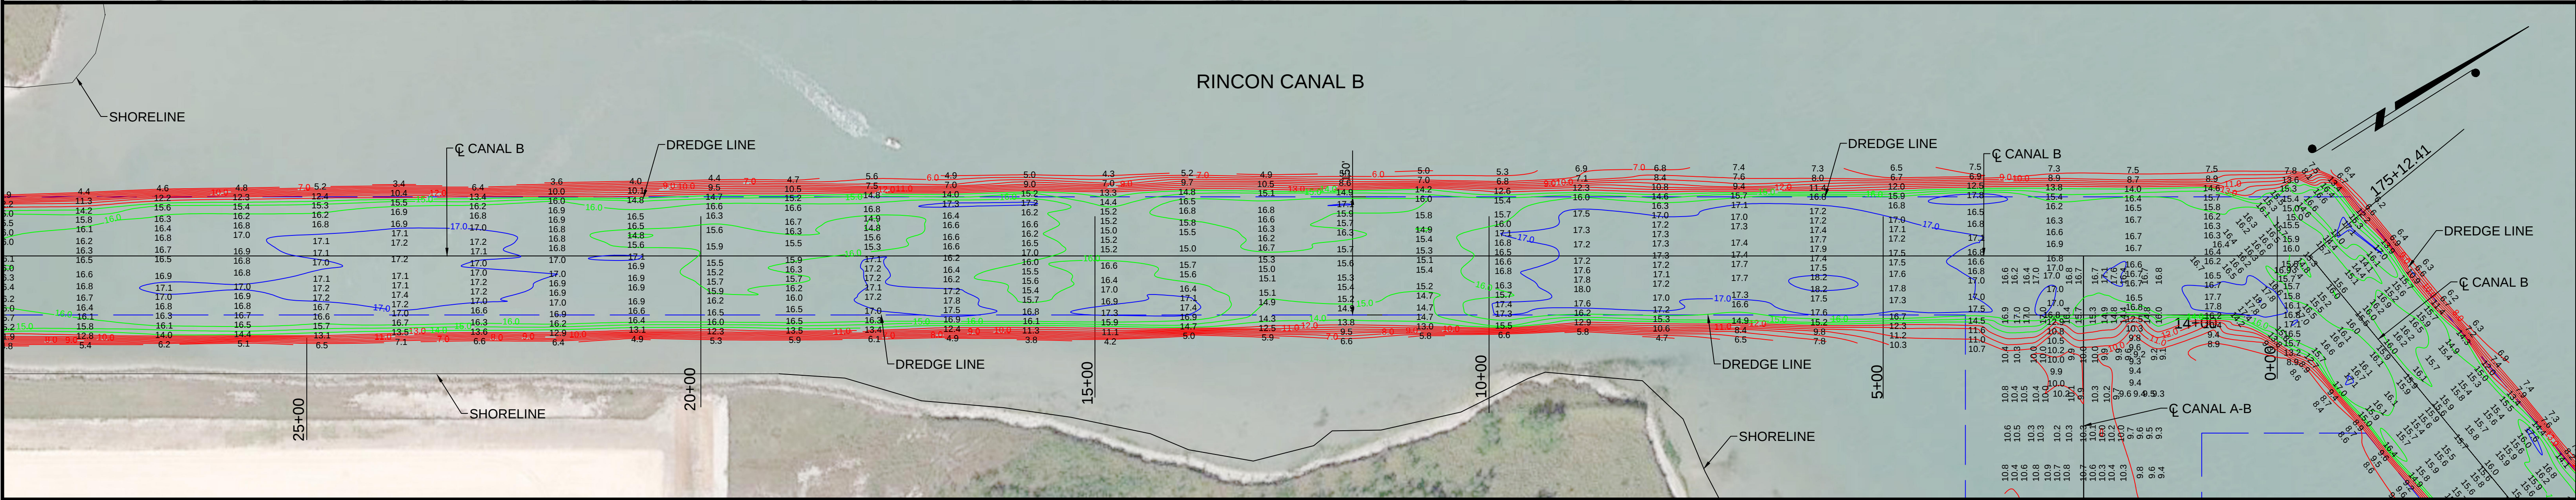
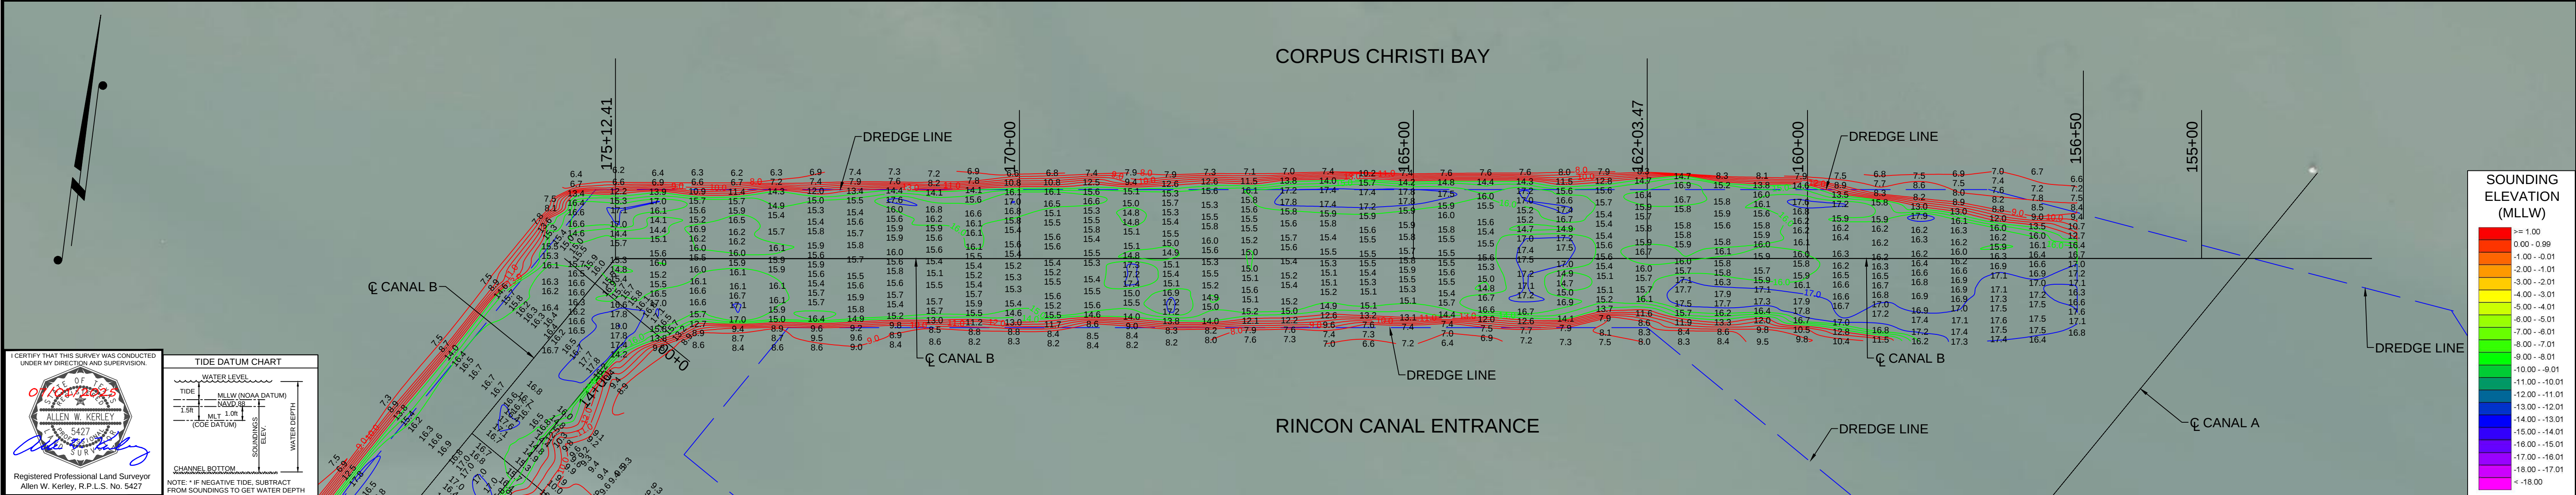
APPROVED BY: AWK  
JOB NO.: 2025.0225  
SHEET NO: 2 OF 3

1. SOUNDING DATA WAS RECORDED BY T. BAKER SMITH ON 2 JUNE, 2025 SEA FLOOR CONDITIONS ARE SUBJECT TO CHANGE.

5. TO GET THE DEPTH OF WATER, ADD THE CURRENT TIDE LEVEL TO THE READINGS SHOWN. (SEE TIDE DATUM CHART).

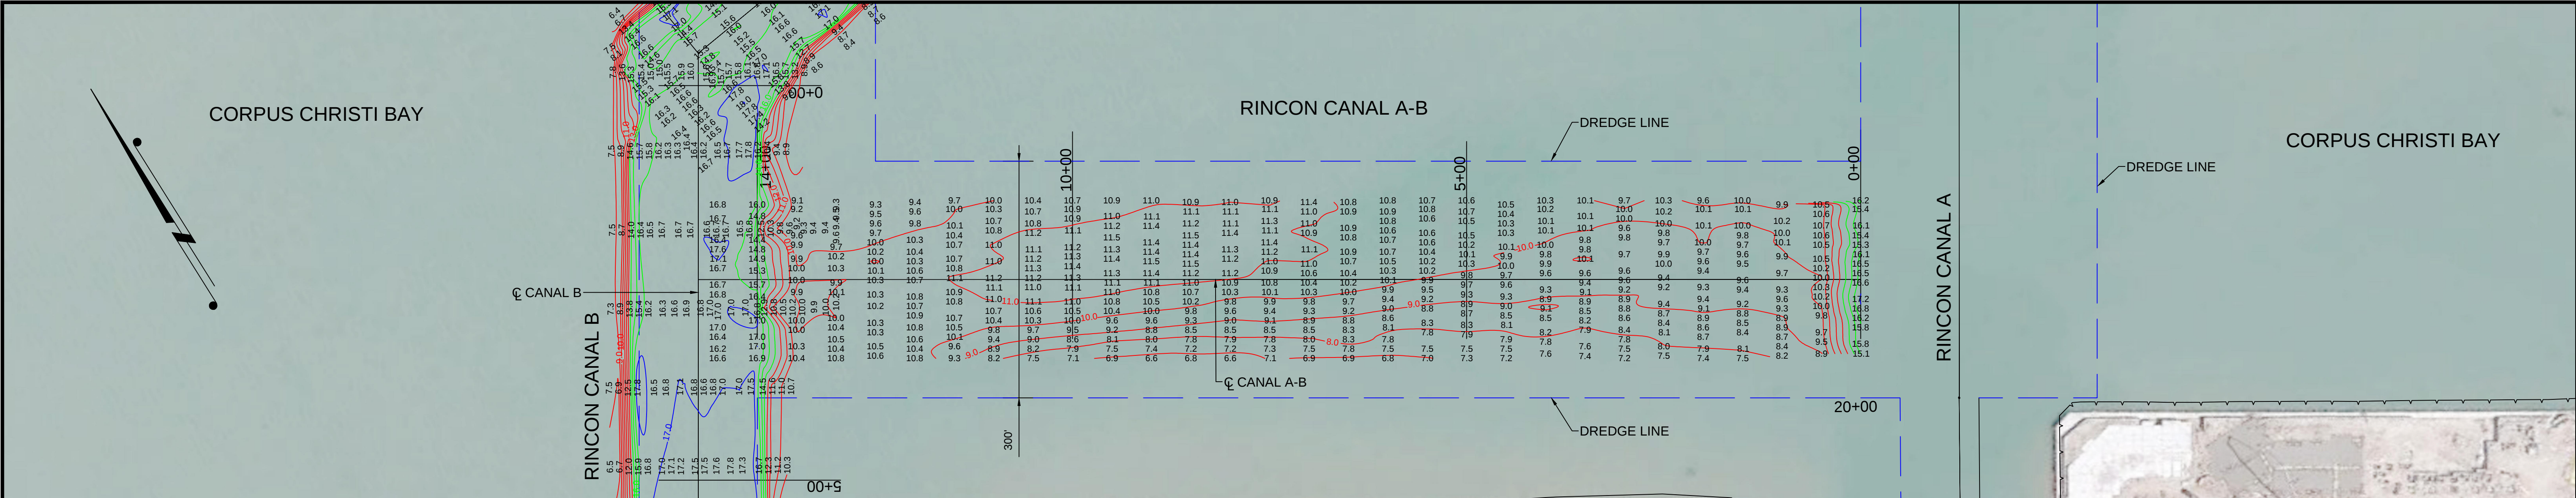
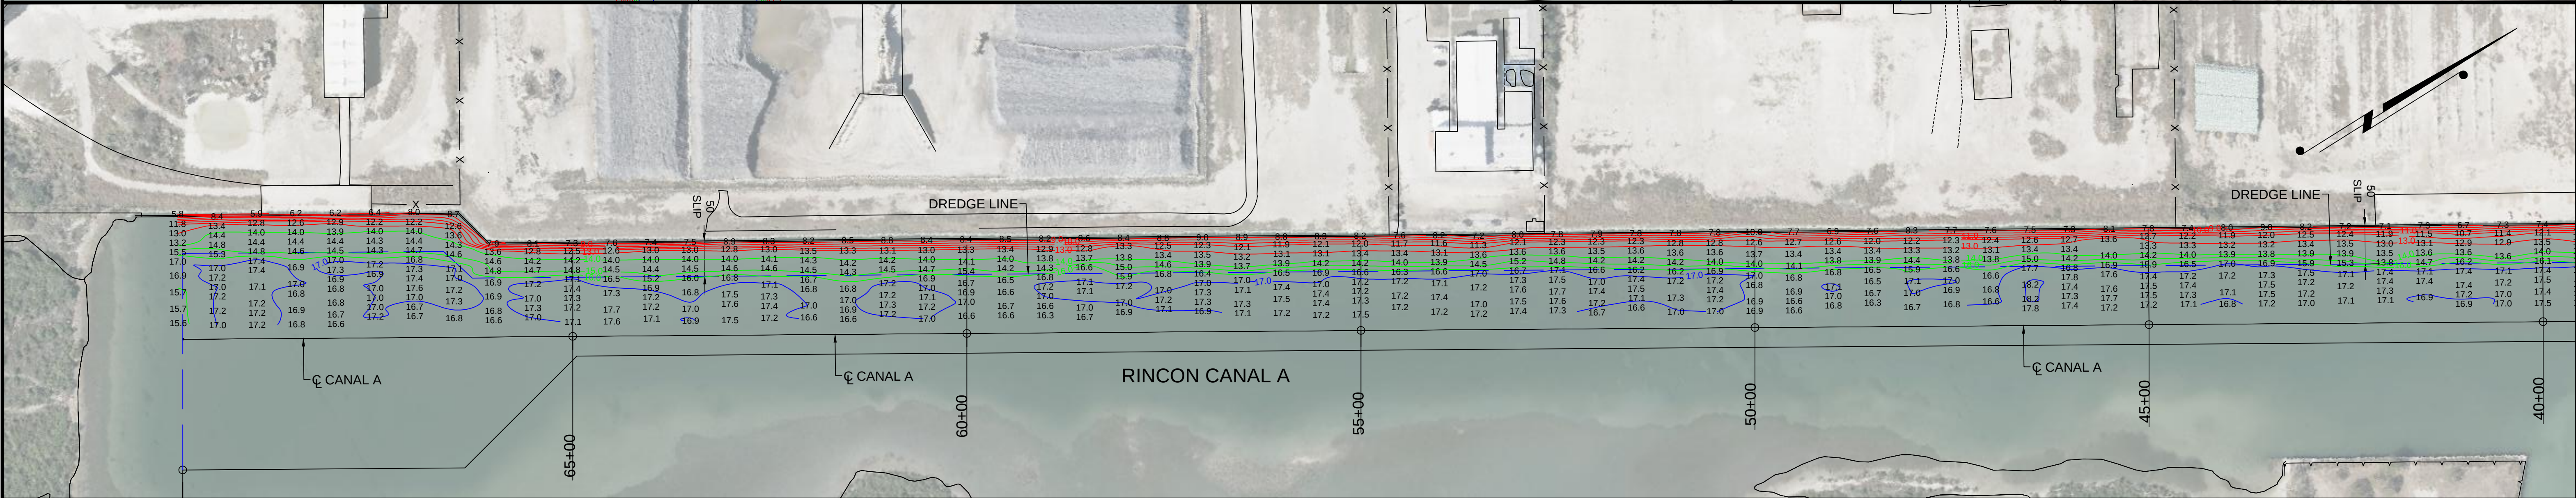
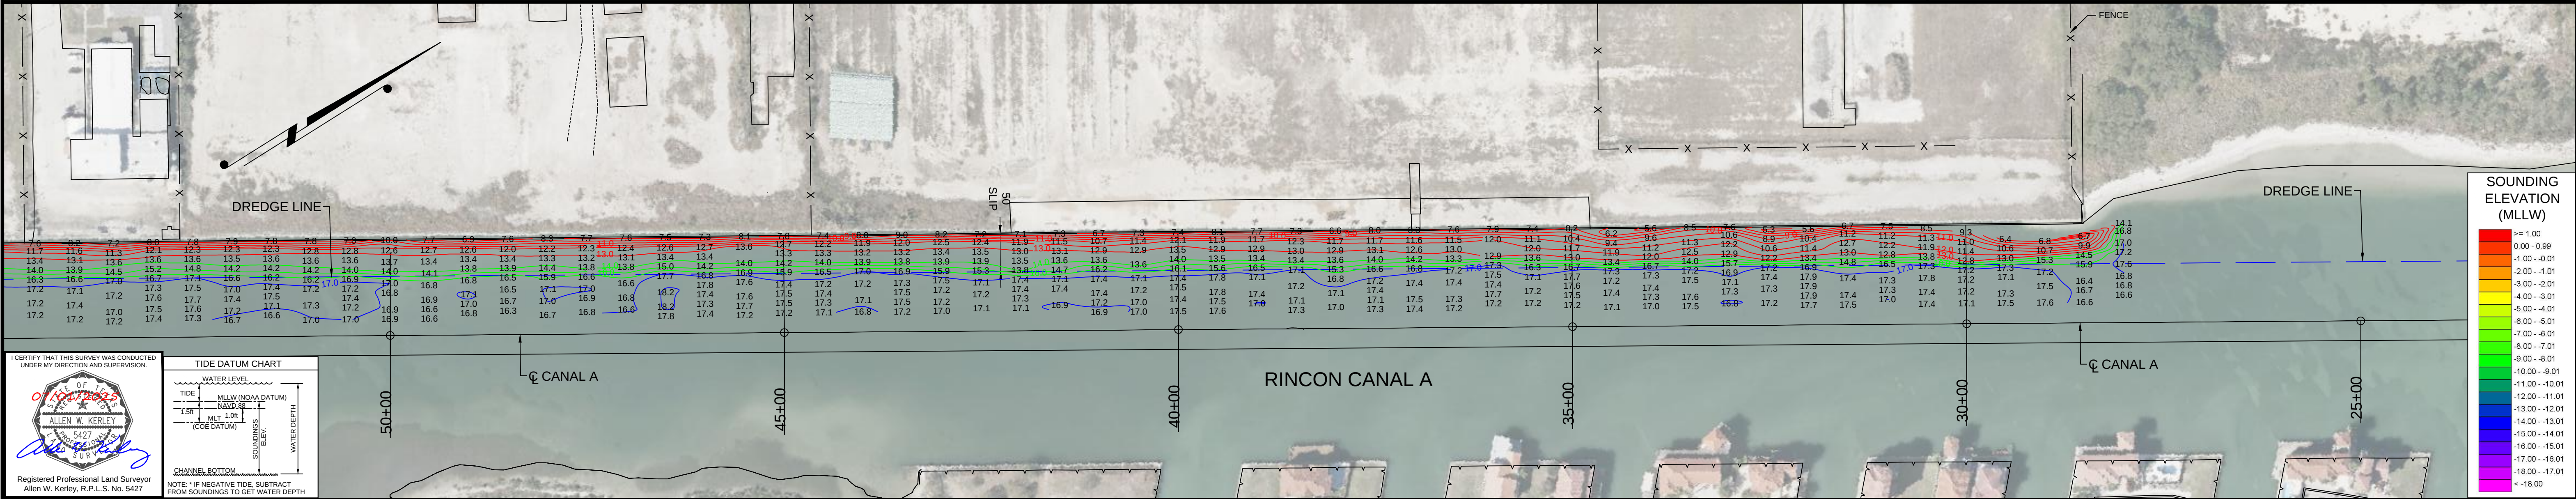
SHEET NO: 3 OF 3

WATER LEVEL  
TIDE: MLLW (NOAA DATUM)  
1.8' MLLW  
1.8' MLLW  
(CODE DATUM)

NOTE: \* IF NEGATIVE TIDE, SUBTRACT FROM SOUNDINGS TO GET WATER DEPTH

1. SOUNDING DATA WAS RECORDED BY T. BAKER SMITH ON 2 JUNE, 2025 SEA FLOOR CONDITIONS ARE SUBJECT TO CHANGE.
