PORT OF CORPUS CHRISTI AUTHORITY

2022 Q3 - 2022 Q4 ANALYSIS
OIL DOCK 14

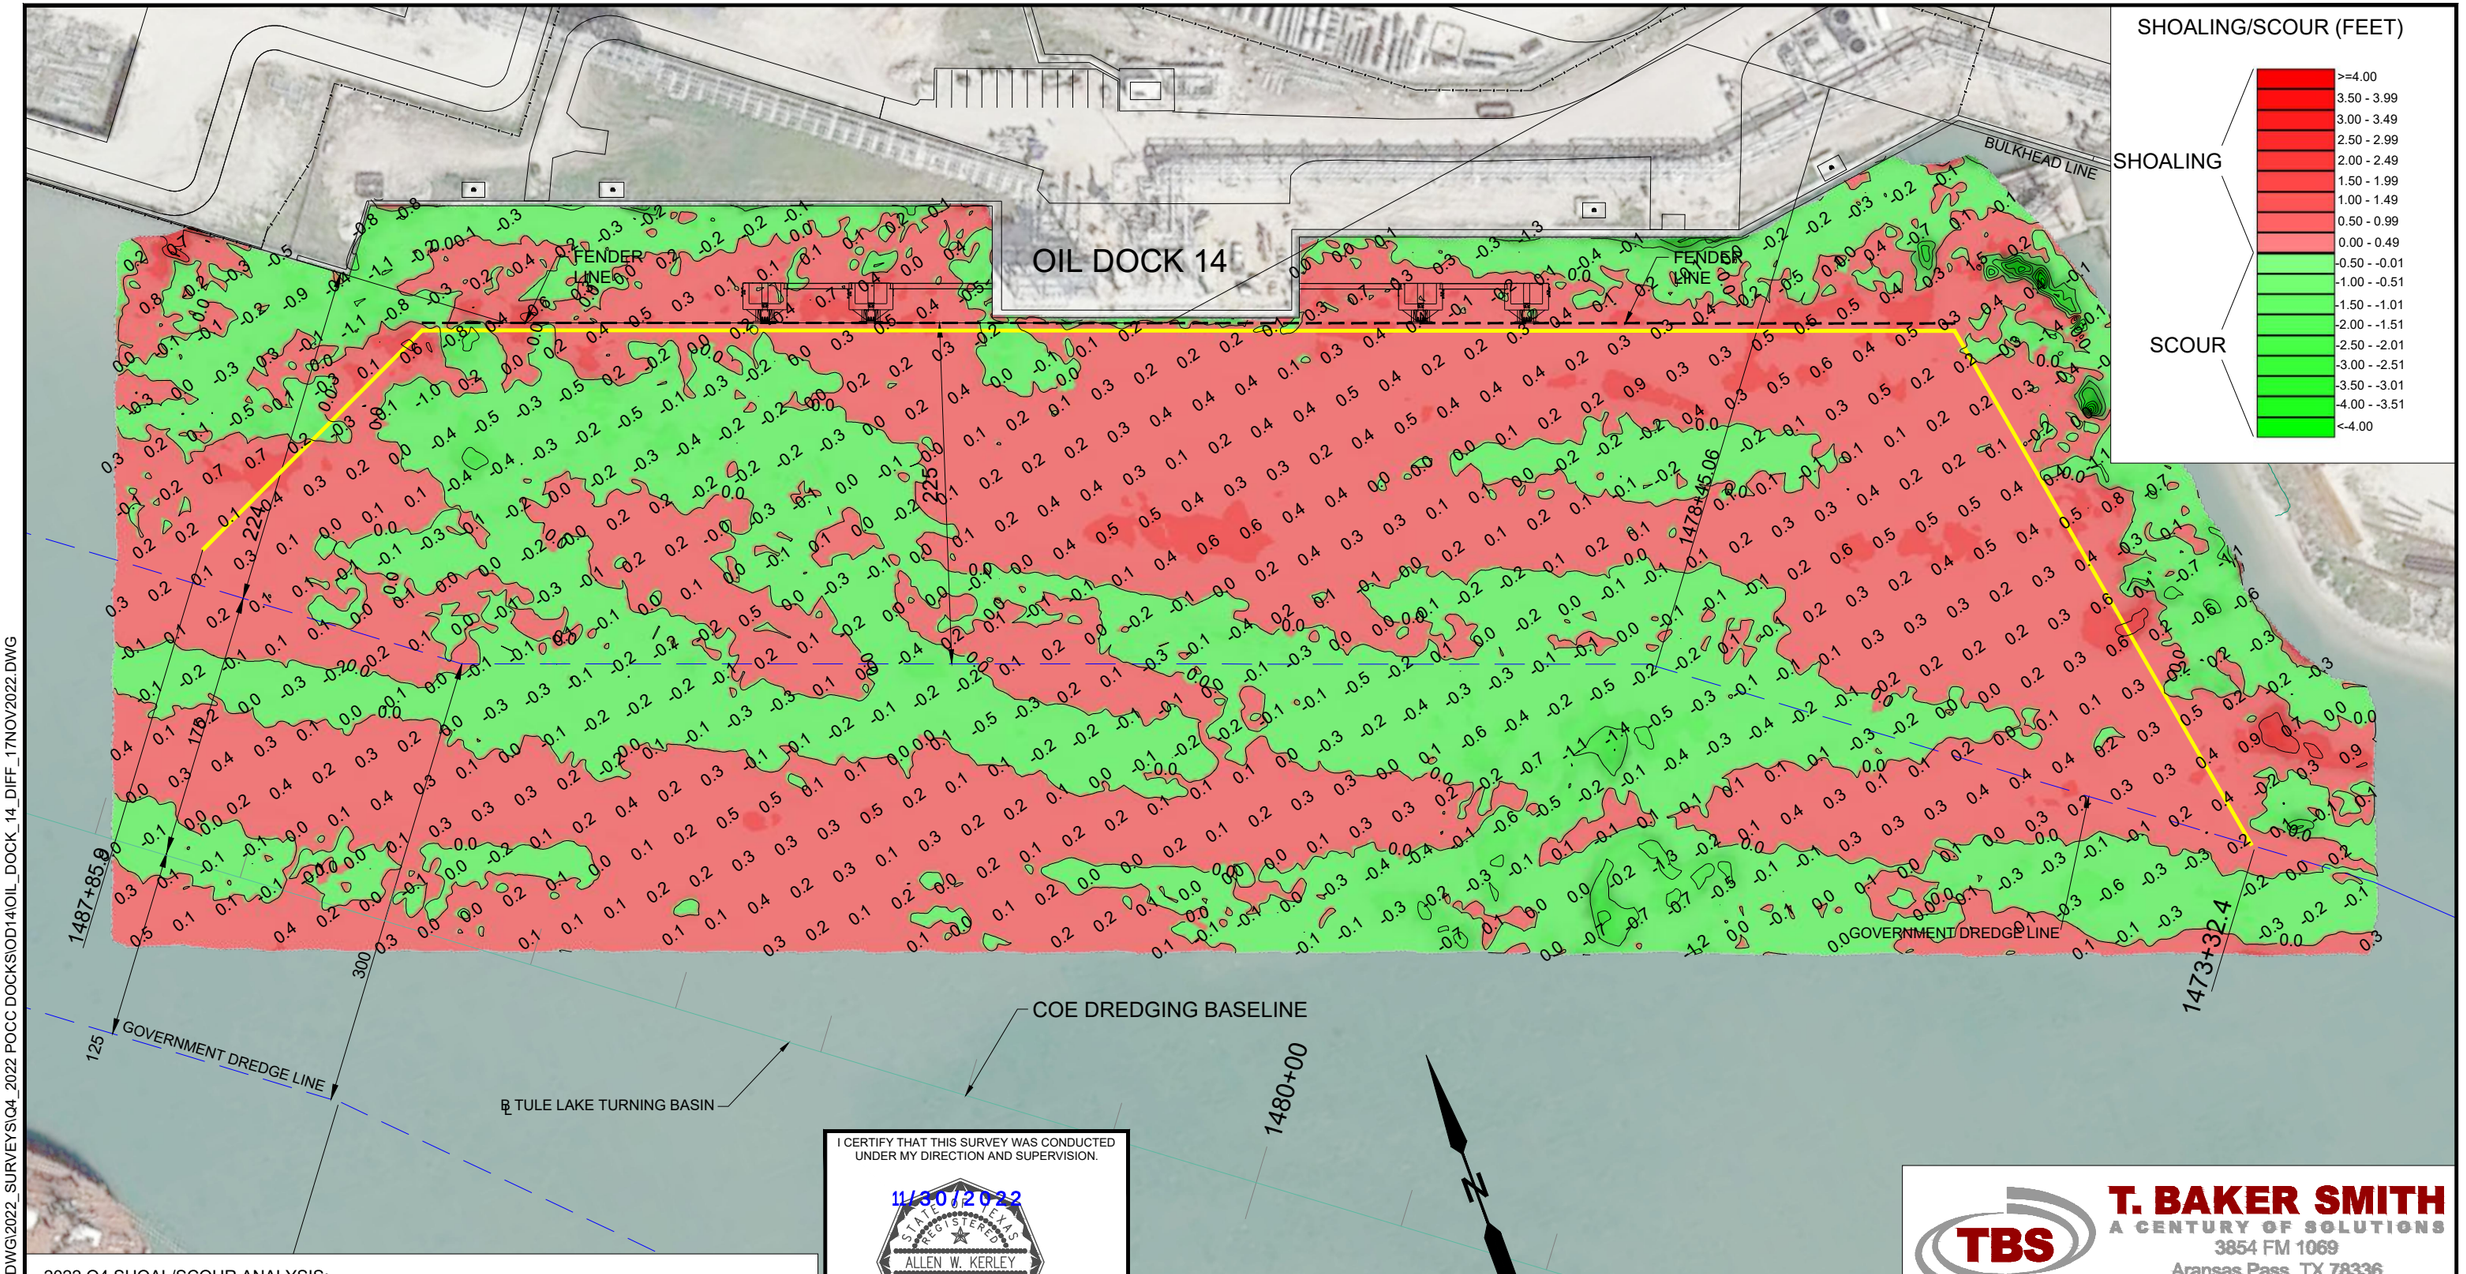
2022 Q4 SHOAL/SCOUR ANALYSIS:
- OBSERVED NEGLIGIBLE SHOALING AT THE EAST END OF THE DOCK..
- OBSERVED NEGLIGIBLE SCOURING AT THE WEST END OF THE DOCK.
