| PORT OF CORPUS CHRISTI AUTHORITY | | |
| SOUNDINGS<br>OIL DOCK 1 | | |
| SCALE: 1" = 100' | PLAN | DATE: JAN. 2021 |

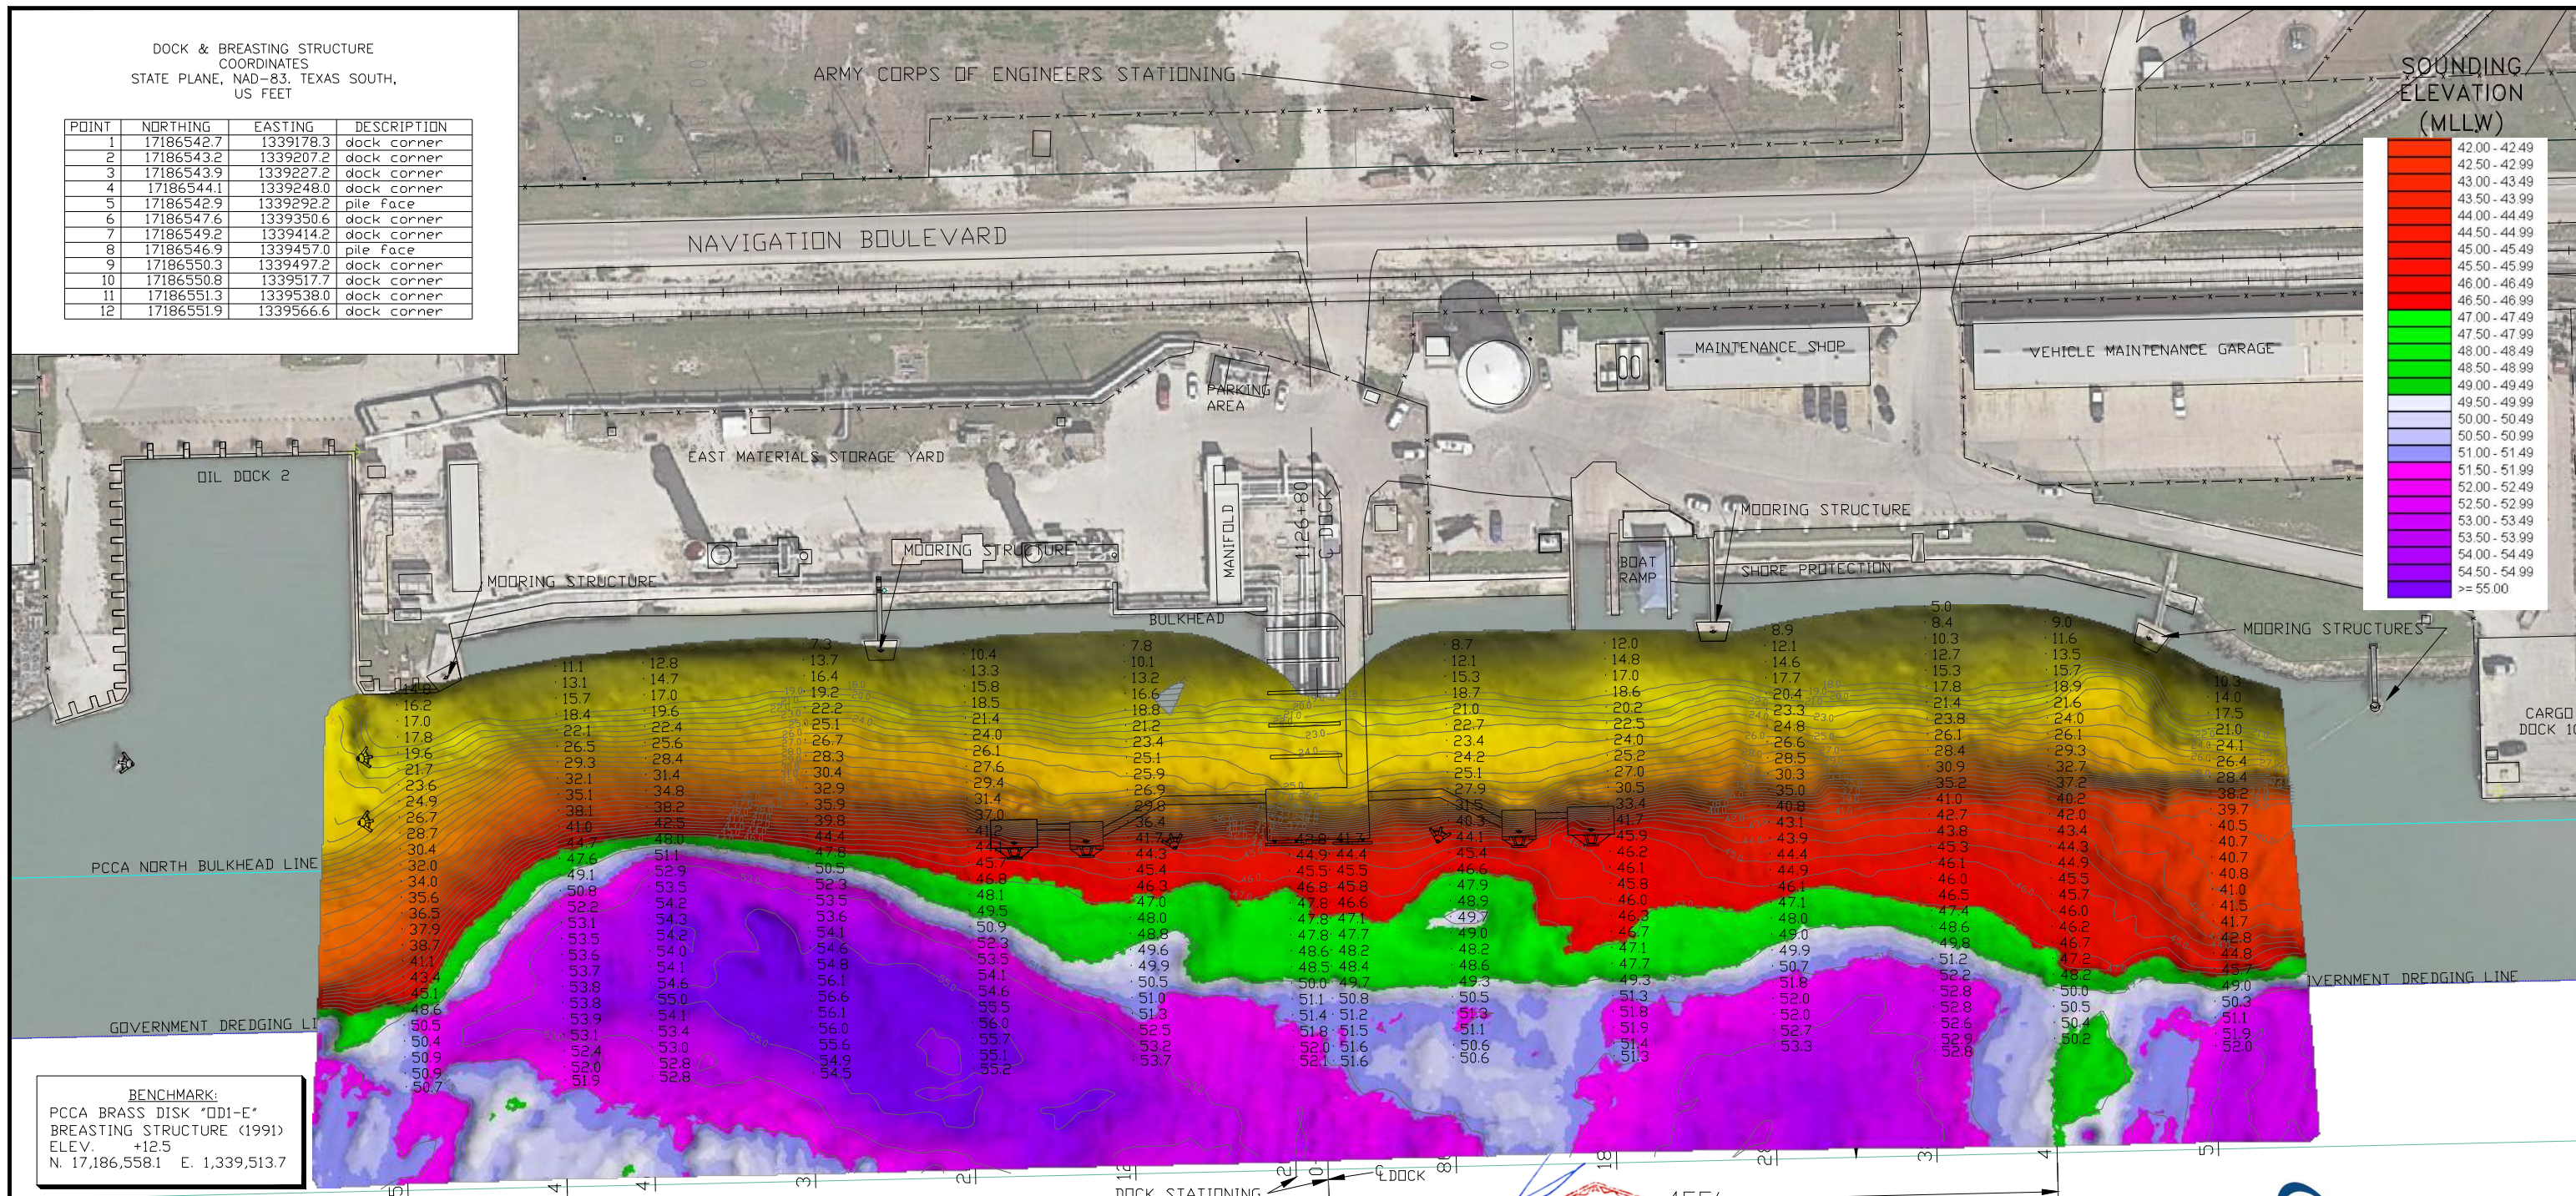
SOUNDING  
ELEVATION  
(MLLW)

1. VESSEL LENGTH LIMIT IS 1,000 FEET.
2. TOP OF DOCK ELEVATION IS 14.2 FT ABOVE MEAN LOWER LOW WATER (0.0')
2. SOUNDINGS WERE RECORDED BY NAIMSMITH MARINE SERVICES ON 18 JANUARY, 2021. SEA FLOOR CONDITIONS ARE SUBJECT TO CHANGE.
3. THE PORT OF CORPUS CHRISTI ASSUMES NO LIABILITY FOR THE ACCURACY OF THIS INFORMATION. THE INFORMATION DEPICTED ON THIS MAP REPRESENTS THE RESULTS OF SURVEYS MADE ON THE DATE DEPICTED AND CAN ONLY BE CONSIDERED AS INDICATING THE GENERAL CONDITIONS AT THAT TIME. THESE CONDITIONS ARE SUBJECT TO RAPID CHANGE DUE TO SHOALING EVENTS.
4. ALL READINGS ARE BASED ON THE NATIONAL OCEANIC AND ATMOSPHERIC ADMINISTRATION (NOAA) MEAN LOWER LOW WATER (MLLW) DATUM, (0.0')
5. HORIZONTAL DATUM: NAD-83, STATE PLANE, TEXAS SOUTH ZONE, US FEET.
6. TO GET THE DEPTH OF WATER, ADD THE CURRENT TIDE LEVEL TO THE READINGS SHOWN. (SEE TIDE DATUM CHART).
