PORT OF CORPUS CHRISTI AUTHORITY		
SOUNDINGS BULK TERMINAL DOCK 3		
SCALE: 1" = 100'	PLAN	DATE: JULY 2021
DWN. BY: CDW

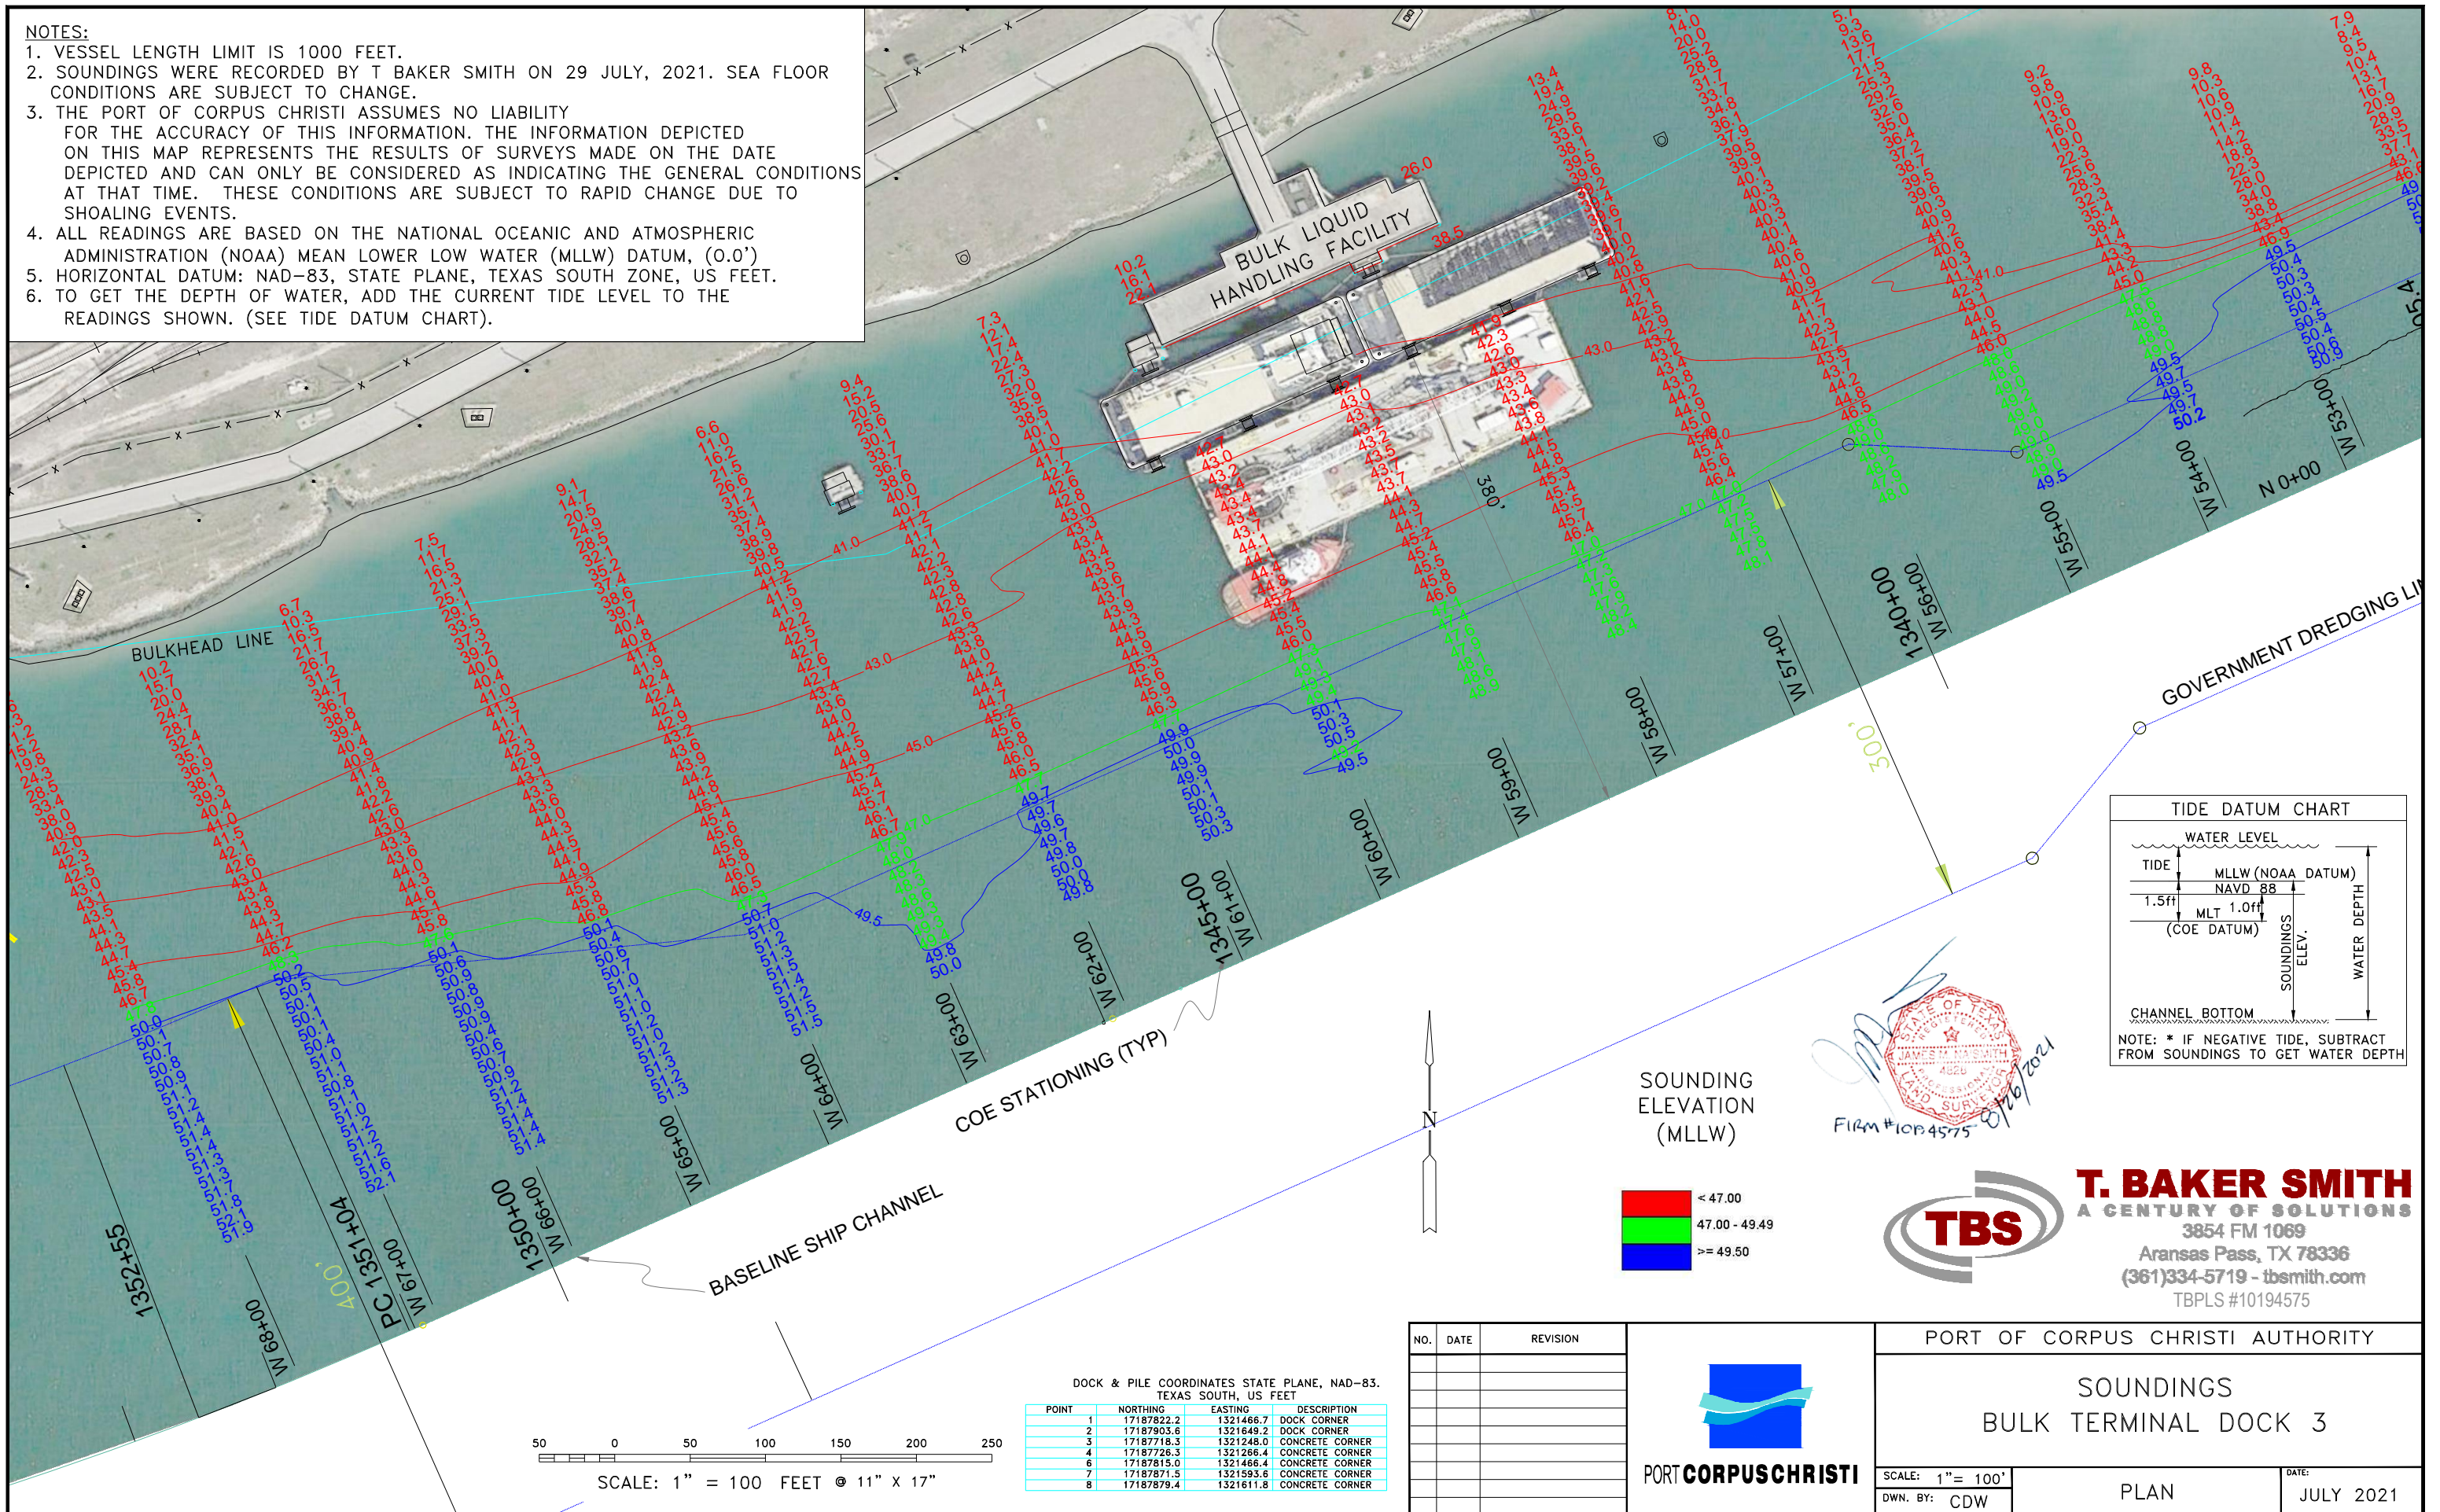
SOUNDING ELEVATION (MLLW)
