DOCK & BREASTING STRUCTURE  
COORDINATES  
STATE PLANE, NAD-83, TEXAS SOUTH,  
US FEET

| PORT OF CORPUS CHRISTI AUTHORITY | | |
| SOUNDINGS<br>OIL DOCK 1 | | |

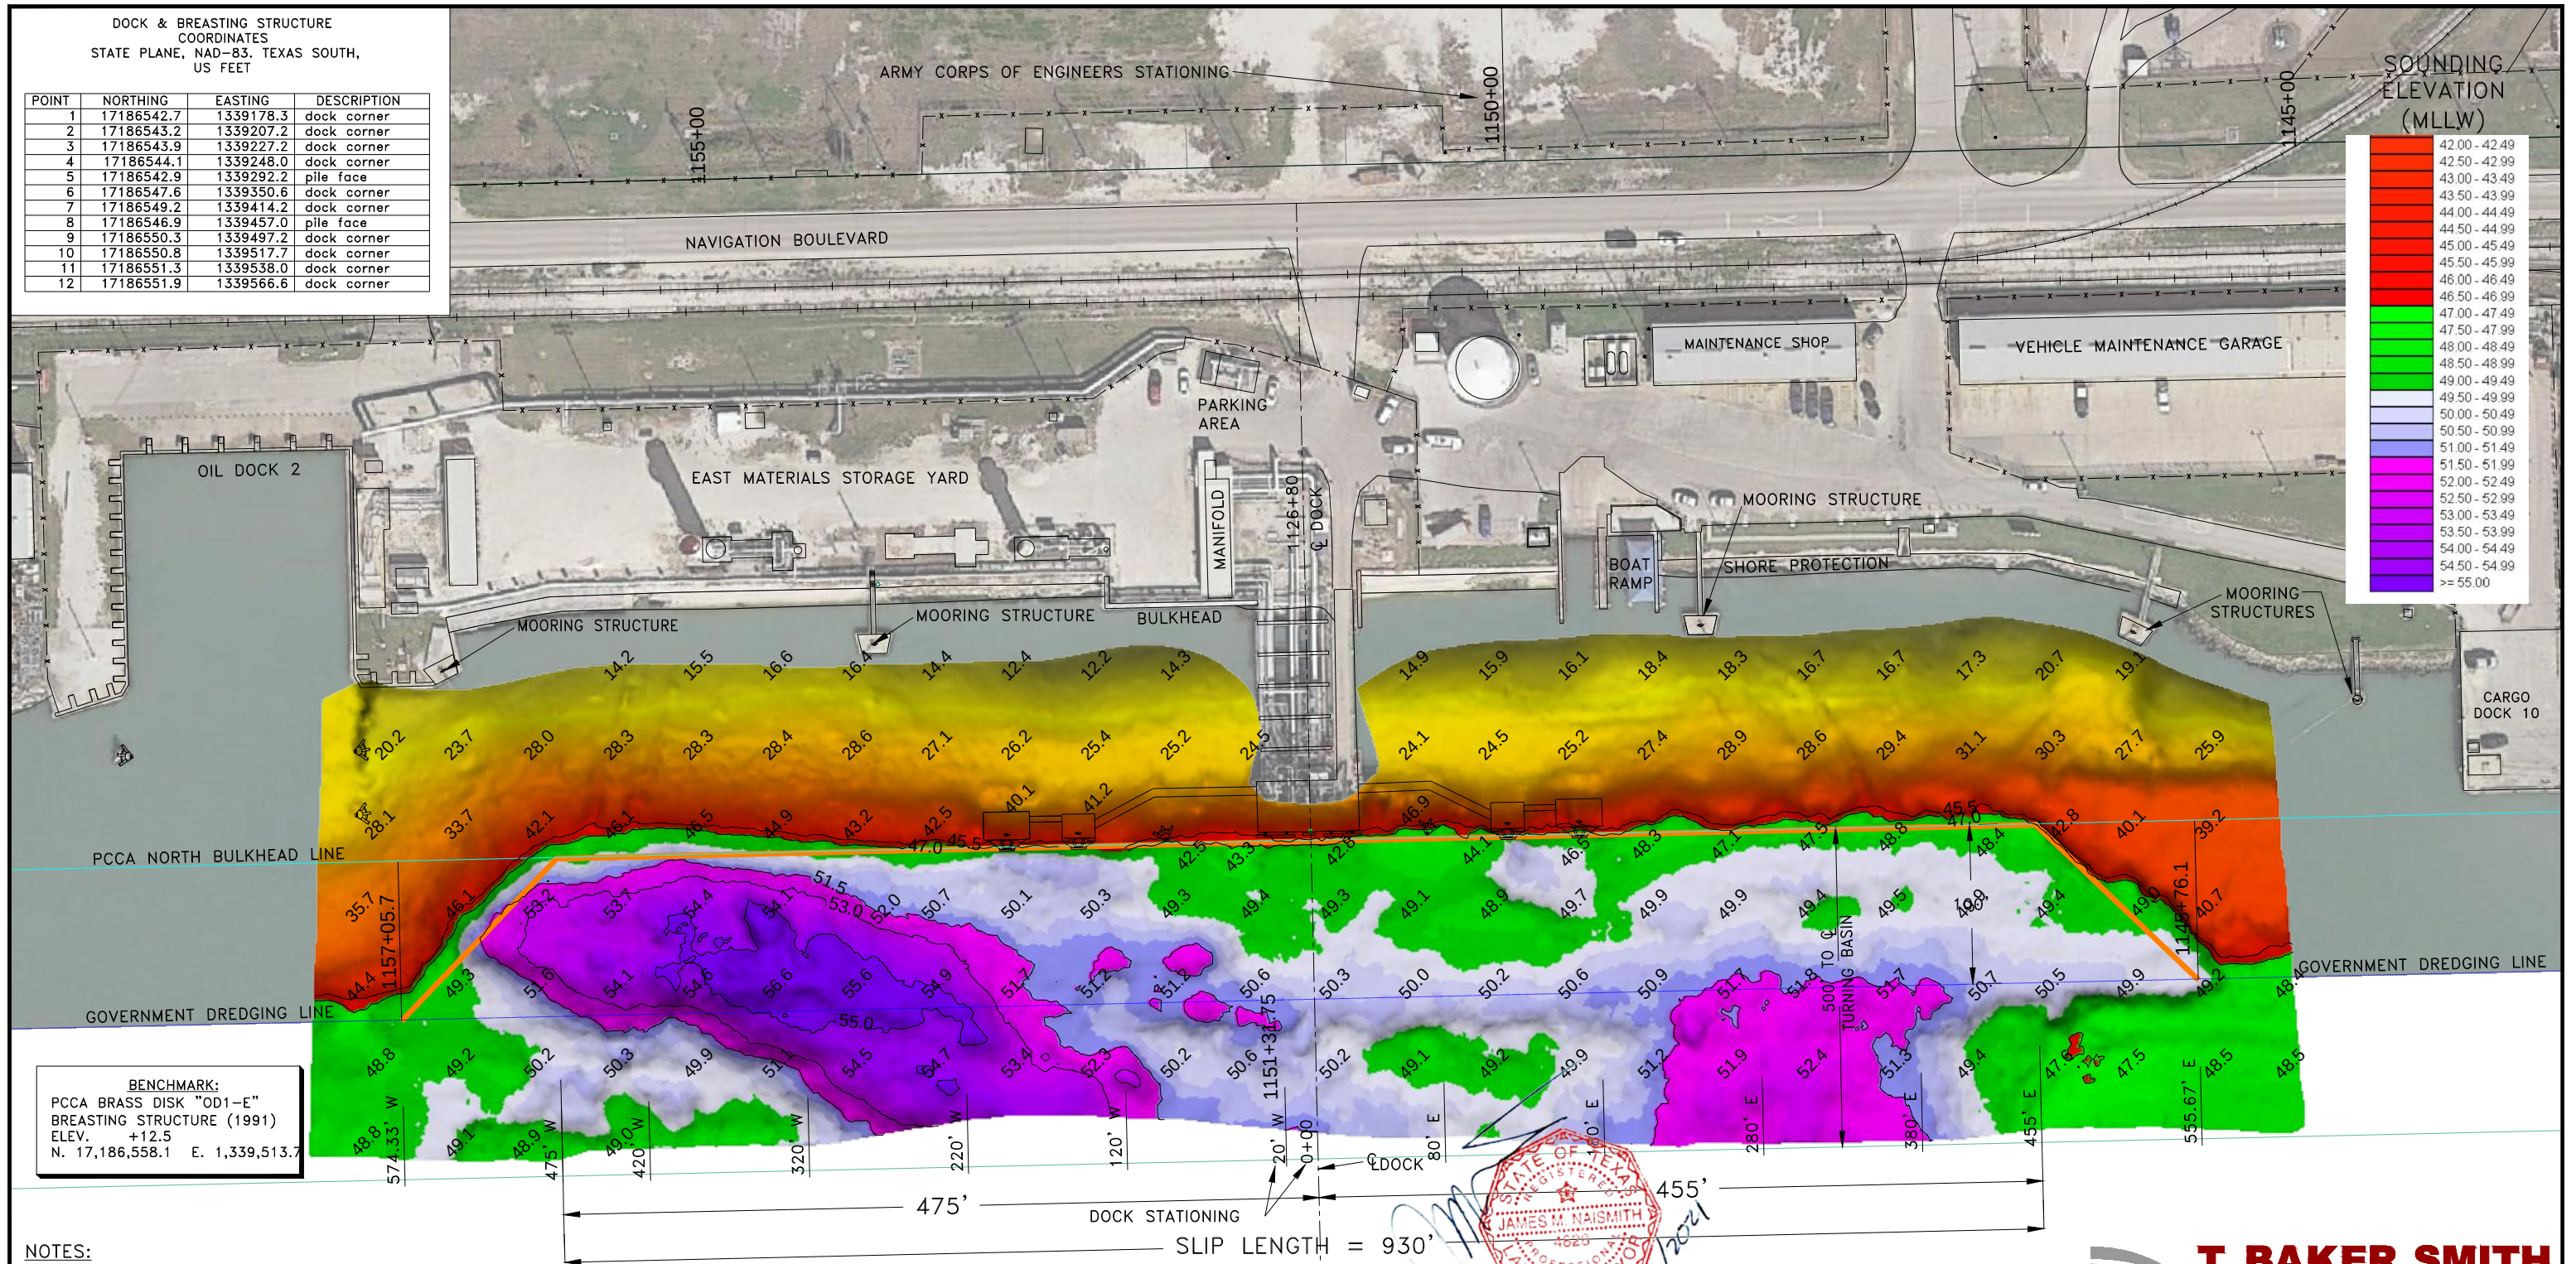
BENCHMARK:  
PCCA BRASS DISK "OD1-E"  
BREASTING STRUCTURE (1991)  
ELEV. +12.5  
N. 17,186,558.1 E. 1,339,513.7

- NOTES:
1. VESSEL LENGTH LIMIT IS 1,000 FEET.
  2. TOP OF DOCK ELEVATION IS 14.2 FT ABOVE MEAN LOWER LOW WATER (0.0')
  3. SOUNDINGS WERE RECORDED BY T. BAKER SMITH ON 21 JULY, 2021.  
SEA FLOOR CONDITIONS ARE SUBJECT TO CHANGE.
  4. THE PORT OF CORPUS CHRISTI ASSUMES NO LIABILITY FOR THE ACCURACY OF THIS INFORMATION. THE INFORMATION DEPICTED ON THIS MAP REPRESENTS THE RESULTS OF SURVEYS MADE ON THE DATE DEPICTED AND CAN ONLY BE CONSIDERED AS INDICATING THE GENERAL CONDITIONS AT THAT TIME. THESE CONDITIONS ARE SUBJECT TO RAPID CHANGE DUE TO SHOALING EVENTS.
  5. ALL READINGS ARE BASED ON THE NATIONAL OCEANIC AND ATMOSPHERIC ADMINISTRATION (NOAA) MEAN LOWER LOW WATER (MLLW) DATUM, (0.0')
  6. HORIZONTAL DATUM: NAD-83, STATE PLANE, TEXAS SOUTH ZONE, US FEET.
  7. TO GET THE DEPTH OF WATER, ADD THE CURRENT TIDE LEVEL TO THE READINGS SHOWN. (SEE TIDE DATUM CHART).
