PORT OF CORPUS CHRISTI AUTHORITY

SOUNDINGS
OIL DOCK 1

PLAN

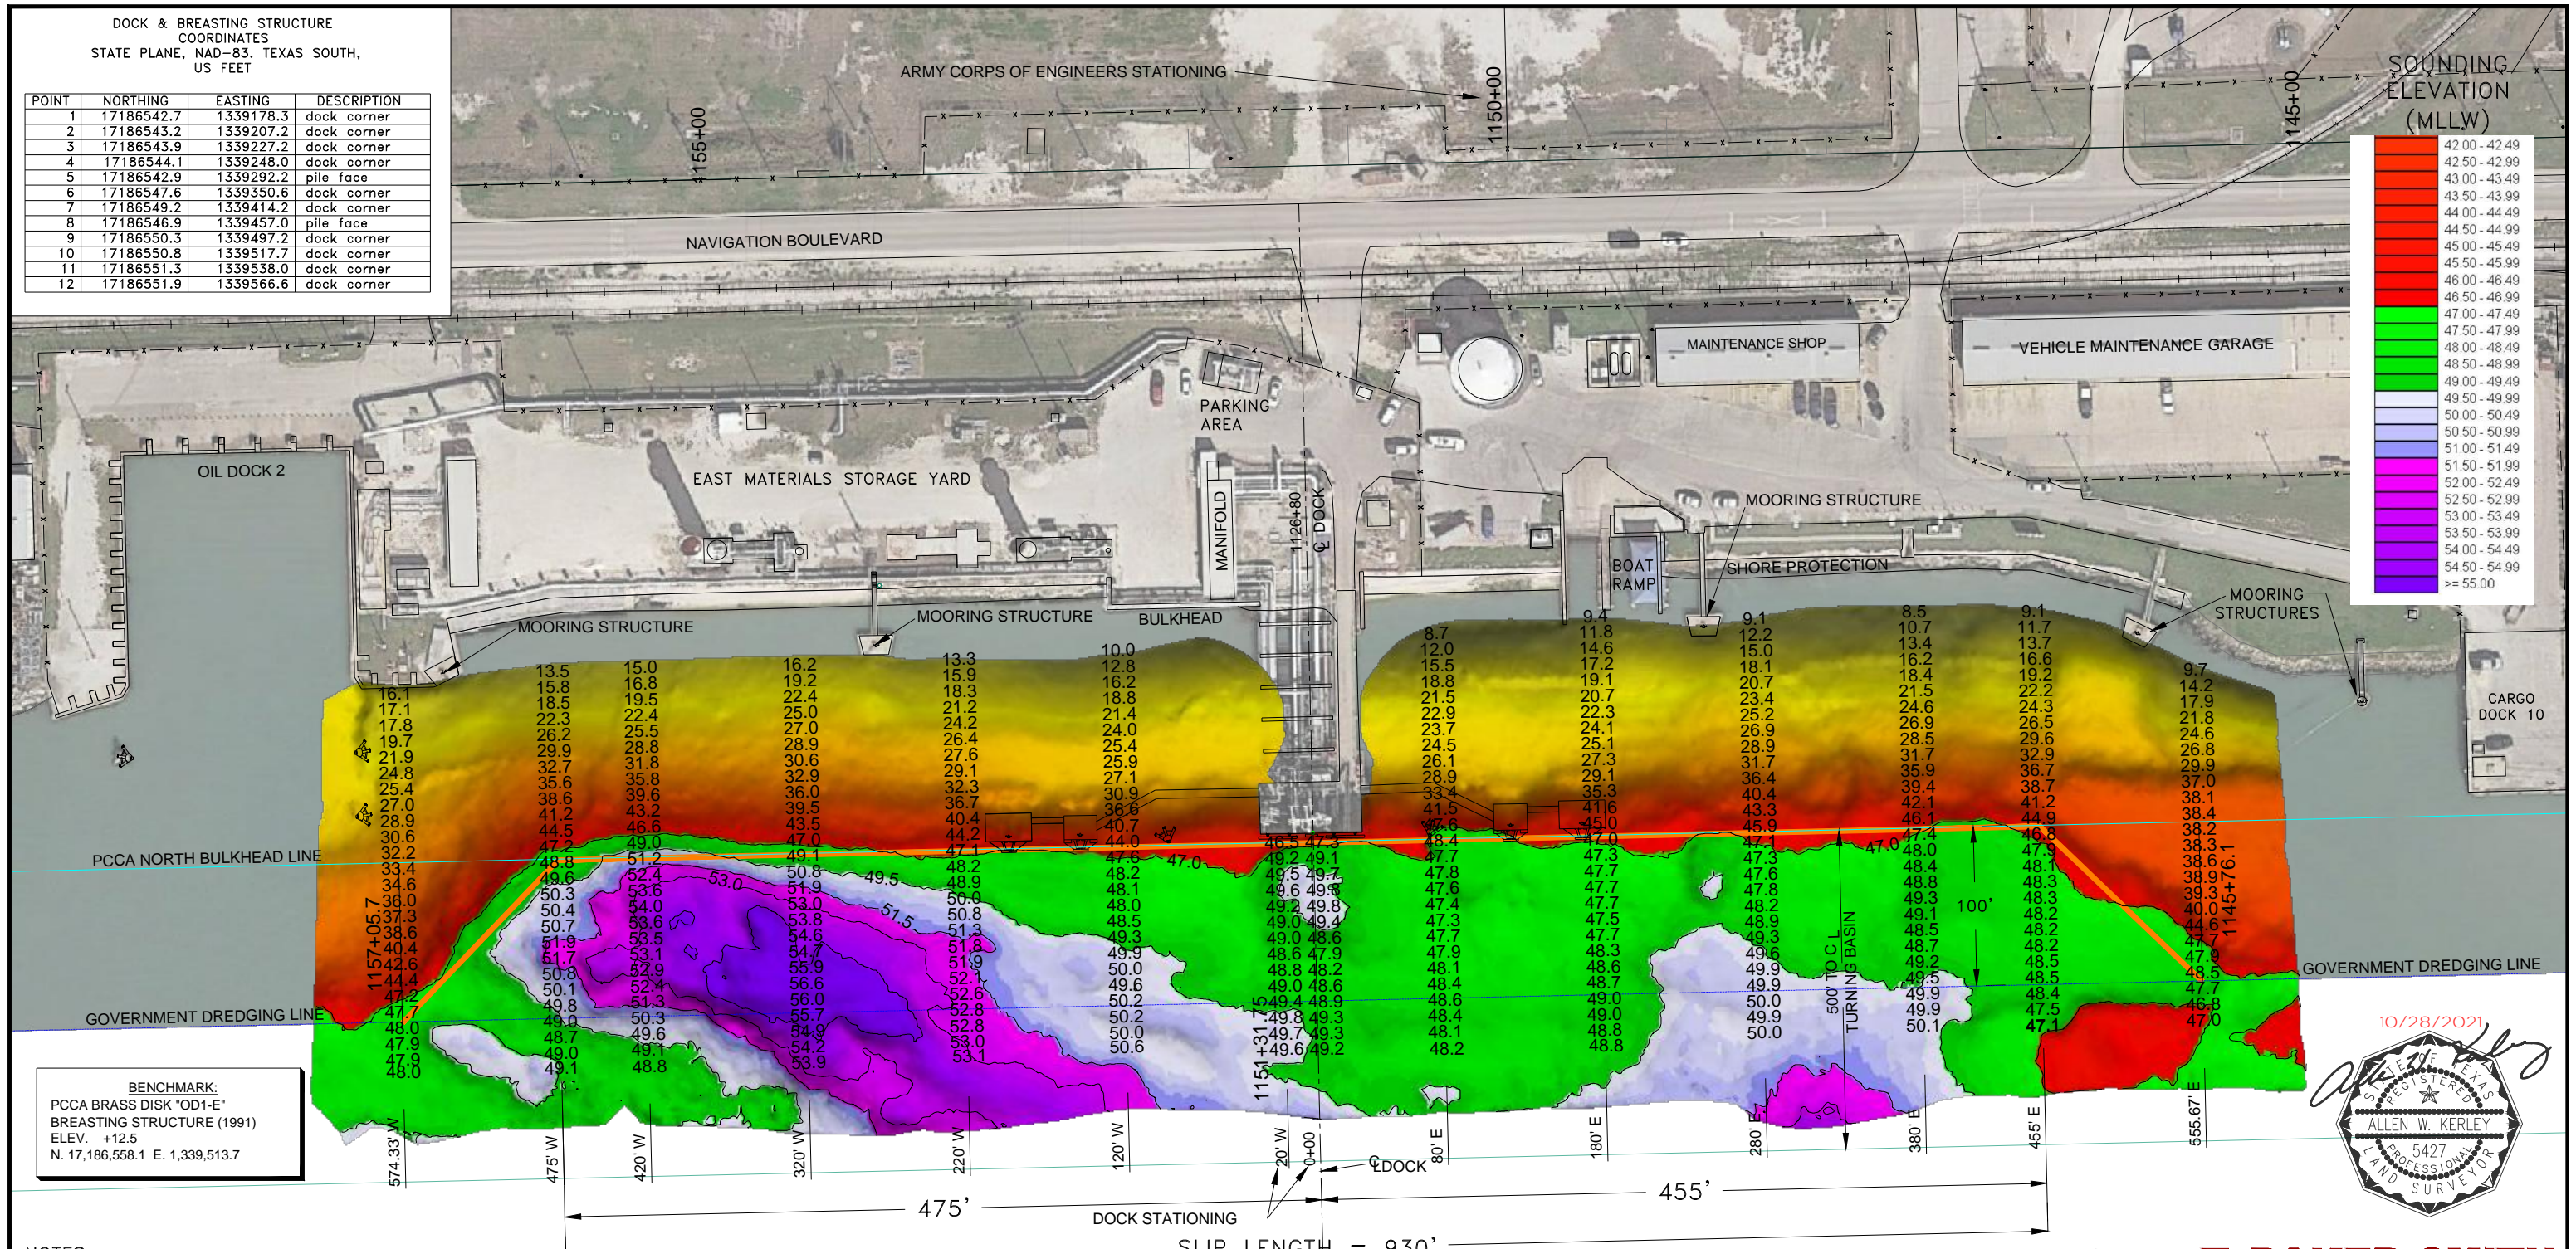
- NOTES:
1. VESSEL LENGTH LIMIT IS 1,000 FEET.
 2. TOP OF DOCK ELEVATION IS 14.2 FT ABOVE MEAN LOWER LOW WATER (0.0')
 3. SOUNDINGS WERE RECORDED BY T. BAKER SMITH ON 9 OCTOBER, 2021. SEA FLOOR CONDITIONS ARE SUBJECT TO CHANGE.
 4. THE PORT OF CORPUS CHRISTI ASSUMES NO LIABILITY FOR THE ACCURACY OF THIS INFORMATION. THE INFORMATION DEPICTED ON THIS MAP REPRESENTS THE RESULTS OF SURVEYS MADE ON THE DATE DEPICTED AND CAN ONLY BE CONSIDERED AS INDICATING THE GENERAL CONDITIONS AT THAT TIME. THESE CONDITIONS ARE SUBJECT TO RAPID CHANGE DUE TO SHOALING EVENTS.
 5. ALL READINGS ARE BASED ON THE NATIONAL OCEANIC AND ATMOSPHERIC ADMINISTRATION (NOAA) MEAN LOWER LOW WATER (MLLW) DATUM, (0.0')
 6. HORIZONTAL DATUM: NAD-83, STATE PLANE, TEXAS SOUTH ZONE, US FEET.
 7. TO GET THE DEPTH OF WATER, ADD THE CURRENT TIDE LEVEL TO THE READINGS SHOWN. (SEE TIDE DATUM CHART).
