PORT OF CORPUS CHRISTI AUTHORITY

SOUNDINGS-CARGO DOCKS 14 & 15

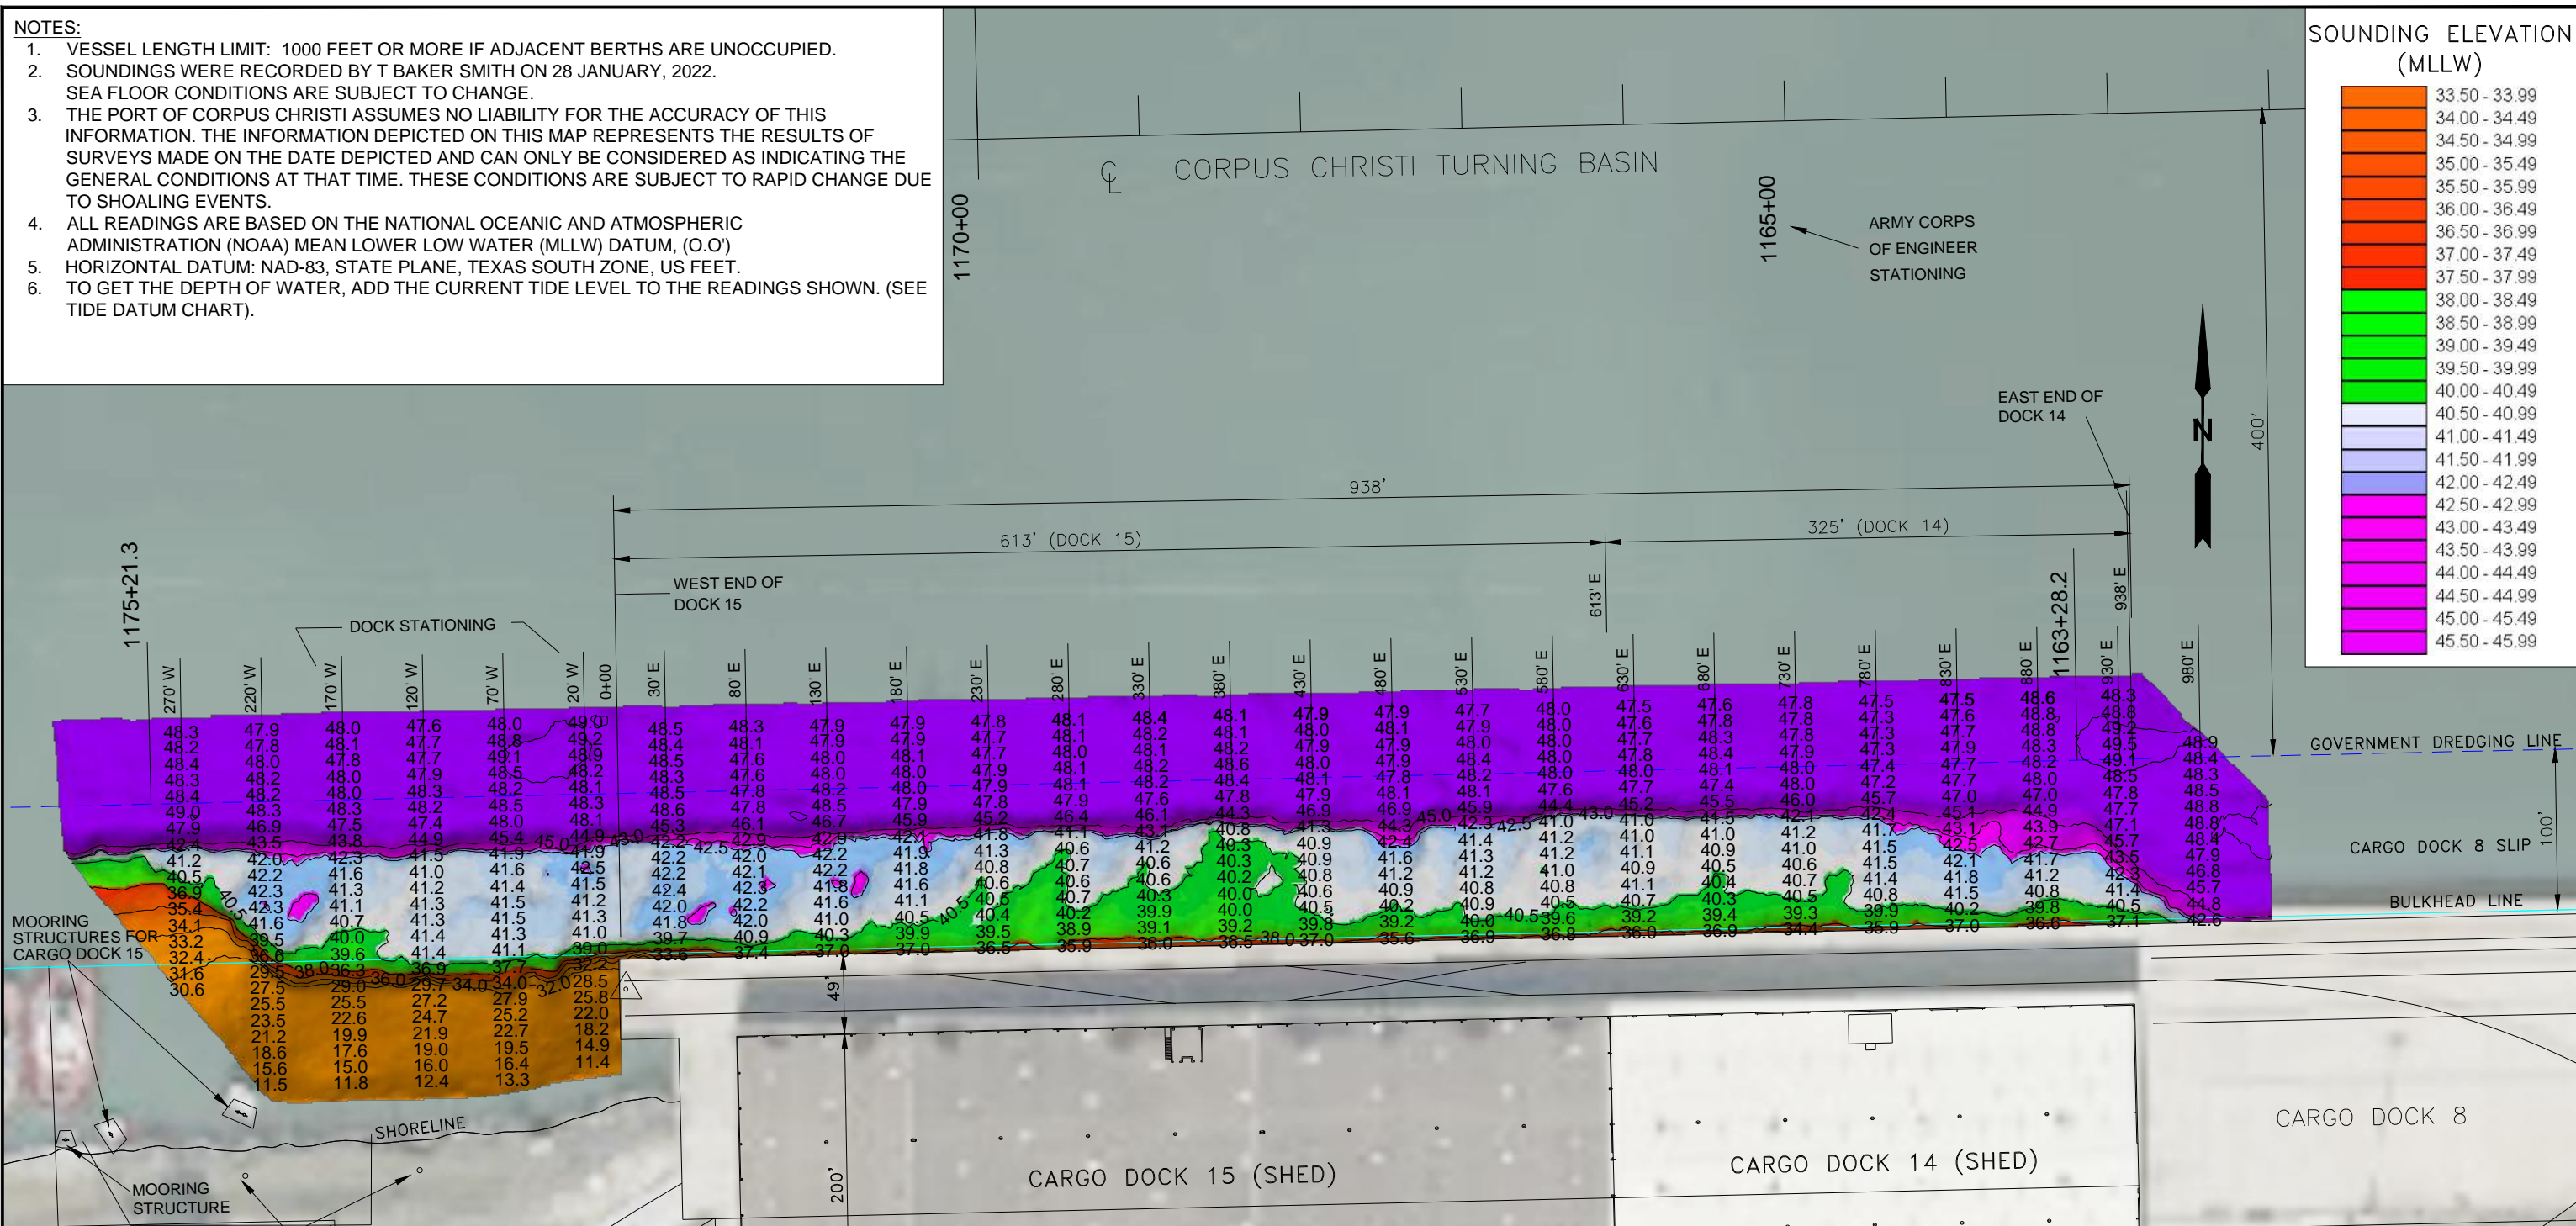
PLAN

SOUNDING ELEVATION (MLLW)

DOCK COORDINATES
STATE PLANE, NAD-83, TEXAS SOUTH, US FEET

POINT	NORTHING	EASTING	DESCRIPTION
1	17185491.8	1337305.8	DOCK CORNER
2	17185513.7	1338243.7	DOCK CORNER
