PORT OF CORPUS CHRISTI AUTHORITY

SOUNDINGS-CARGO DOCKS 14 & 15

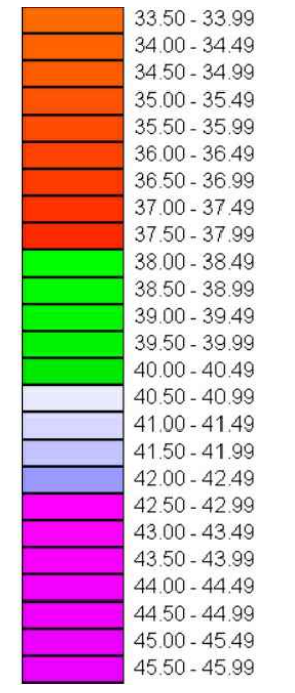
PLAN

1. VESSEL LENGTH LIMIT: 1000 FEET OR MORE IF ADJACENT BERTHS ARE UNOCCUPIED.
2. SOUNDINGS WERE RECORDED BY T BAKER SMITH ON 19 MAY 2022. SEA FLOOR CONDITIONS ARE SUBJECT TO CHANGE.
3. THE PORT OF CORPUS CHRISTI ASSUMES NO LIABILITY FOR THE ACCURACY OF THIS INFORMATION. THE INFORMATION DEPICTED ON THIS MAP REPRESENTS THE RESULTS OF SURVEYS MADE ON THE DATE DEPICTED AND CAN ONLY BE CONSIDERED AS INDICATING THE GENERAL CONDITIONS AT THAT TIME. THESE CONDITIONS ARE SUBJECT TO RAPID CHANGE DUE TO SHOALING EVENTS.
4. ALL READINGS ARE BASED ON THE NATIONAL OCEANIC AND ATMOSPHERIC ADMINISTRATION (NOAA) MEAN LOWER LOW WATER (MLLW) DATUM, (O.O')
5. HORIZONTAL DATUM: NAD-83, STATE PLANE, TEXAS SOUTH ZONE, US FEET.
6. TO GET THE DEPTH OF WATER, ADD THE CURRENT TIDE LEVEL TO THE READINGS SHOWN. (SEE TIDE DATUM CHART).

SOUNDING ELEVATION (MLLW)

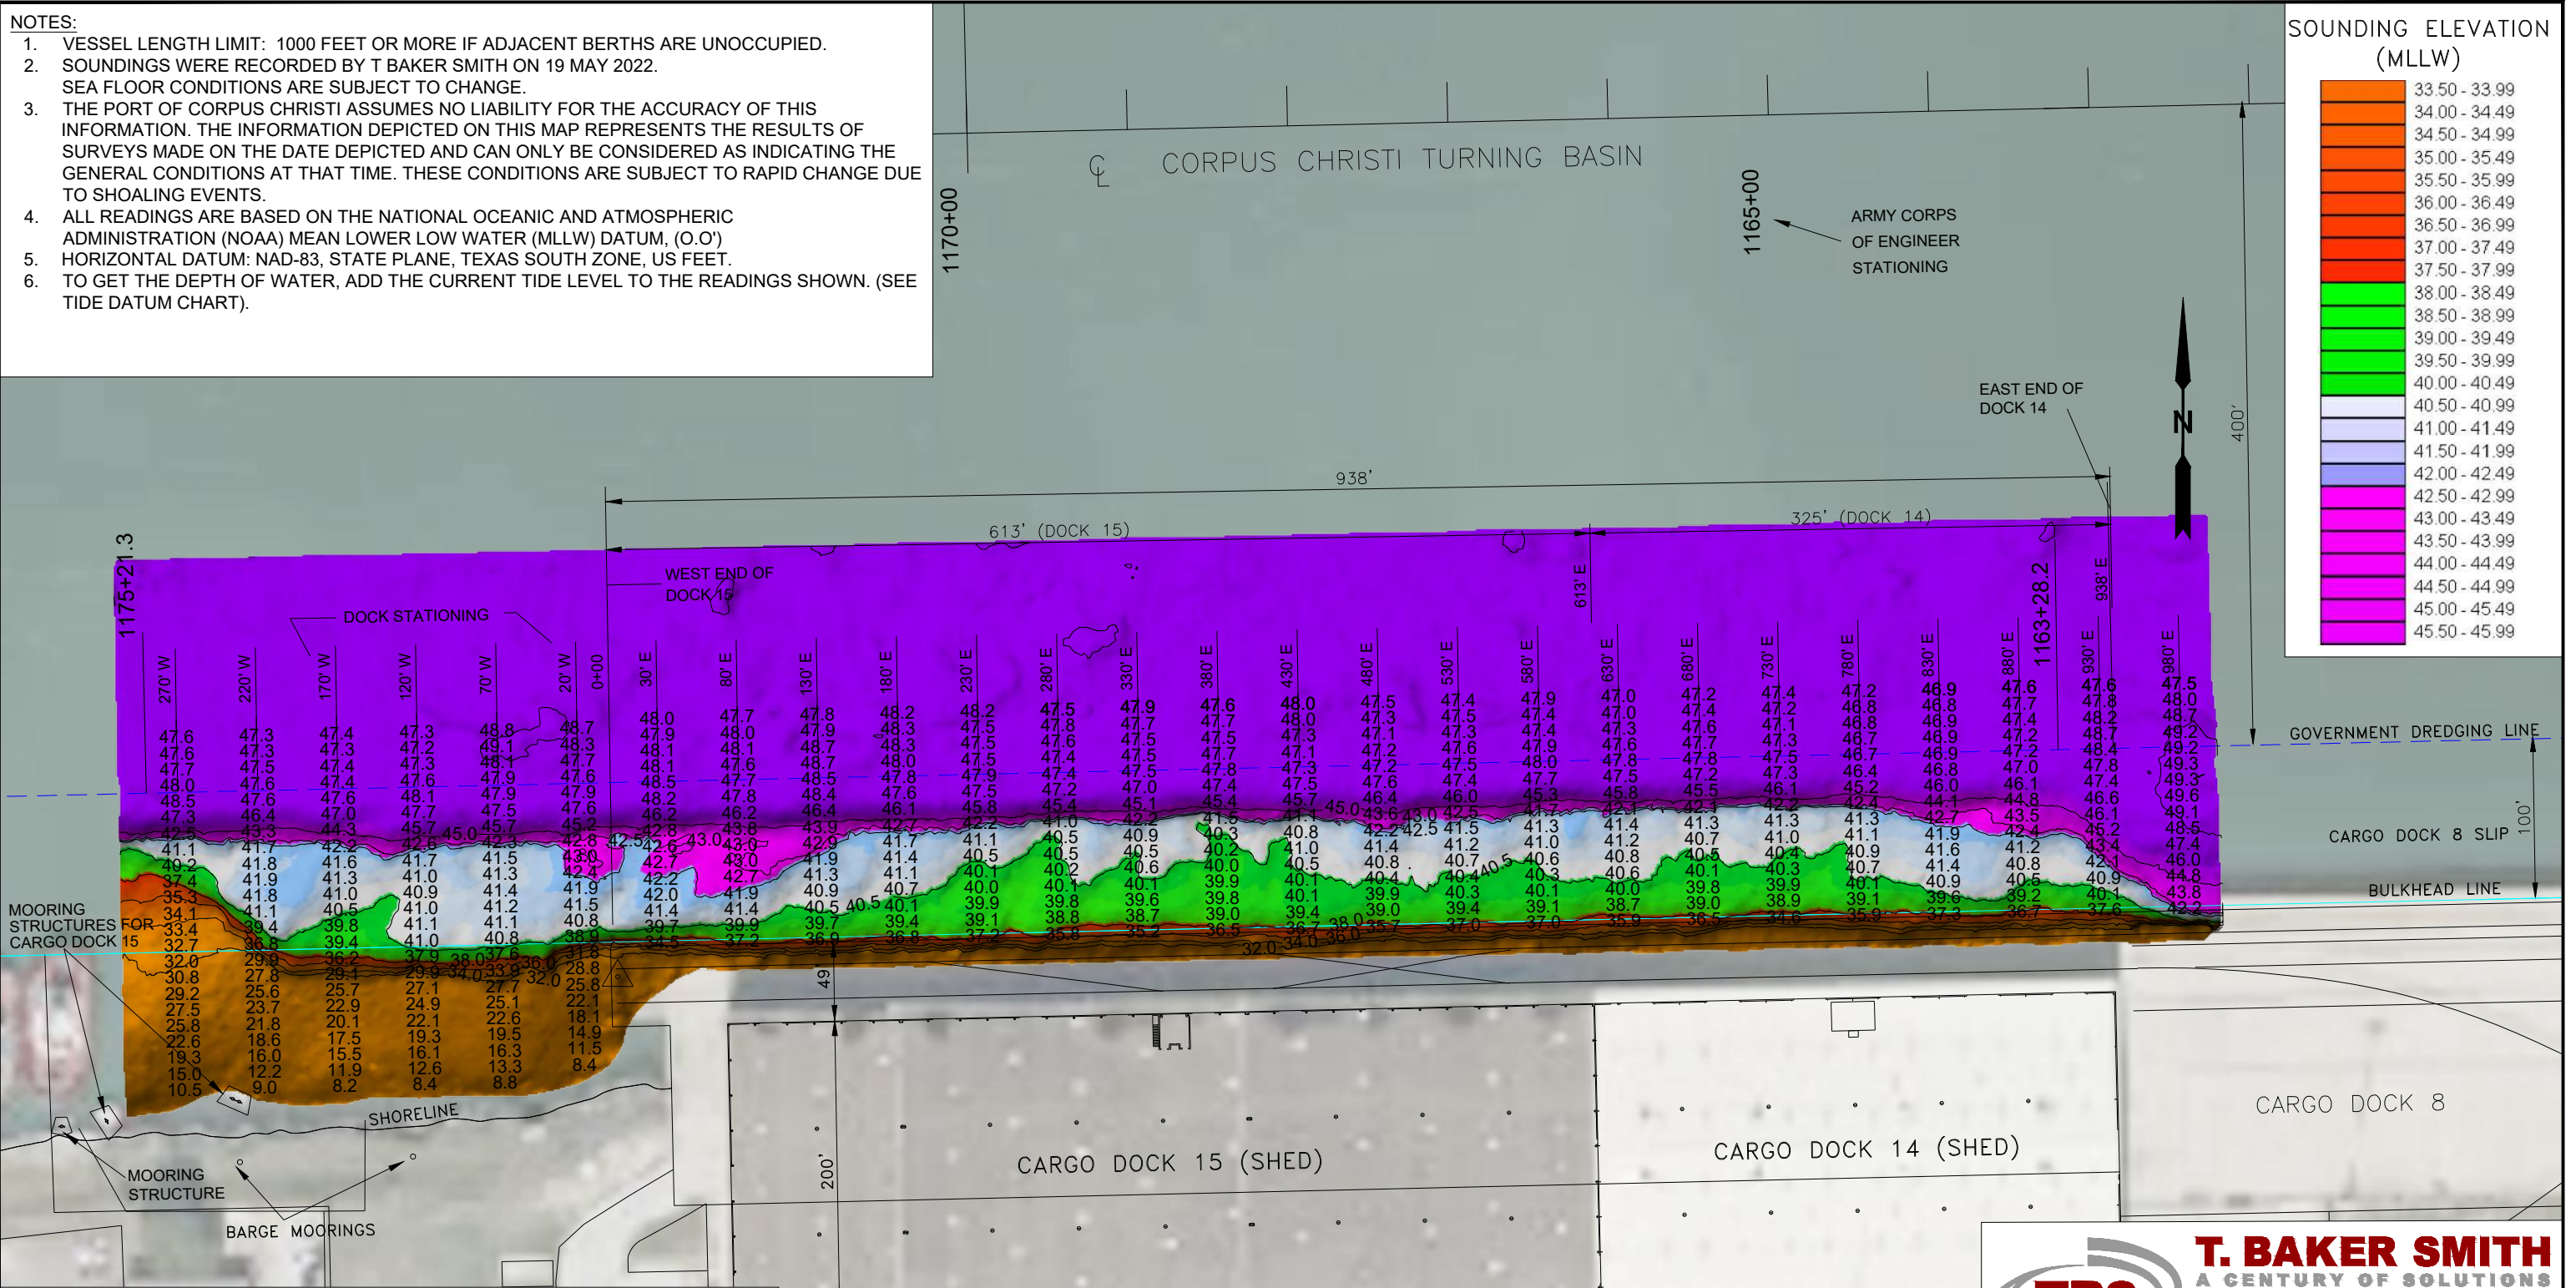
DOCK COORDINATES
STATE PLANE, NAD-83, TEXAS SOUTH, US FEET

POINT	NORTHING	EASTING	DESCRIPTION
1	17185491.8	1337305.8	DOCK CORNER
2	17185513.7	1338243.7	DOCK CORNER
