PORT OF CORPUS CHRISTI AUTHORITY

SOUNDINGS-REFRIGERATED DISTRIBUTION CENTER CARGO DOCK 10

PLAN

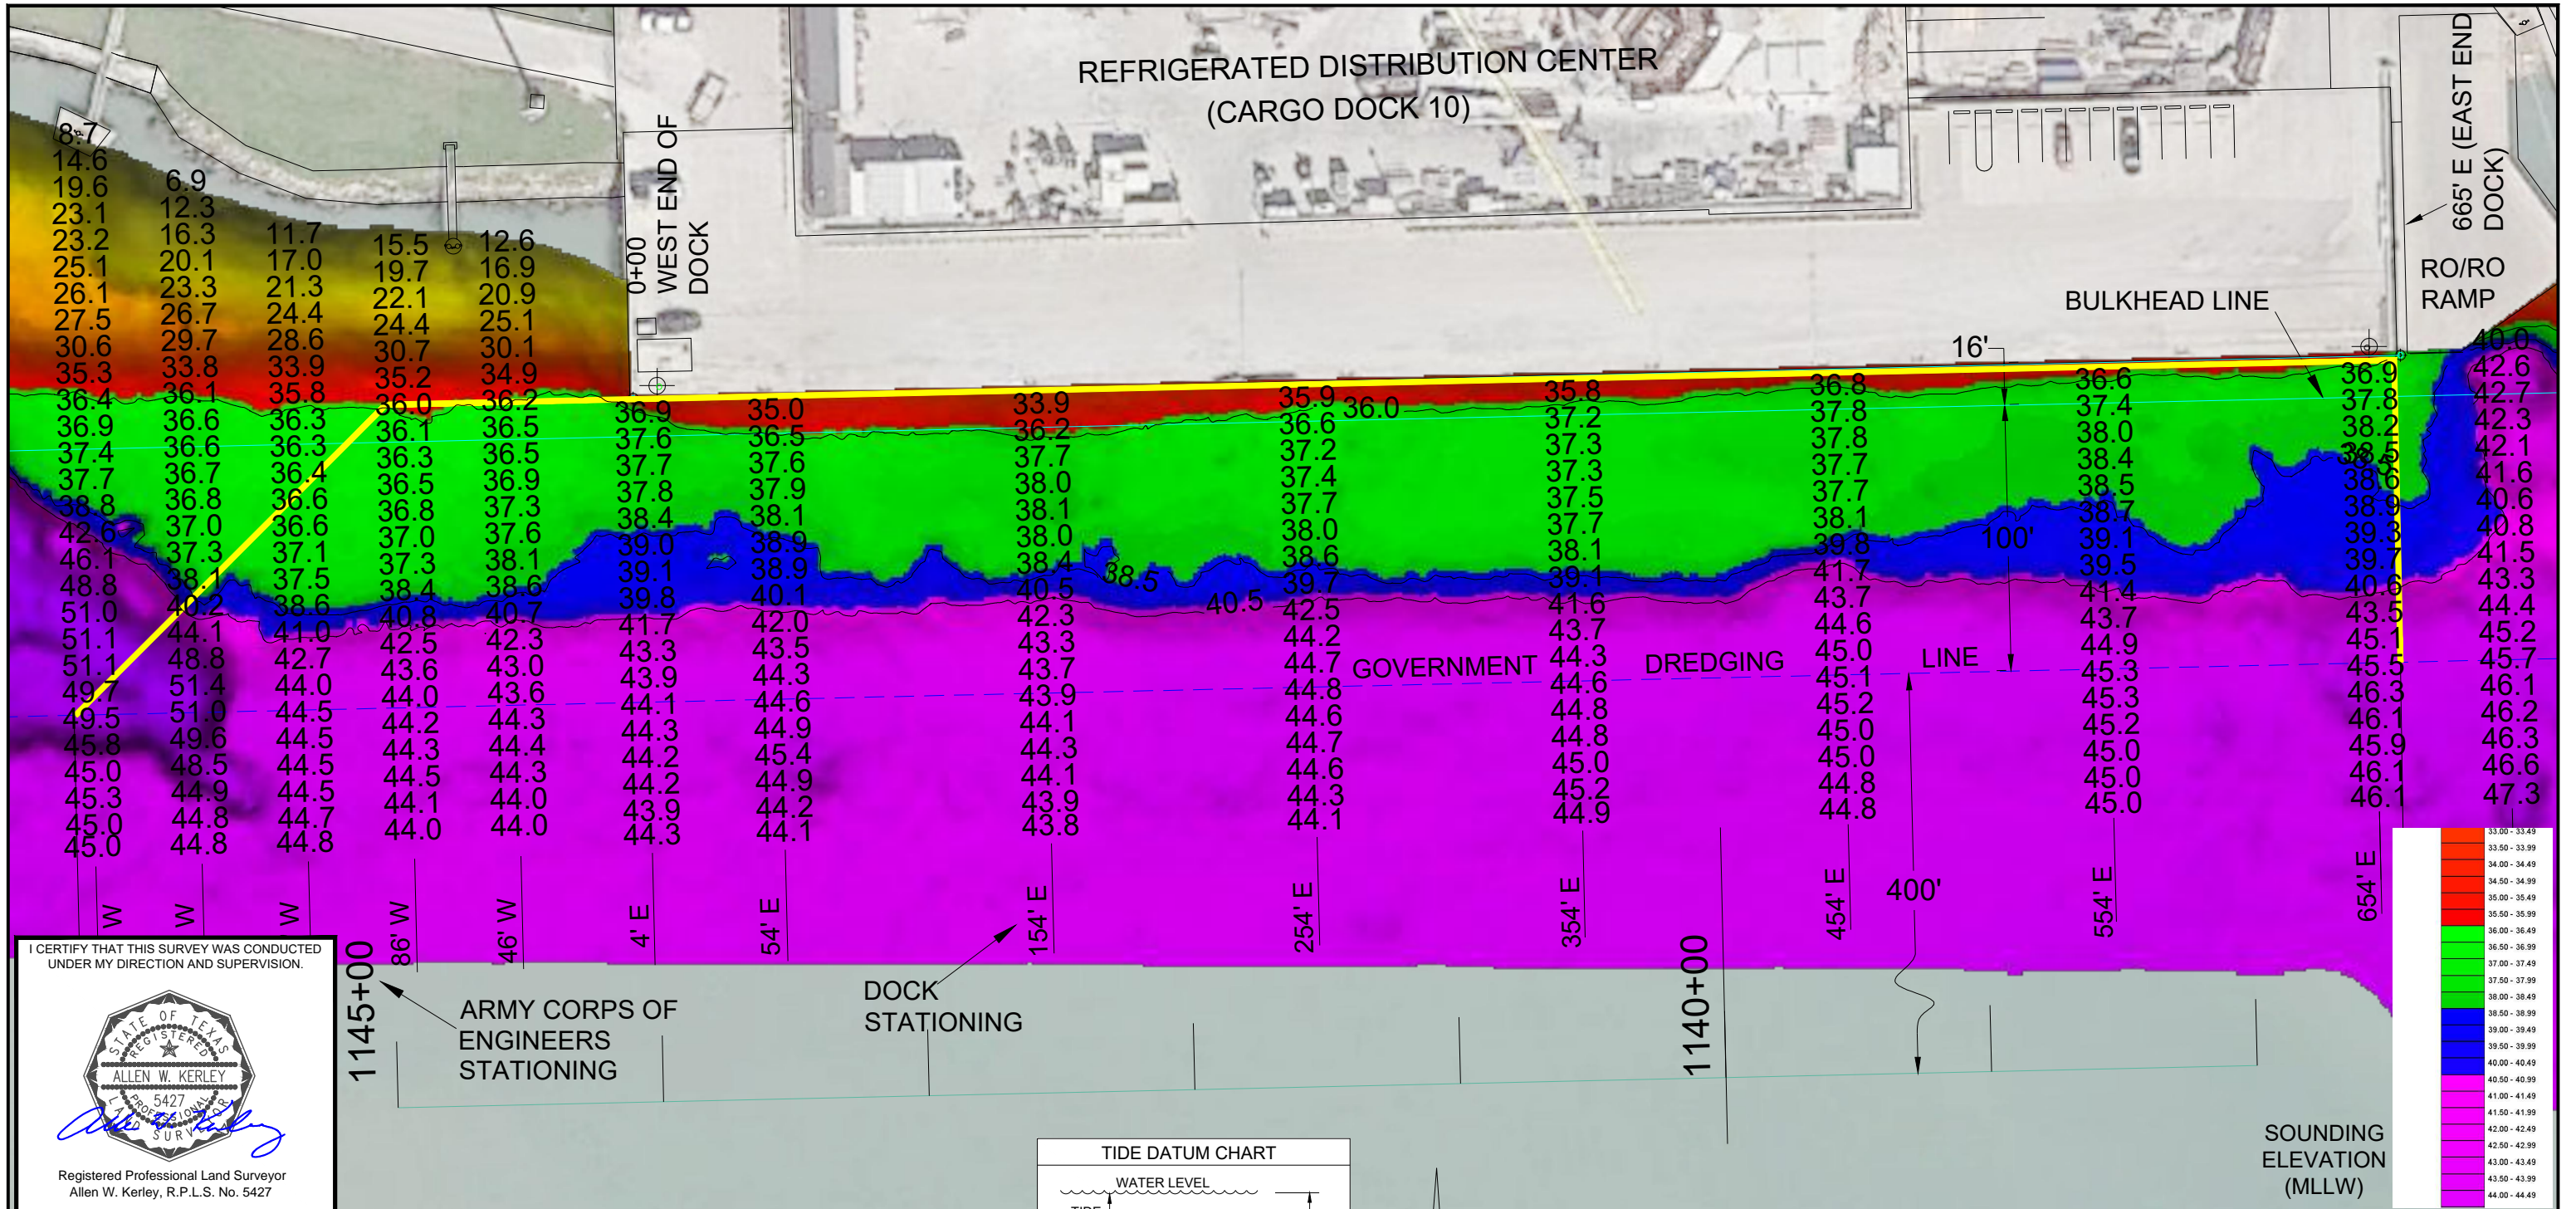
- NOTES:**
1. VESSEL LENGTH LIMIT IS 700 FEET.
 2. SOUNDINGS WERE RECORDED BY T BAKER SMITH ON 11 AUGUST, 2022. SEA FLOOR CONDITIONS ARE SUBJECT TO CHANGE.
 3. THE PORT OF CORPUS CHRISTI ASSUMES NO LIABILITY FOR THE ACCURACY OF THIS INFORMATION. THE INFORMATION DEPICTED ON THIS MAP REPRESENTS THE RESULTS OF SURVEYS MADE ON THE DATE DEPICTED AND CAN ONLY BE CONSIDERED AS INDICATING THE GENERAL CONDITIONS AT THAT TIME. THESE CONDITIONS ARE SUBJECT TO RAPID CHANGE DUE TO SHOALING EVENTS.
 4. ALL READINGS ARE BASED ON THE NATIONAL OCEANIC AND ATMOSPHERIC ADMINISTRATION (NOAA) MEAN LOWER LOW WATER (MLLW) DATUM, (O.O')
 5. HORIZONTAL DATUM: NAD-83, STATE PLANE, TEXAS SOUTH ZONE, US FEET.
 6. TO GET THE DEPTH OF WATER, ADD THE CURRENT TIDE LEVEL TO THE READINGS SHOWN. (SEE TIDE DATUM CHART).
