PORT OF CORPUS CHRISTI AUTHORITY

SOUNDINGS

OIL DOCK 6

PLAN

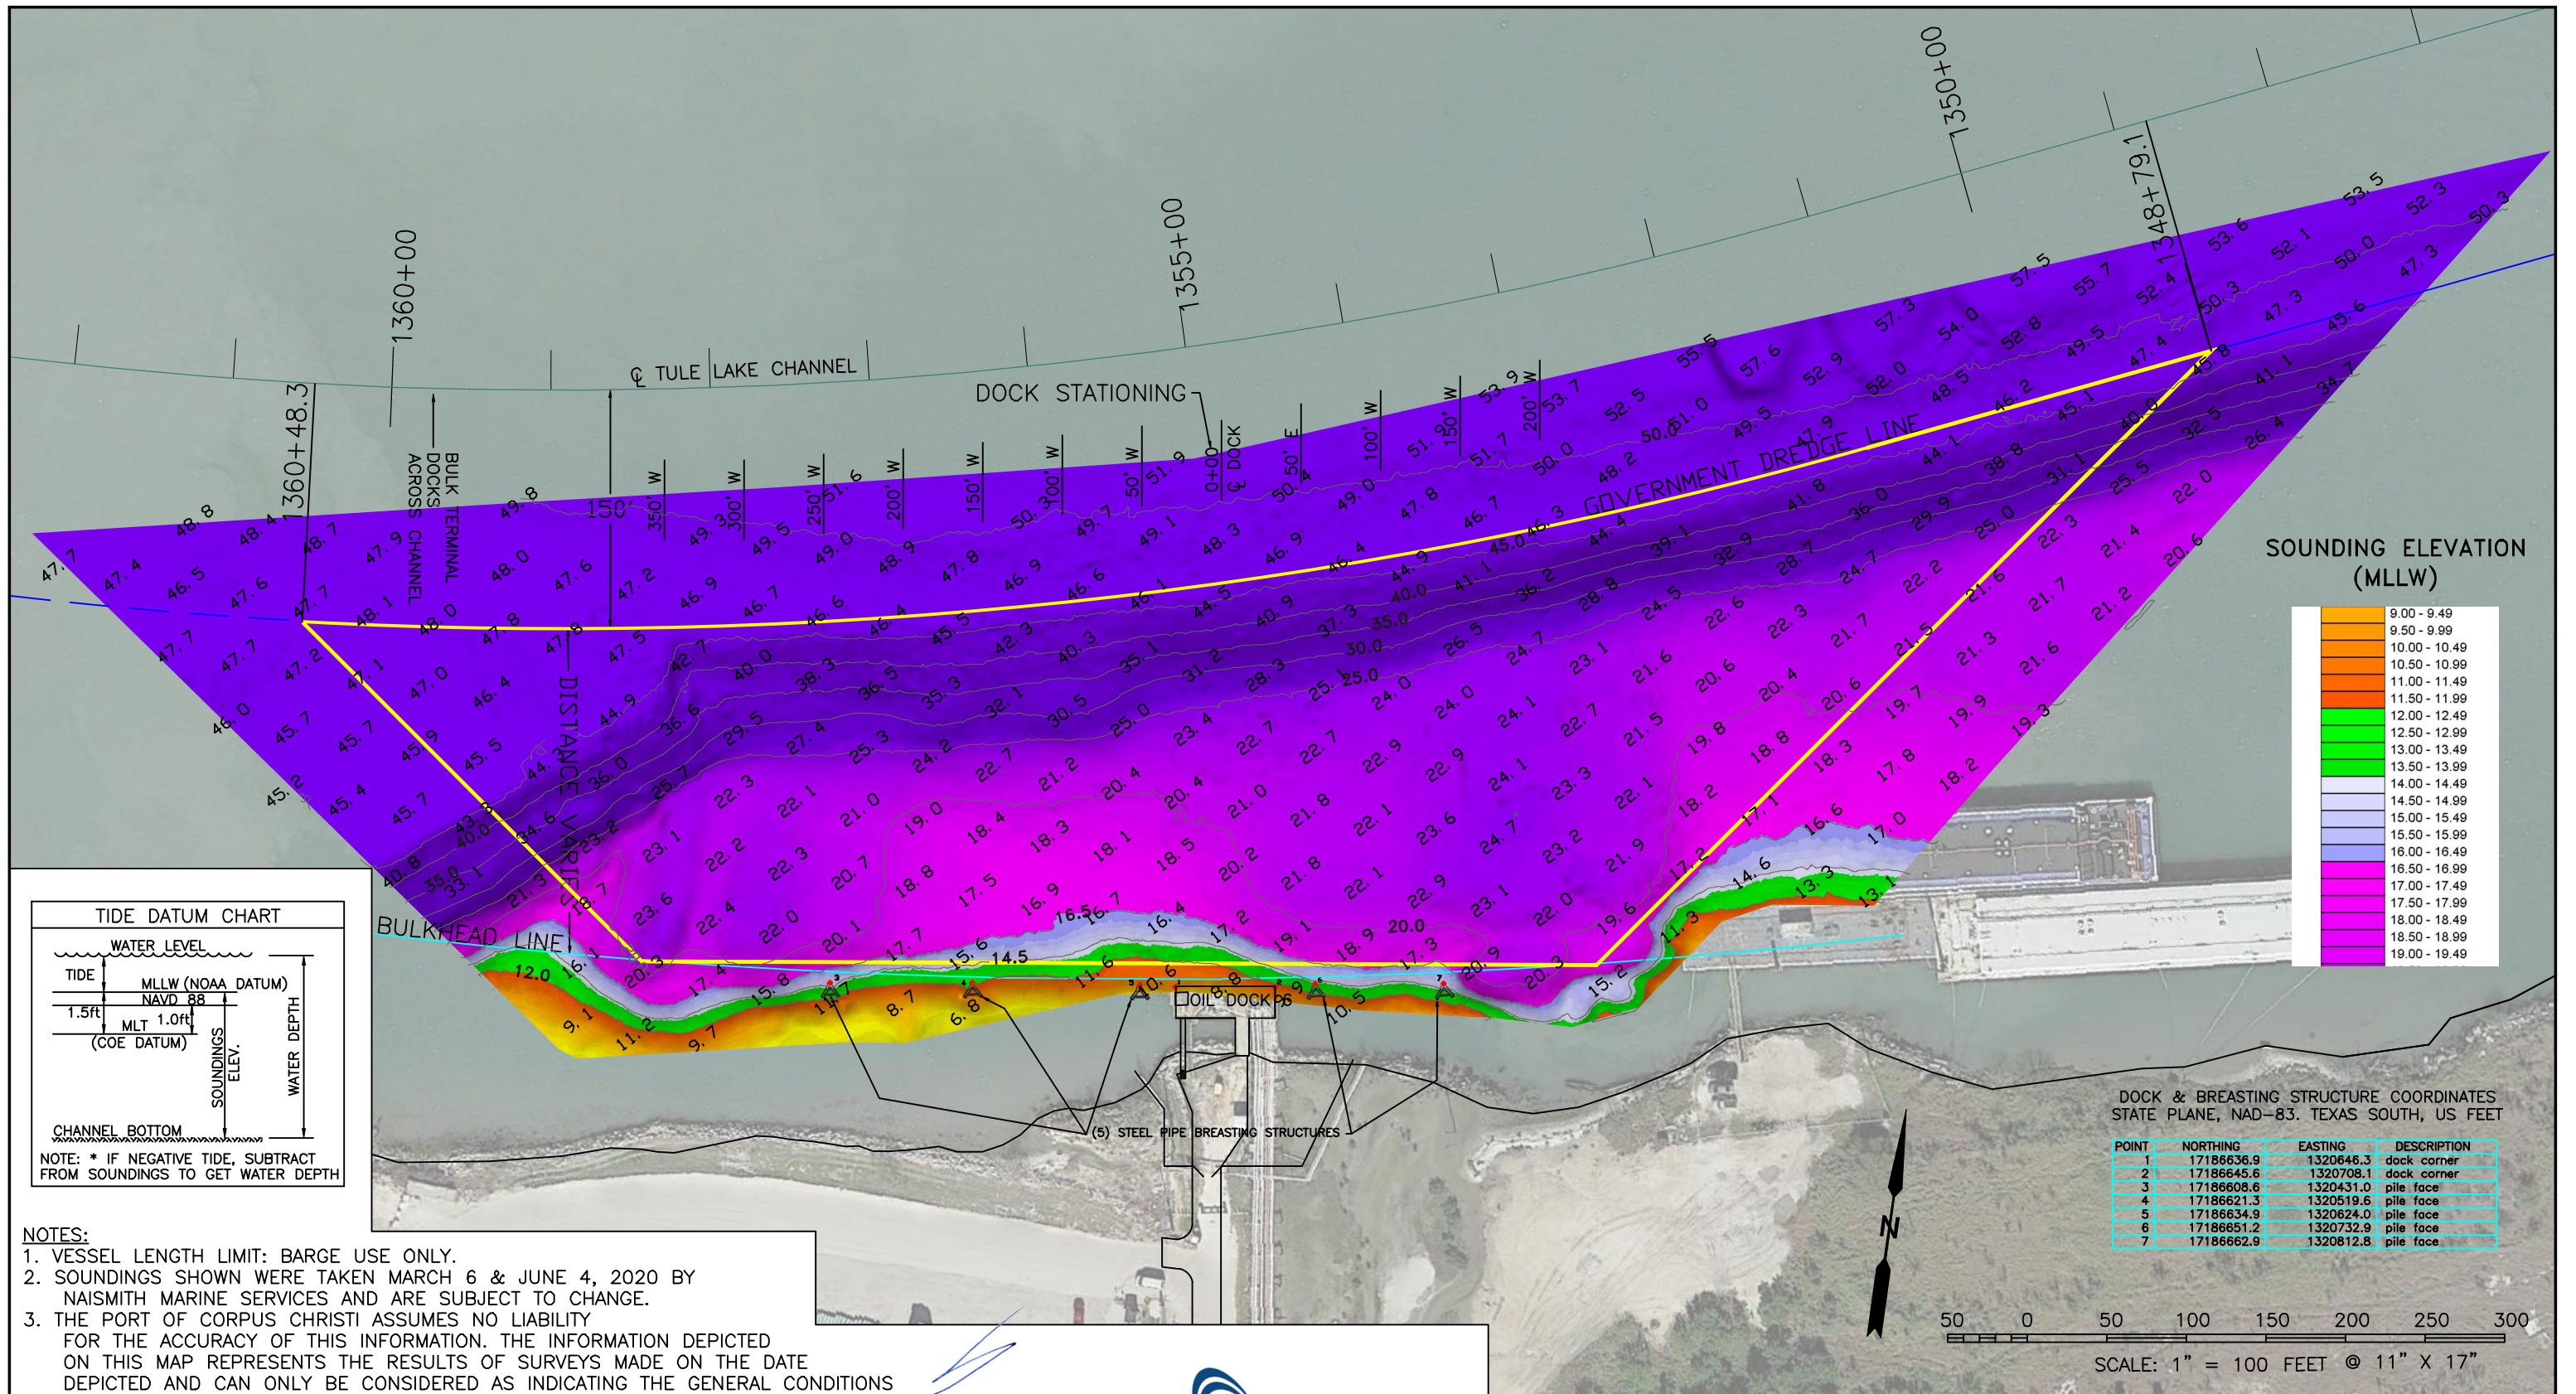
DOCK & BREASTING STRUCTURE COORDINATES
STATE PLANE, NAD-83, TEXAS SOUTH, US FEET
