DRAWN BY:	MES	APPROVED BY:	AWK
DATE:	03/26/2026	JOB NO:	2026.0151
DRAWING NAME:	BULK_DOCK_2_-25MAR2026		
PROJECTION:	TEXAS STATE PLANE SOUTH ZONE		
GEO. DATUM:	NAD83 (2011) VERT. DATUM: MLLW		
GRID UNITS:	US SURVEY FEET		
SHEET NO:	1	OF	1

PORT OF CORPUS CHRISTI AUTHORITY
BULK TERMINAL DOCK 2
2026-Q1
AN EXHIBIT OF A
BATHYMETRIC SURVEY
LOCATED IN
CORPUS CHRISTI, TEXAS

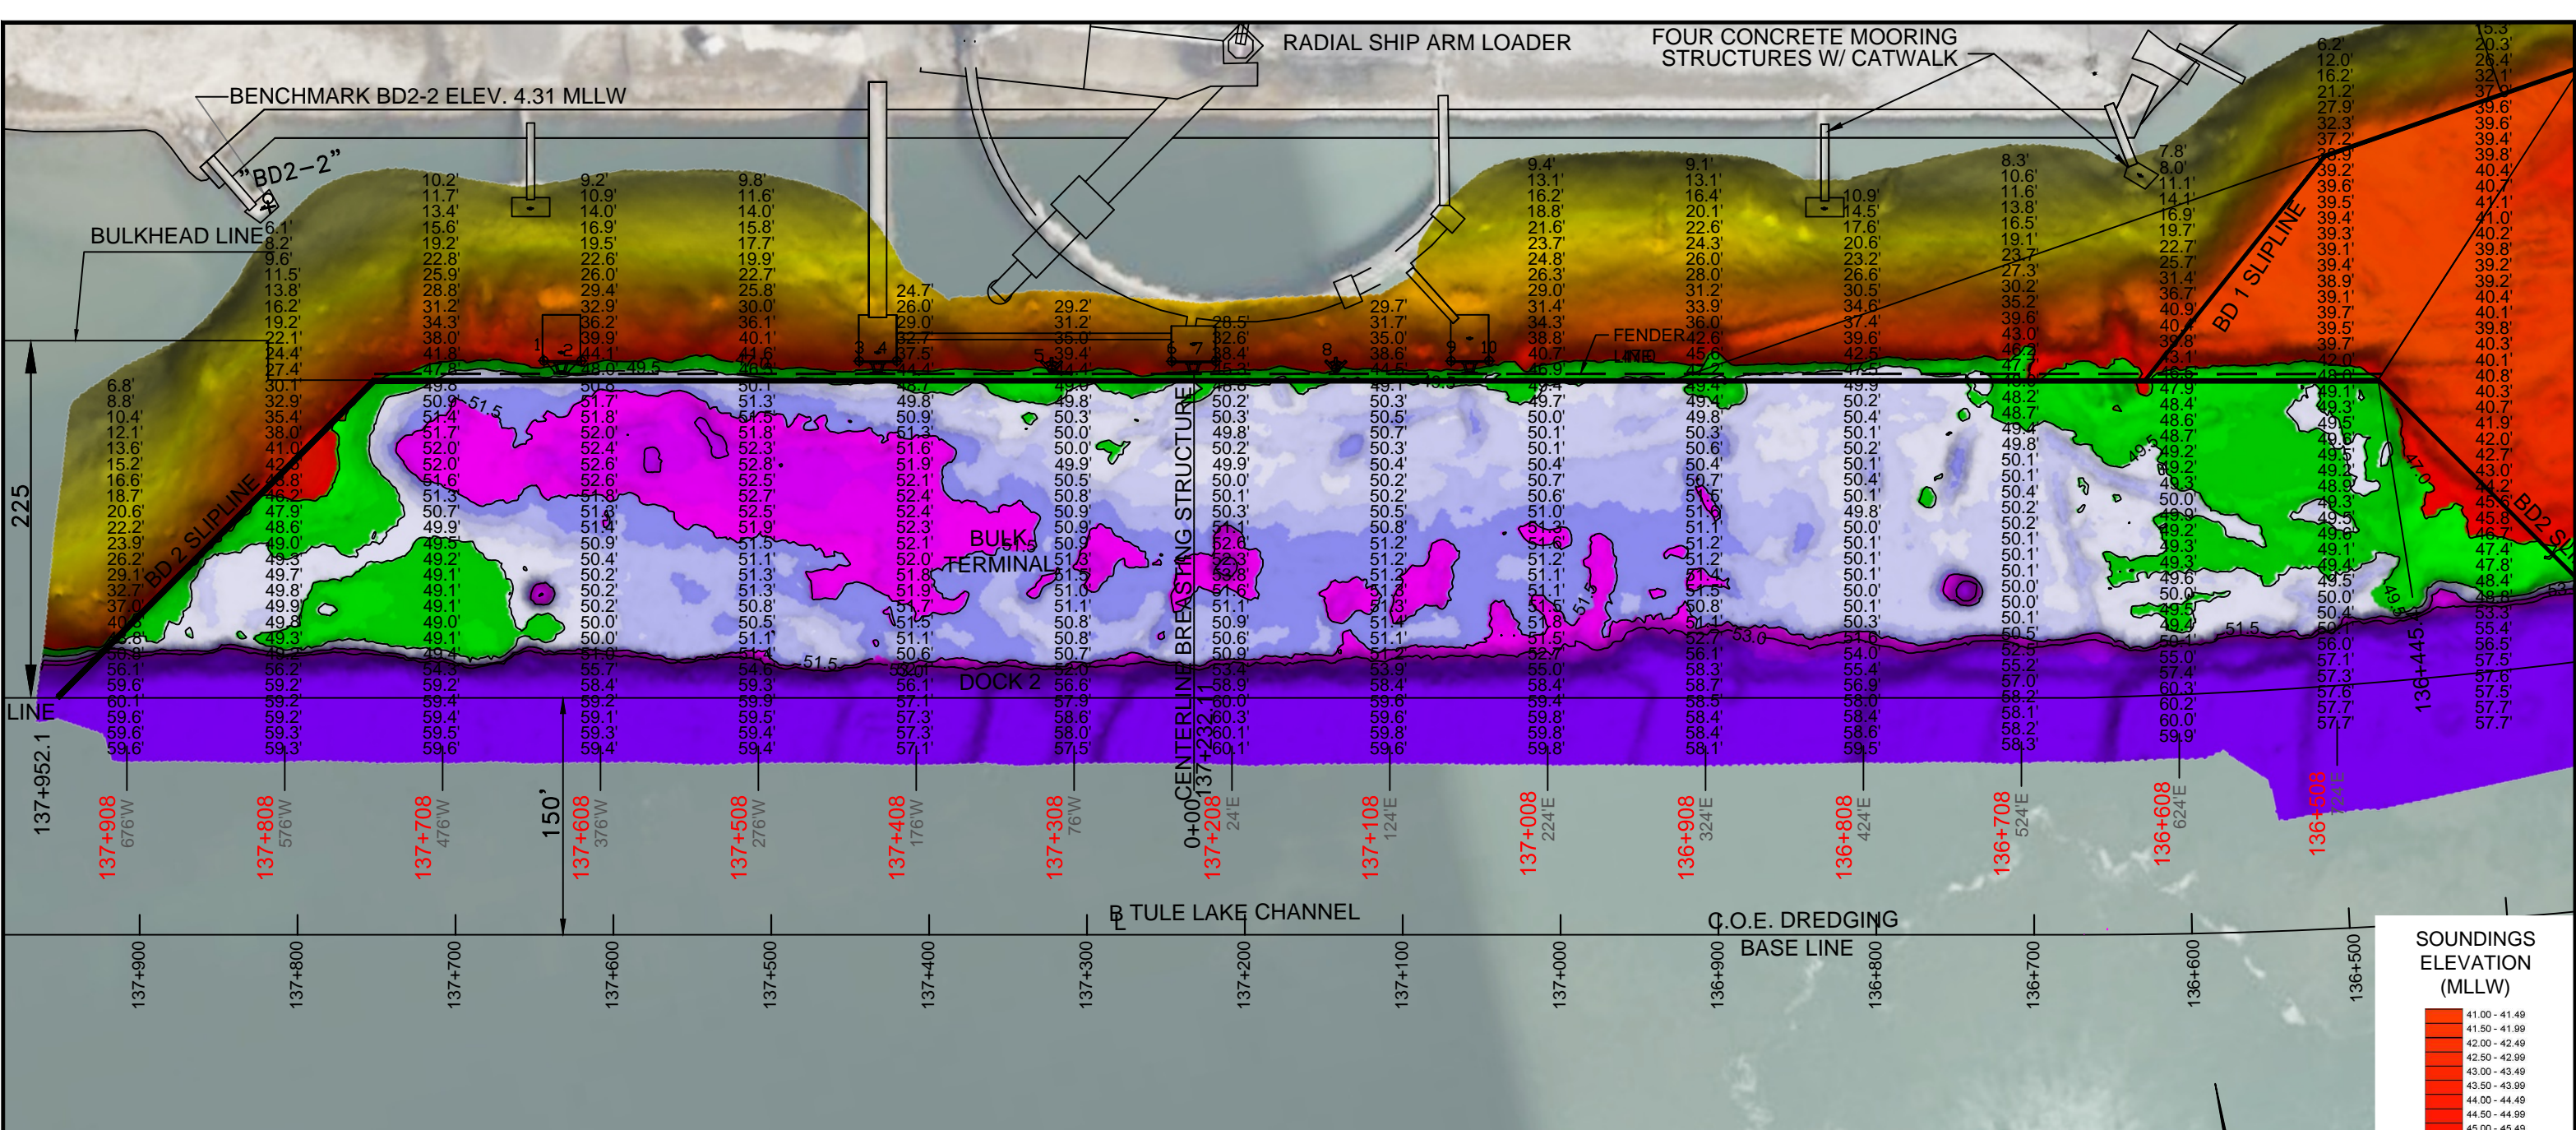
- NOTES:**
1. VESSEL LENGTH LIMIT IS 1,270 FEET.
 2. SOUNDINGS WERE RECORDED BY T BAKER SMITH ON 25 MARCH, 2026. SEA FLOOR CONDITIONS ARE SUBJECT TO CHANGE.
 3. THE PORT OF CORPUS CHRISTI ASSUMES NO LIABILITY FOR THE ACCURACY OF THIS INFORMATION. THE INFORMATION DEPICTED ON THIS MAP REPRESENTS THE RESULTS OF SURVEYS MADE ON THE DATE DEPICTED AND CAN ONLY BE CONSIDERED AS INDICATING THE GENERAL CONDITIONS AT THAT TIME. THESE CONDITIONS ARE SUBJECT TO RAPID CHANGE DUE TO SHOALING EVENTS.
 4. ALL READINGS ARE BASED ON THE NATIONAL OCEANIC AND ATMOSPHERIC ADMINISTRATION (NOAA) MEAN LOWER LOW WATER (MLLW) DATUM, (O.O')
 5. HORIZONTAL DATUM: NAD-83, STATE PLANE, TEXAS SOUTH ZONE, US FEET.
 6. TO GET THE DEPTH OF WATER, ADD THE CURRENT TIDE LEVEL TO READINGS SHOWN. (SEE TIDE DATUM CHART).

DOCK & BREASTING STRUCTURE COORDINATES
STATE PLANE, NAD83, TEXAS SOUTH, US FEET
