**TIDE DATUM CHART**

DOCK & BREASTING STRUCTURE COORDINATES  
STATE PLANE, NAD83, TEXAS SOUTH, US FEET

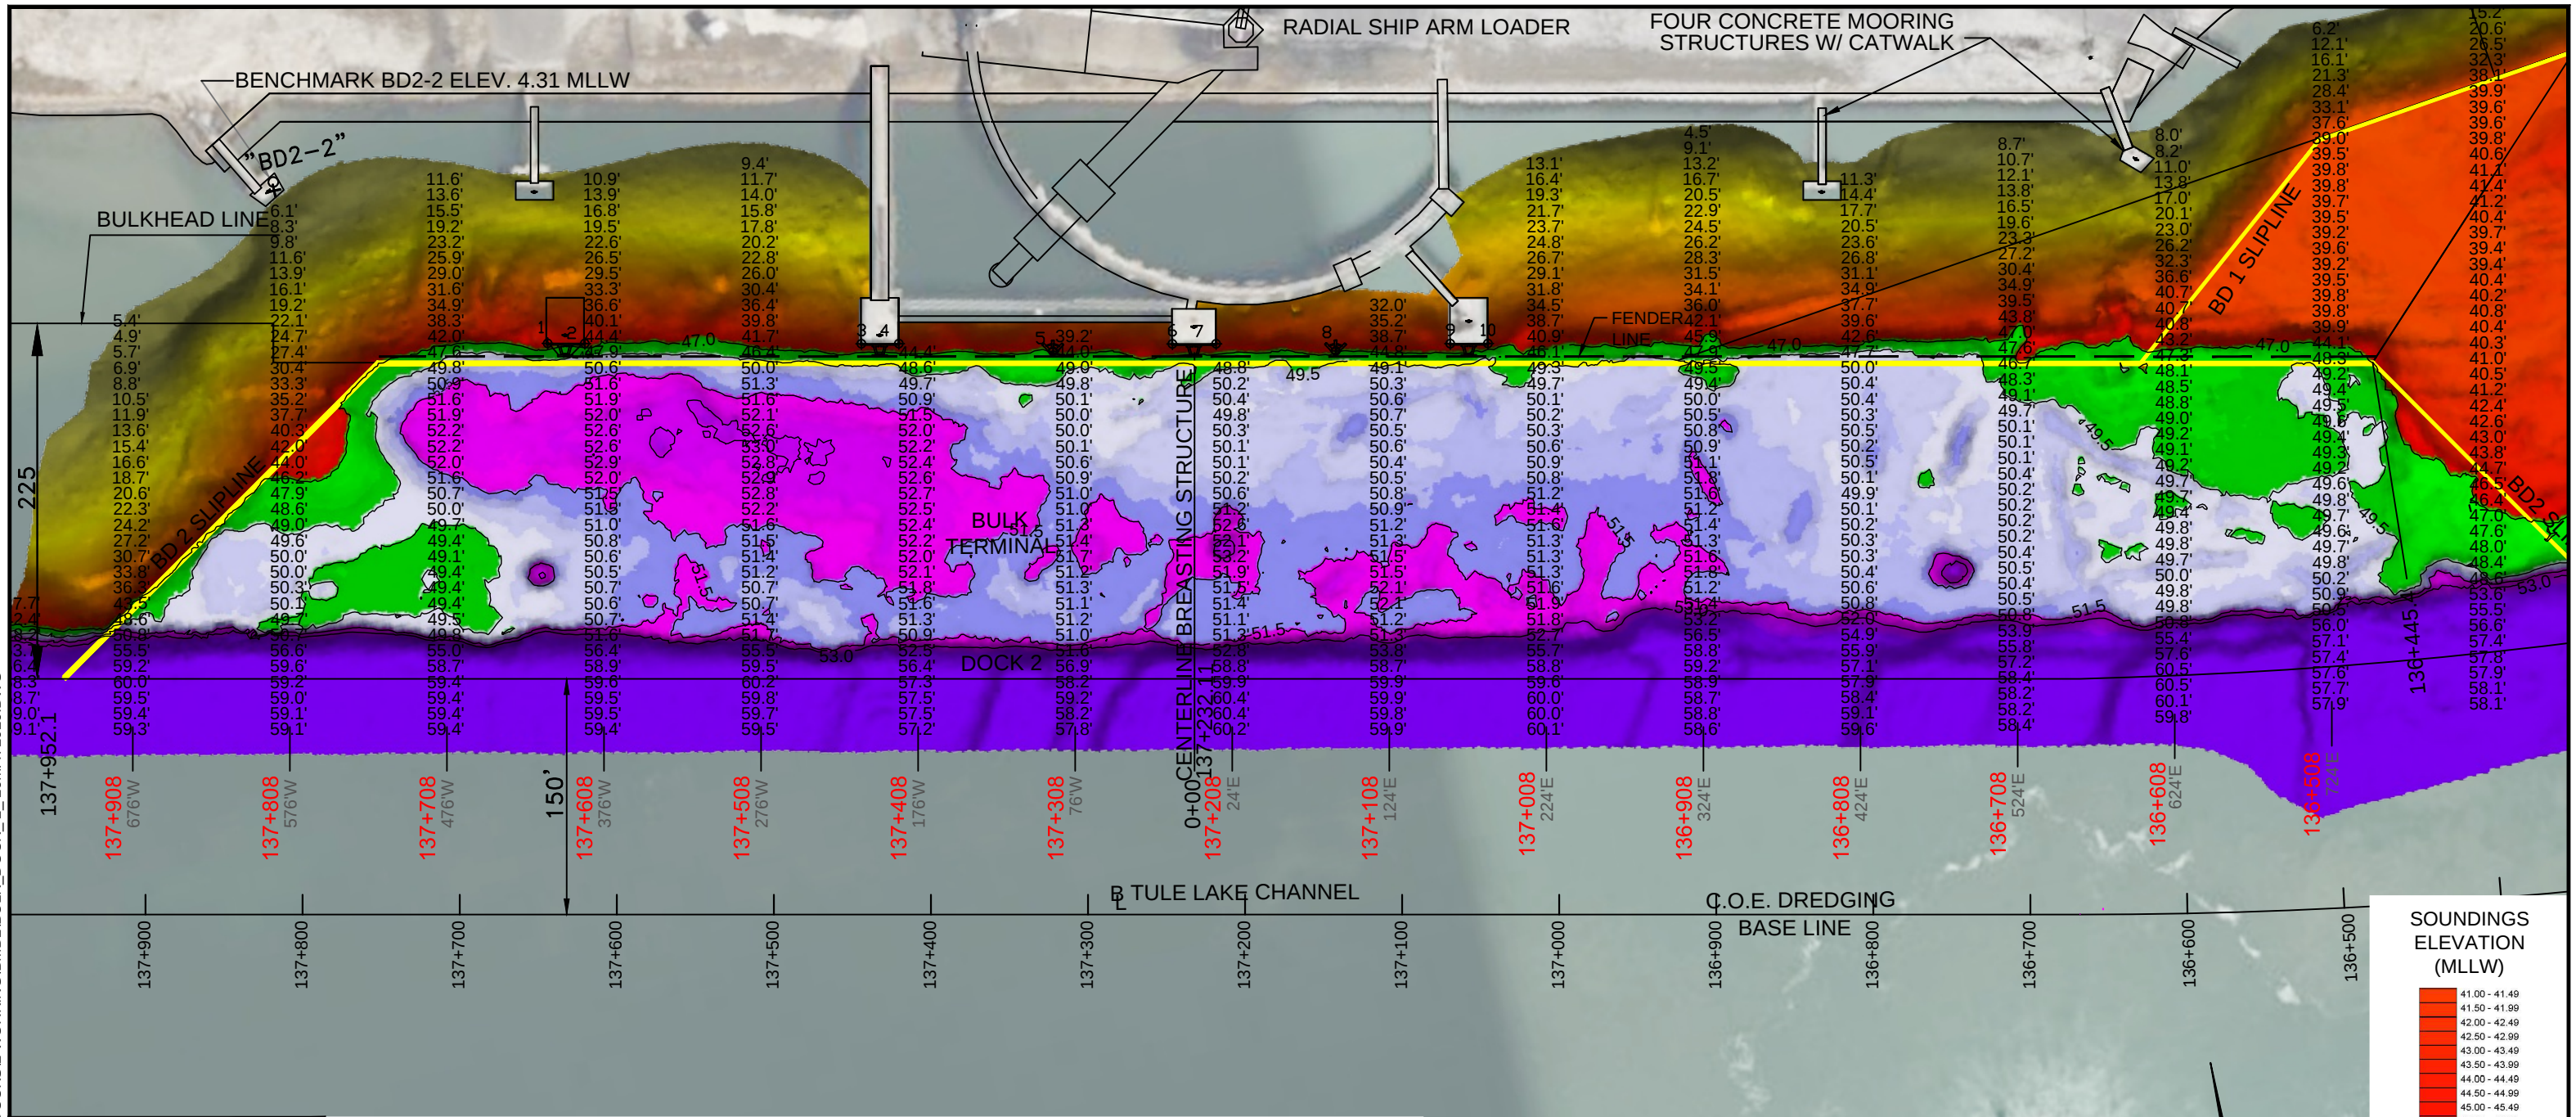
- NOTES:**
1. VESSEL LENGTH LIMIT IS 1,270 FEET.
  2. SOUNDINGS WERE RECORDED BY T BAKER SMITH ON 29 MAY, 2026. SEA FLOOR CONDITIONS ARE SUBJECT TO CHANGE.
  3. THE PORT OF CORPUS CHRISTI ASSUMES NO LIABILITY FOR THE ACCURACY OF THIS INFORMATION. THE INFORMATION DEPICTED ON THIS MAP REPRESENTS THE RESULTS OF SURVEYS MADE ON THE DATE DEPICTED AND CAN ONLY BE CONSIDERED AS INDICATING THE GENERAL CONDITIONS AT THAT TIME. THESE CONDITIONS ARE SUBJECT TO RAPID CHANGE DUE TO SHOALING EVENTS.
  4. ALL READINGS ARE BASED ON THE NATIONAL OCEANIC AND ATMOSPHERIC ADMINISTRATION (NOAA) MEAN LOWER LOW WATER (MLLW) DATUM, (O.O')
  5. HORIZONTAL DATUM: NAD-83, STATE PLANE, TEXAS SOUTH ZONE, US FEET.
  6. TO GET THE DEPTH OF WATER, ADD THE CURRENT TIDE LEVEL TO READINGS SHOWN. (SEE TIDE DATUM CHART).

| POINT | NORTHING | EASTING | DESCRIPTION |
|---|---|---|---|
| 10 | 17187461.9 | 1318972.6 | calculated dock corner (broken) |
