DRAWING NAME: BULK DOCK 3 16AUG2024

PORT OF CORPUS CHRISTI AUTHORITY

BULK TERMINAL DOCK 3
SOUNDINGS
AN EXHIBIT OF A
BATHYMETRIC SURVEY
LOCATED IN
CORPUS CHRISTI, TEXAS

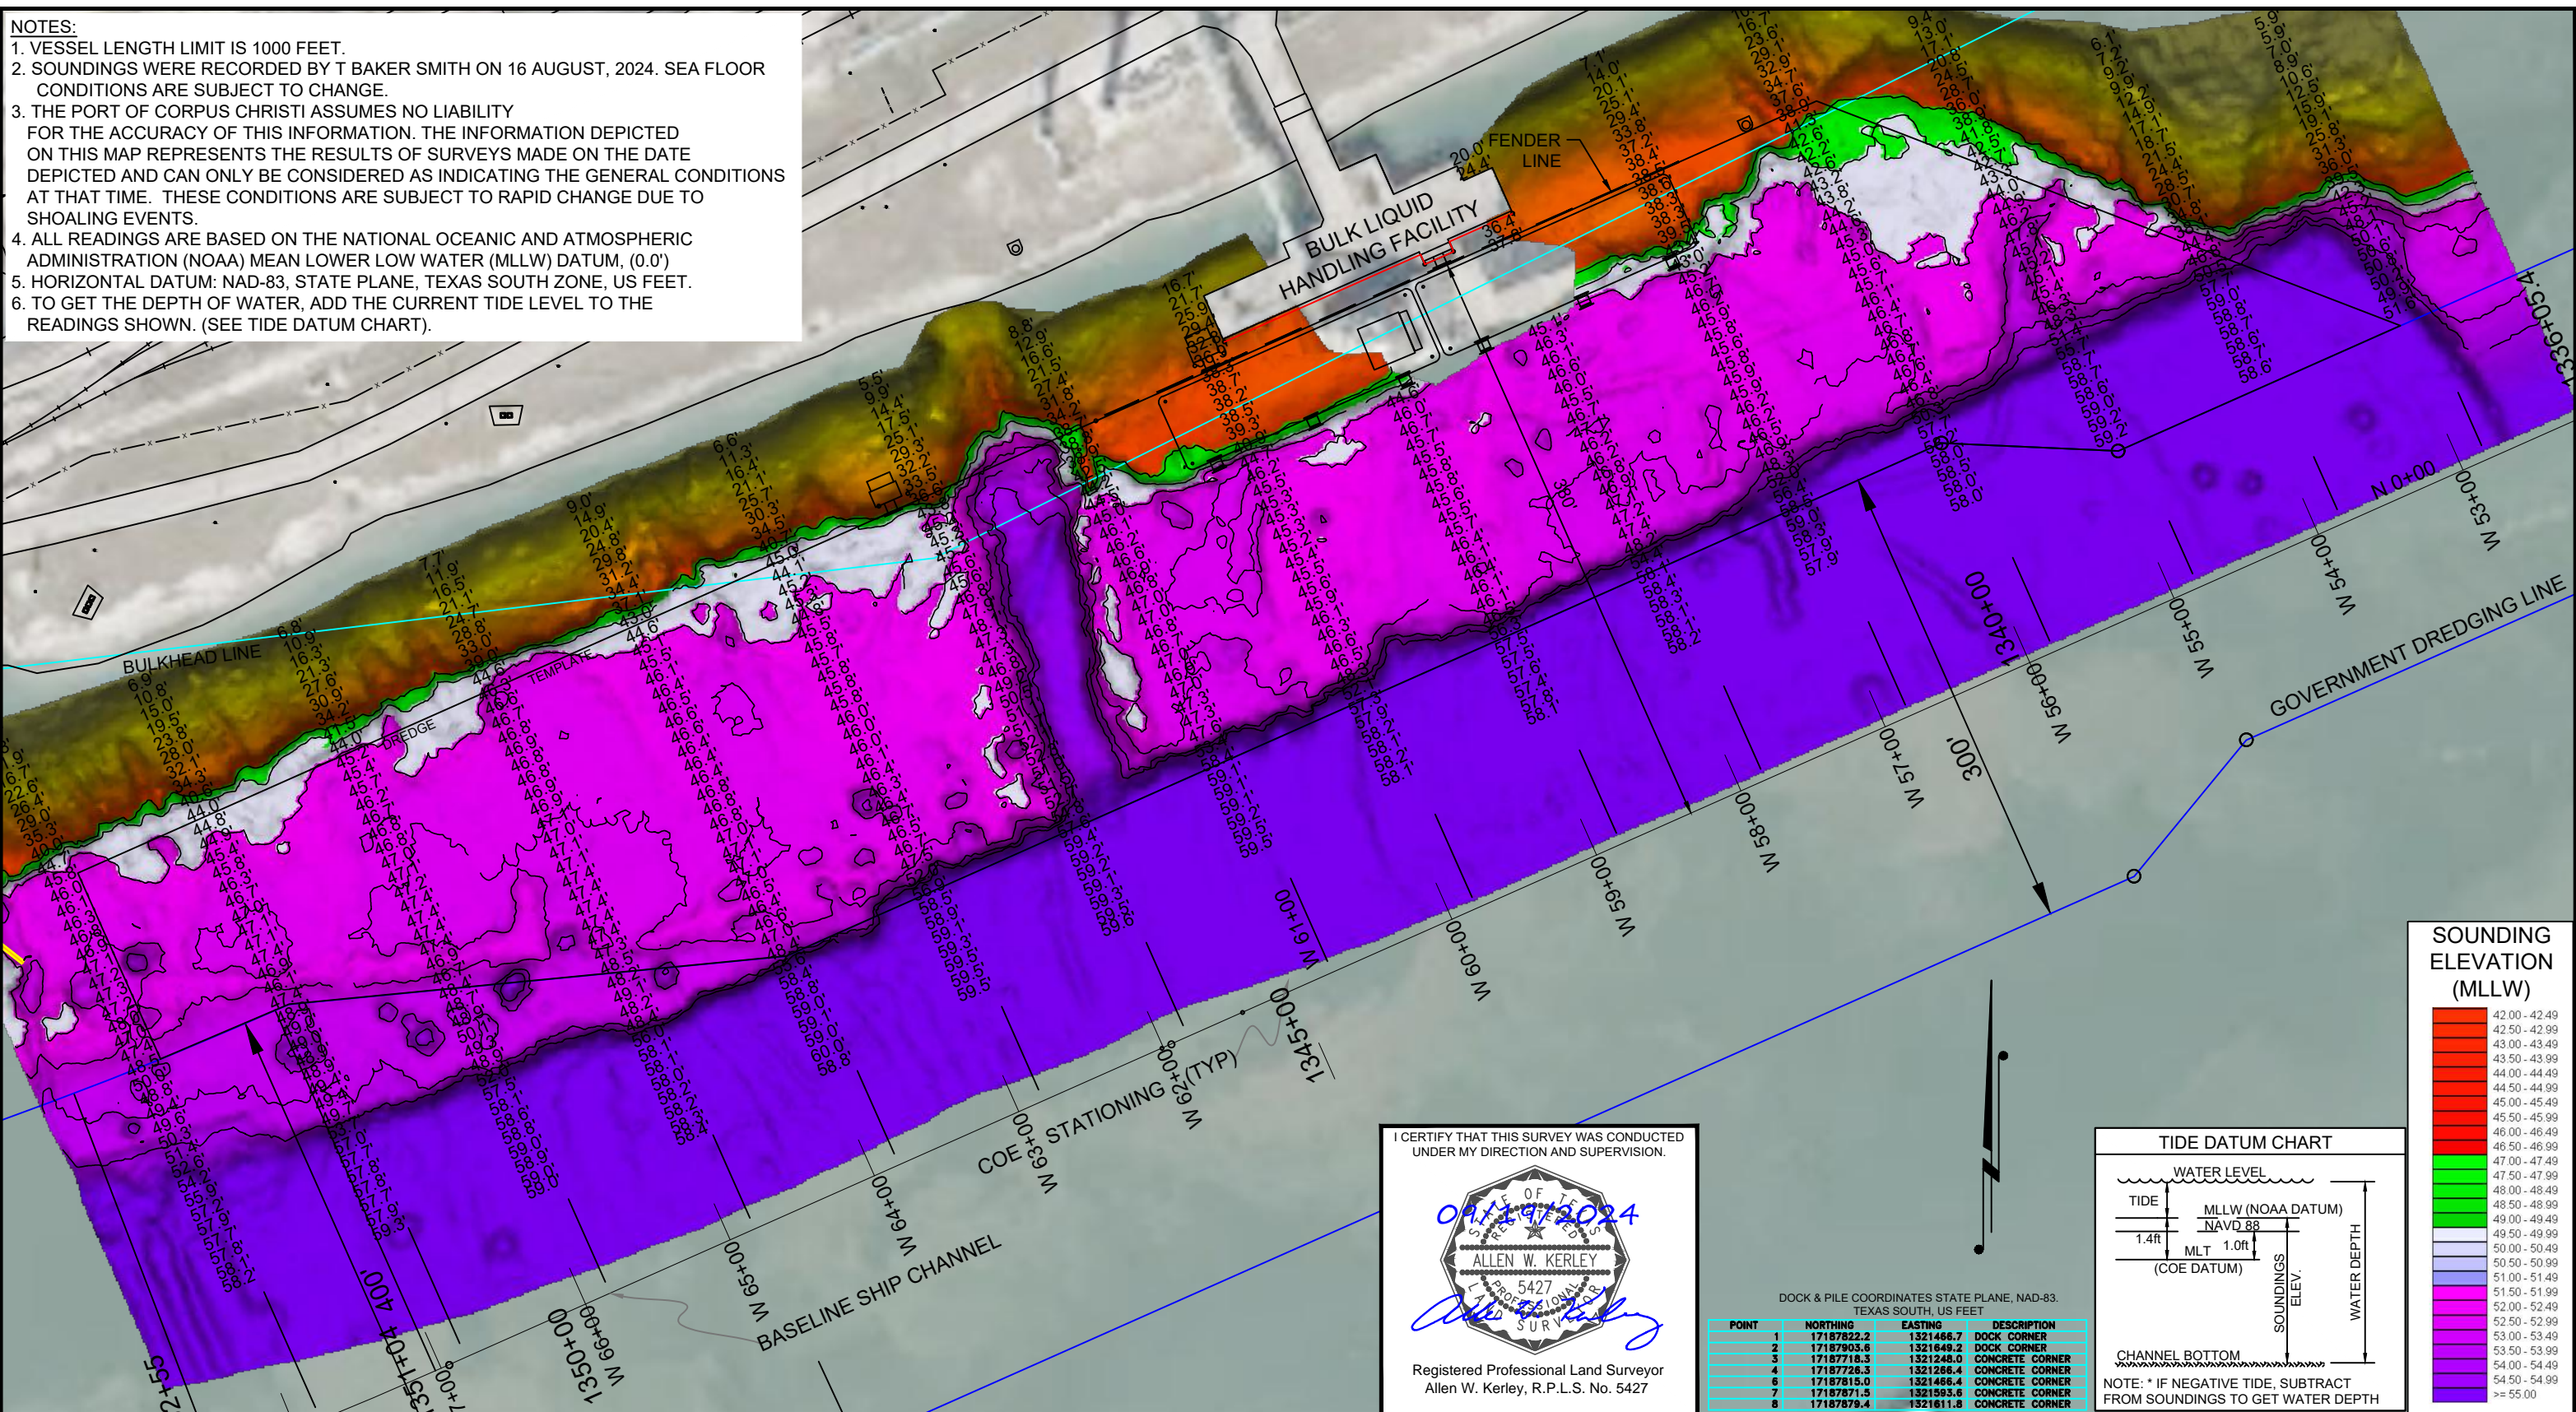
- NOTES:
1. VESSEL LENGTH LIMIT IS 1000 FEET.
 2. SOUNDINGS WERE RECORDED BY T BAKER SMITH ON 16 AUGUST, 2024. SEA FLOOR CONDITIONS ARE SUBJECT TO CHANGE.
 3. THE PORT OF CORPUS CHRISTI ASSUMES NO LIABILITY FOR THE ACCURACY OF THIS INFORMATION. THE INFORMATION DEPICTED ON THIS MAP REPRESENTS THE RESULTS OF SURVEYS MADE ON THE DATE DEPICTED AND CAN ONLY BE CONSIDERED AS INDICATING THE GENERAL CONDITIONS AT THAT TIME. THESE CONDITIONS ARE SUBJECT TO RAPID CHANGE DUE TO SHOALING EVENTS.
 4. ALL READINGS ARE BASED ON THE NATIONAL OCEANIC AND ATMOSPHERIC ADMINISTRATION (NOAA) MEAN LOWER LOW WATER (MLLW) DATUM, (0.0')
 5. HORIZONTAL DATUM: NAD-83, STATE PLANE, TEXAS SOUTH ZONE, US FEET.
 6. TO GET THE DEPTH OF WATER, ADD THE CURRENT TIDE LEVEL TO THE READINGS SHOWN. (SEE TIDE DATUM CHART).
