**PORT OF CORPUS CHRISTI AUTHORITY**

**CARGO DOCK 1 & 2**  
SOUNDINGS  
AN EXHIBIT OF A  
BATHYMETRIC SURVEY  
LOCATED IN  
CORPUS CHRISTI, TEXAS

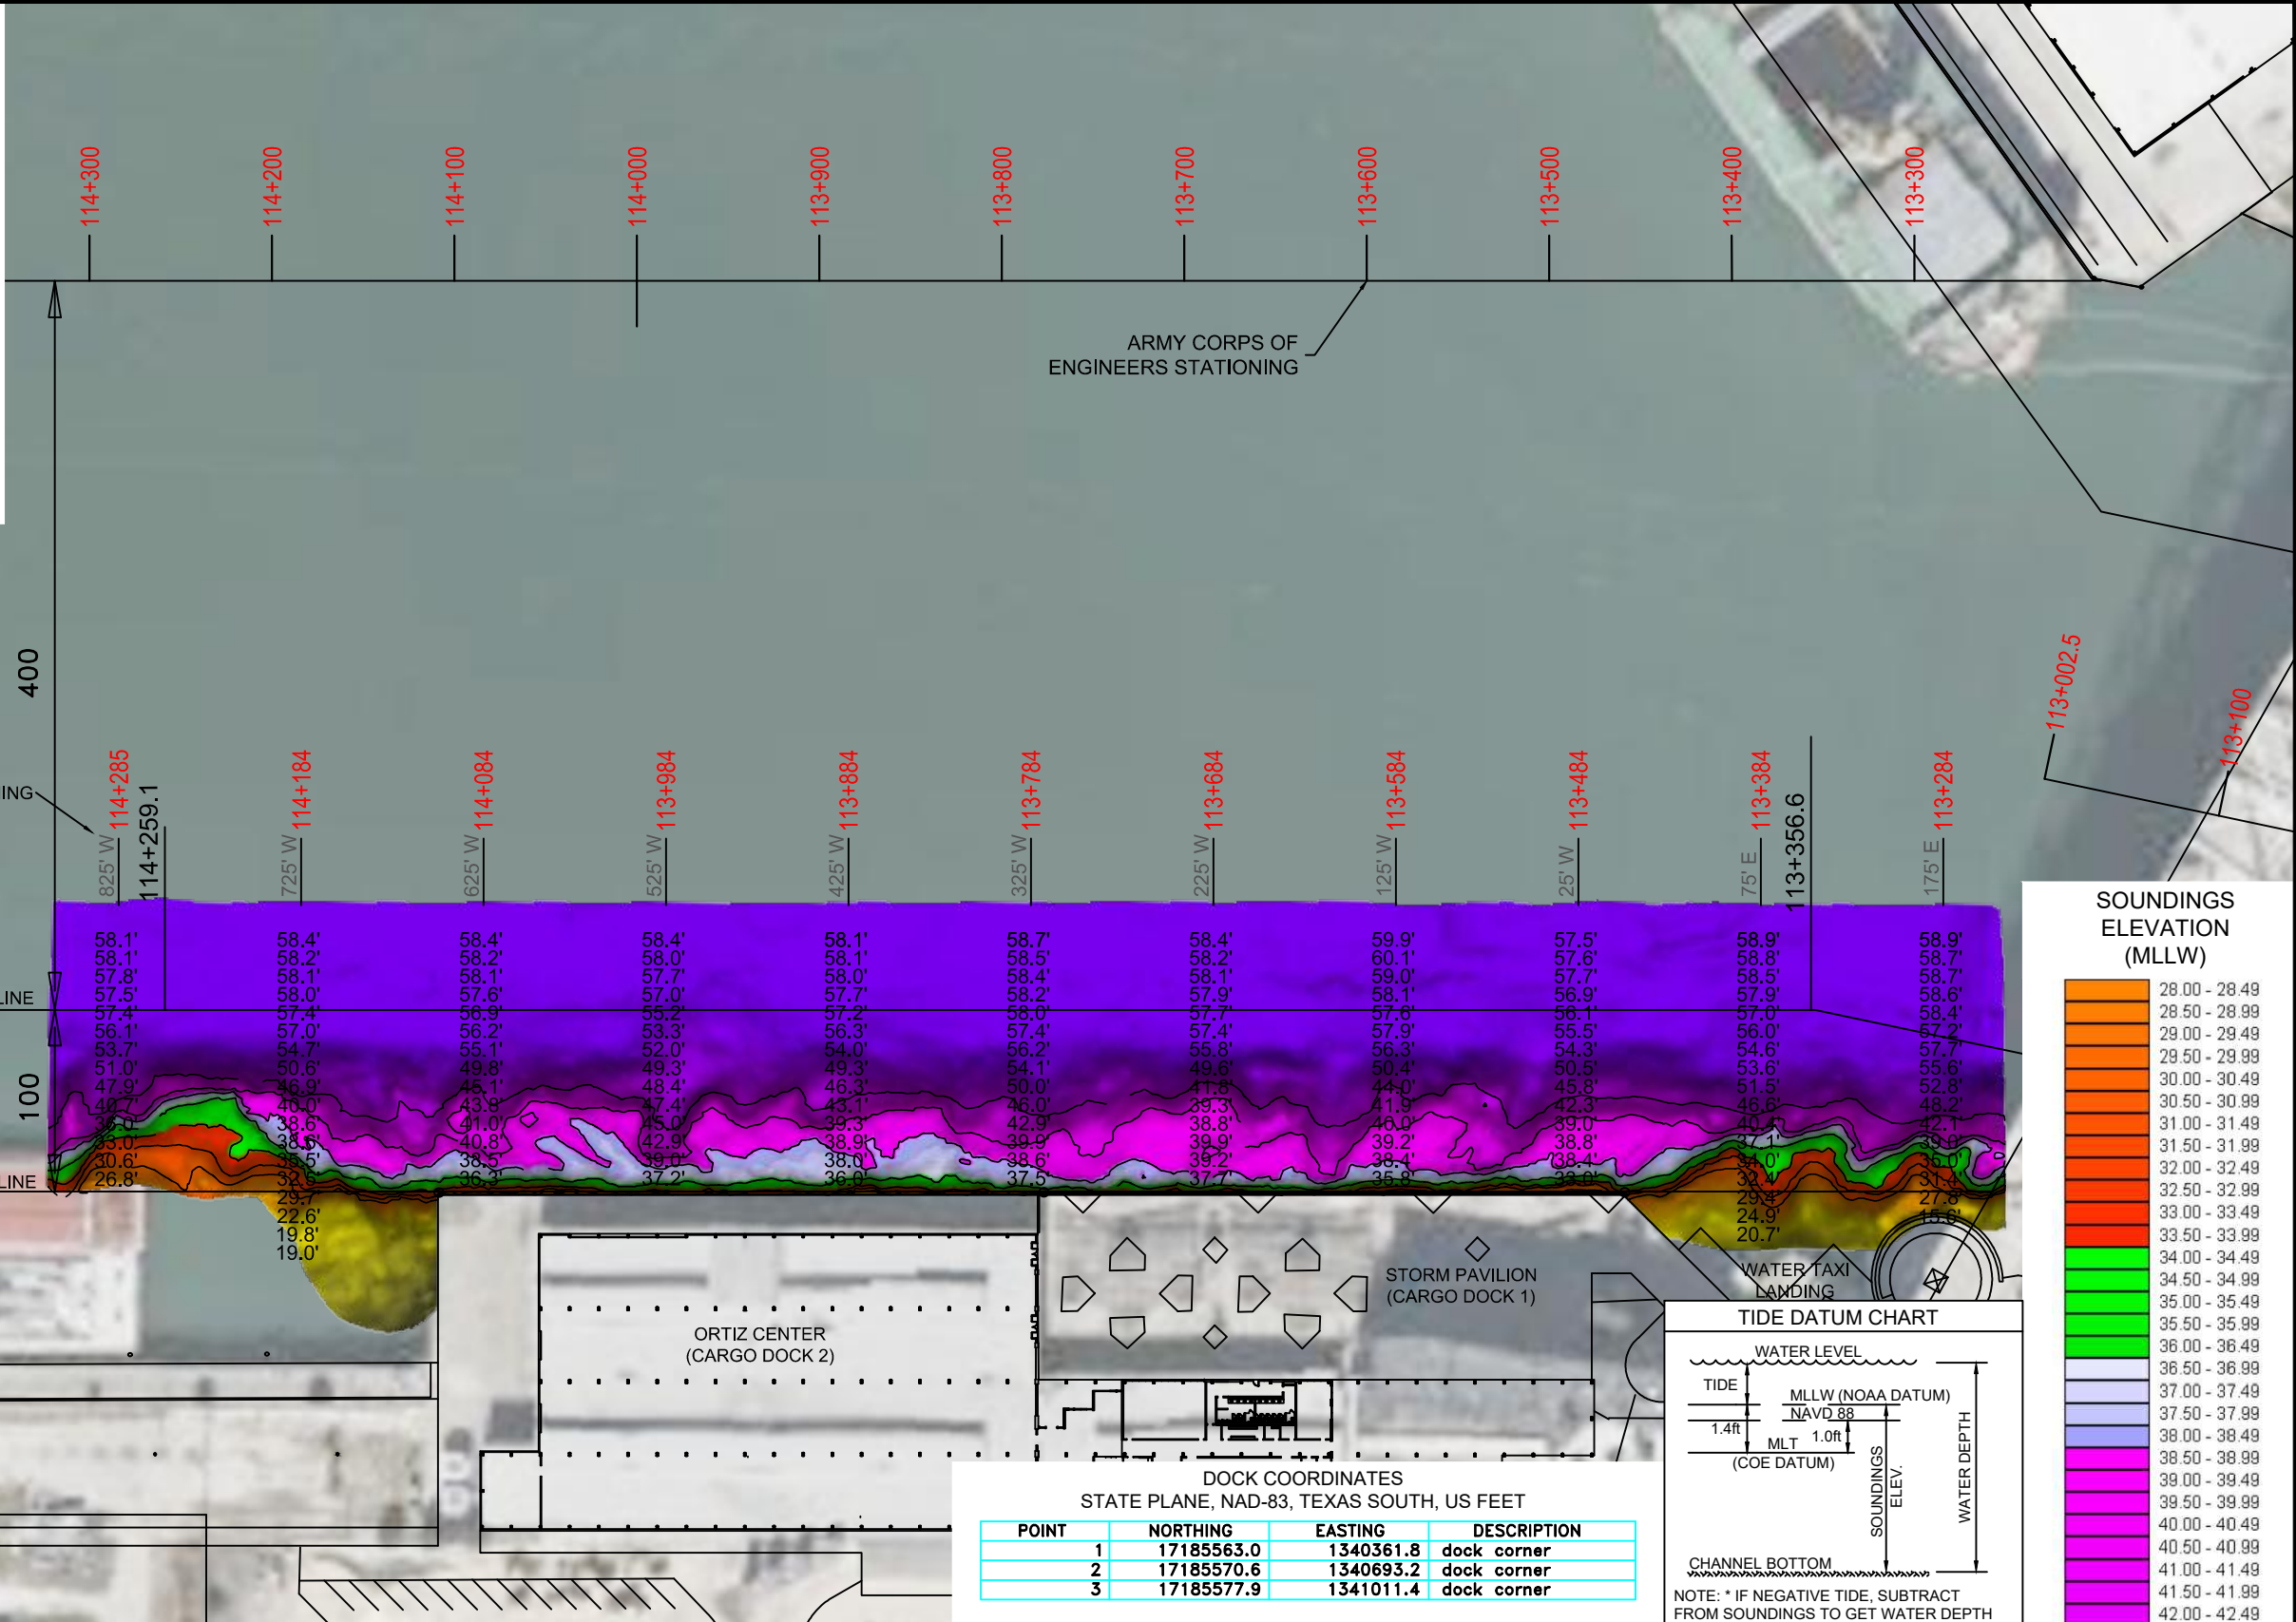
- NOTES:**
1. VESSEL LENGTH LIMIT IS 350 FEET OR MORE IF ADJACENT BERTHS ARE UNOCCUPIED.
  2. SOUNDINGS WERE RECORDED BY T BAKER SMITH ON 14 FEBRUARY, 2025. SEA FLOOR CONDITIONS ARE SUBJECT TO CHANGE.
  3. THE PORT OF CORPUS CHRISTI ASSUMES NO LIABILITY FOR THE ACCURACY OF THIS INFORMATION. THE INFORMATION DEPICTED ON THIS MAP REPRESENTS THE RESULTS OF SURVEYS MADE ON THE DATE DEPICTED AND CAN ONLY BE CONSIDERED AS INDICATING THE GENERAL CONDITIONS AT THAT TIME. THESE CONDITIONS ARE SUBJECT TO RAPID CHANGE DUE TO SHOALING EVENTS.
  4. ALL READINGS ARE BASED ON THE NATIONAL OCEANIC AND ATMOSPHERIC ADMINISTRATION (NOAA) MEAN LOWER LOW WATER (MLLW) DATUM, (0.0')
  5. HORIZONTAL DATUM: NAD-83, STATE PLANE, TEXAS SOUTH ZONE, US FEET.
  6. TO GET THE DEPTH OF WATER, ADD THE CURRENT TIDE LEVEL TO THE READINGS SHOWN. (SEE TIDE DATUM CHART).
