**PORT OF CORPUS CHRISTI AUTHORITY**

**CARGO DOCK 10**  
SOUNDINGS  
AN EXHIBIT OF A  
BATHYMETRIC SURVEY  
LOCATED IN  
CORPUS CHRISTI, TEXAS

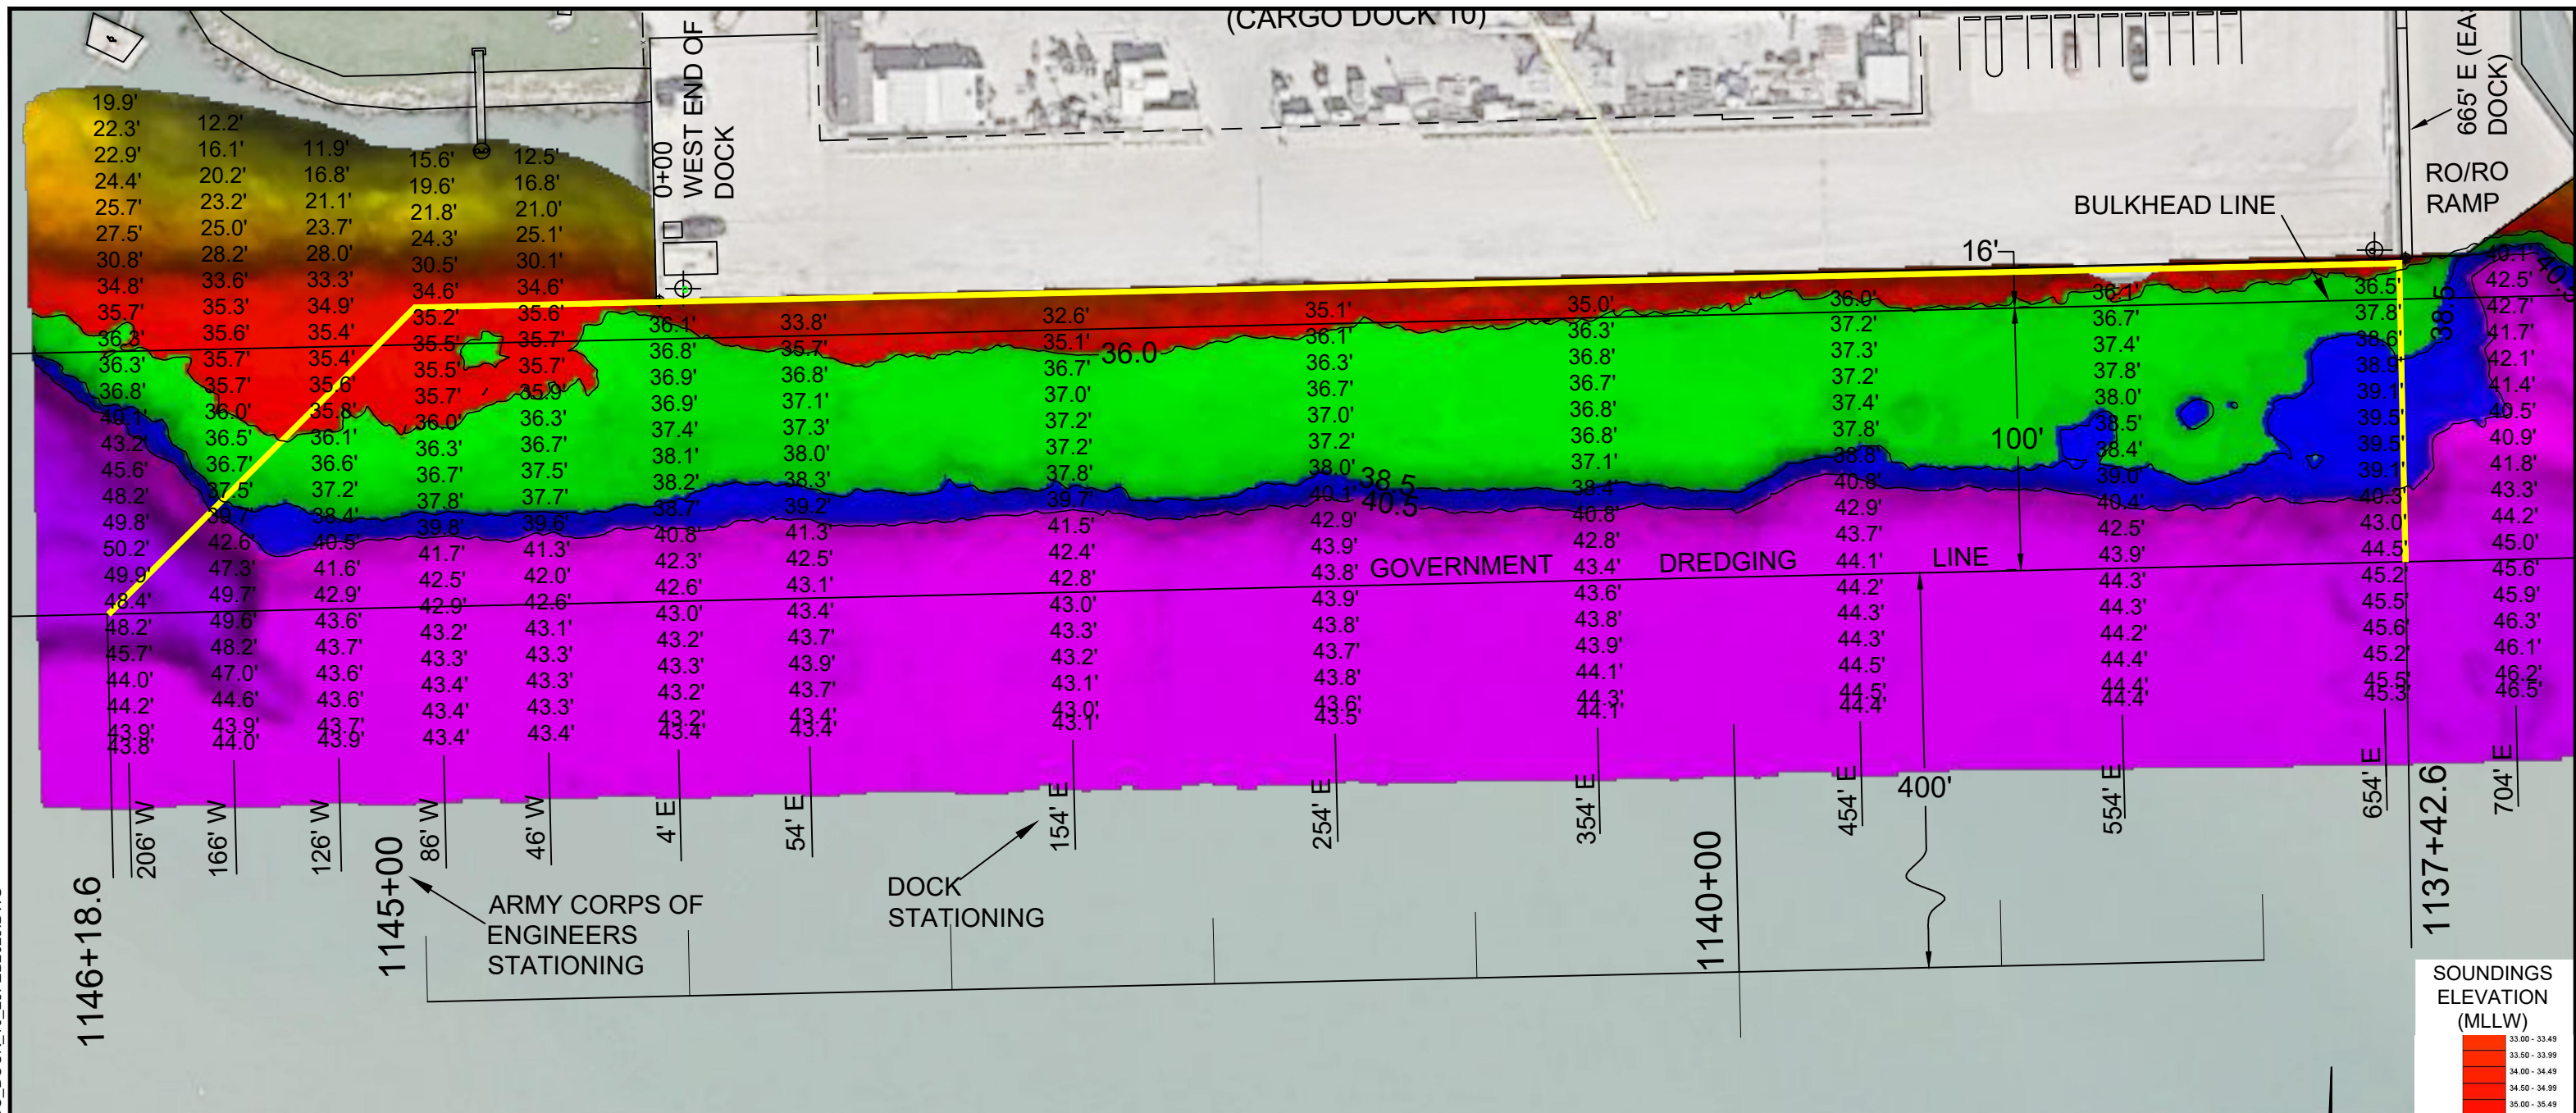
- NOTES:**
1. VESSEL LENGTH LIMIT IS 700 FEET.
  2. SOUNDINGS WERE RECORDED BY T BAKER SMITH ON 28 FEBRUARY, 2023. SEA FLOOR CONDITIONS ARE SUBJECT TO CHANGE.
  3. THE PORT OF CORPUS CHRISTI ASSUMES NO LIABILITY FOR THE ACCURACY OF THIS INFORMATION. THE INFORMATION DEPICTED ON THIS MAP REPRESENTS THE RESULTS OF SURVEYS MADE ON THE DATE DEPICTED AND CAN ONLY BE CONSIDERED AS INDICATING THE GENERAL CONDITIONS AT THAT TIME. THESE CONDITIONS ARE SUBJECT TO RAPID CHANGE DUE TO SHOALING EVENTS.
  4. ALL READINGS ARE BASED ON THE NATIONAL OCEANIC AND ATMOSPHERIC ADMINISTRATION (NOAA) MEAN LOWER LOW WATER (MLLW) DATUM, (O.O')
  5. HORIZONTAL DATUM: NAD-83, STATE PLANE, TEXAS SOUTH ZONE, US FEET.
  6. TO GET THE DEPTH OF WATER, ADD THE CURRENT TIDE LEVEL TO THE READINGS SHOWN. (SEE TIDE DATUM CHART).
