PORT OF CORPUS CHRISTI AUTHORITY

SOUNDINGS-REFRIGERATED DISTRIBUTION CENTER CARGO DOCK 10

PLAN

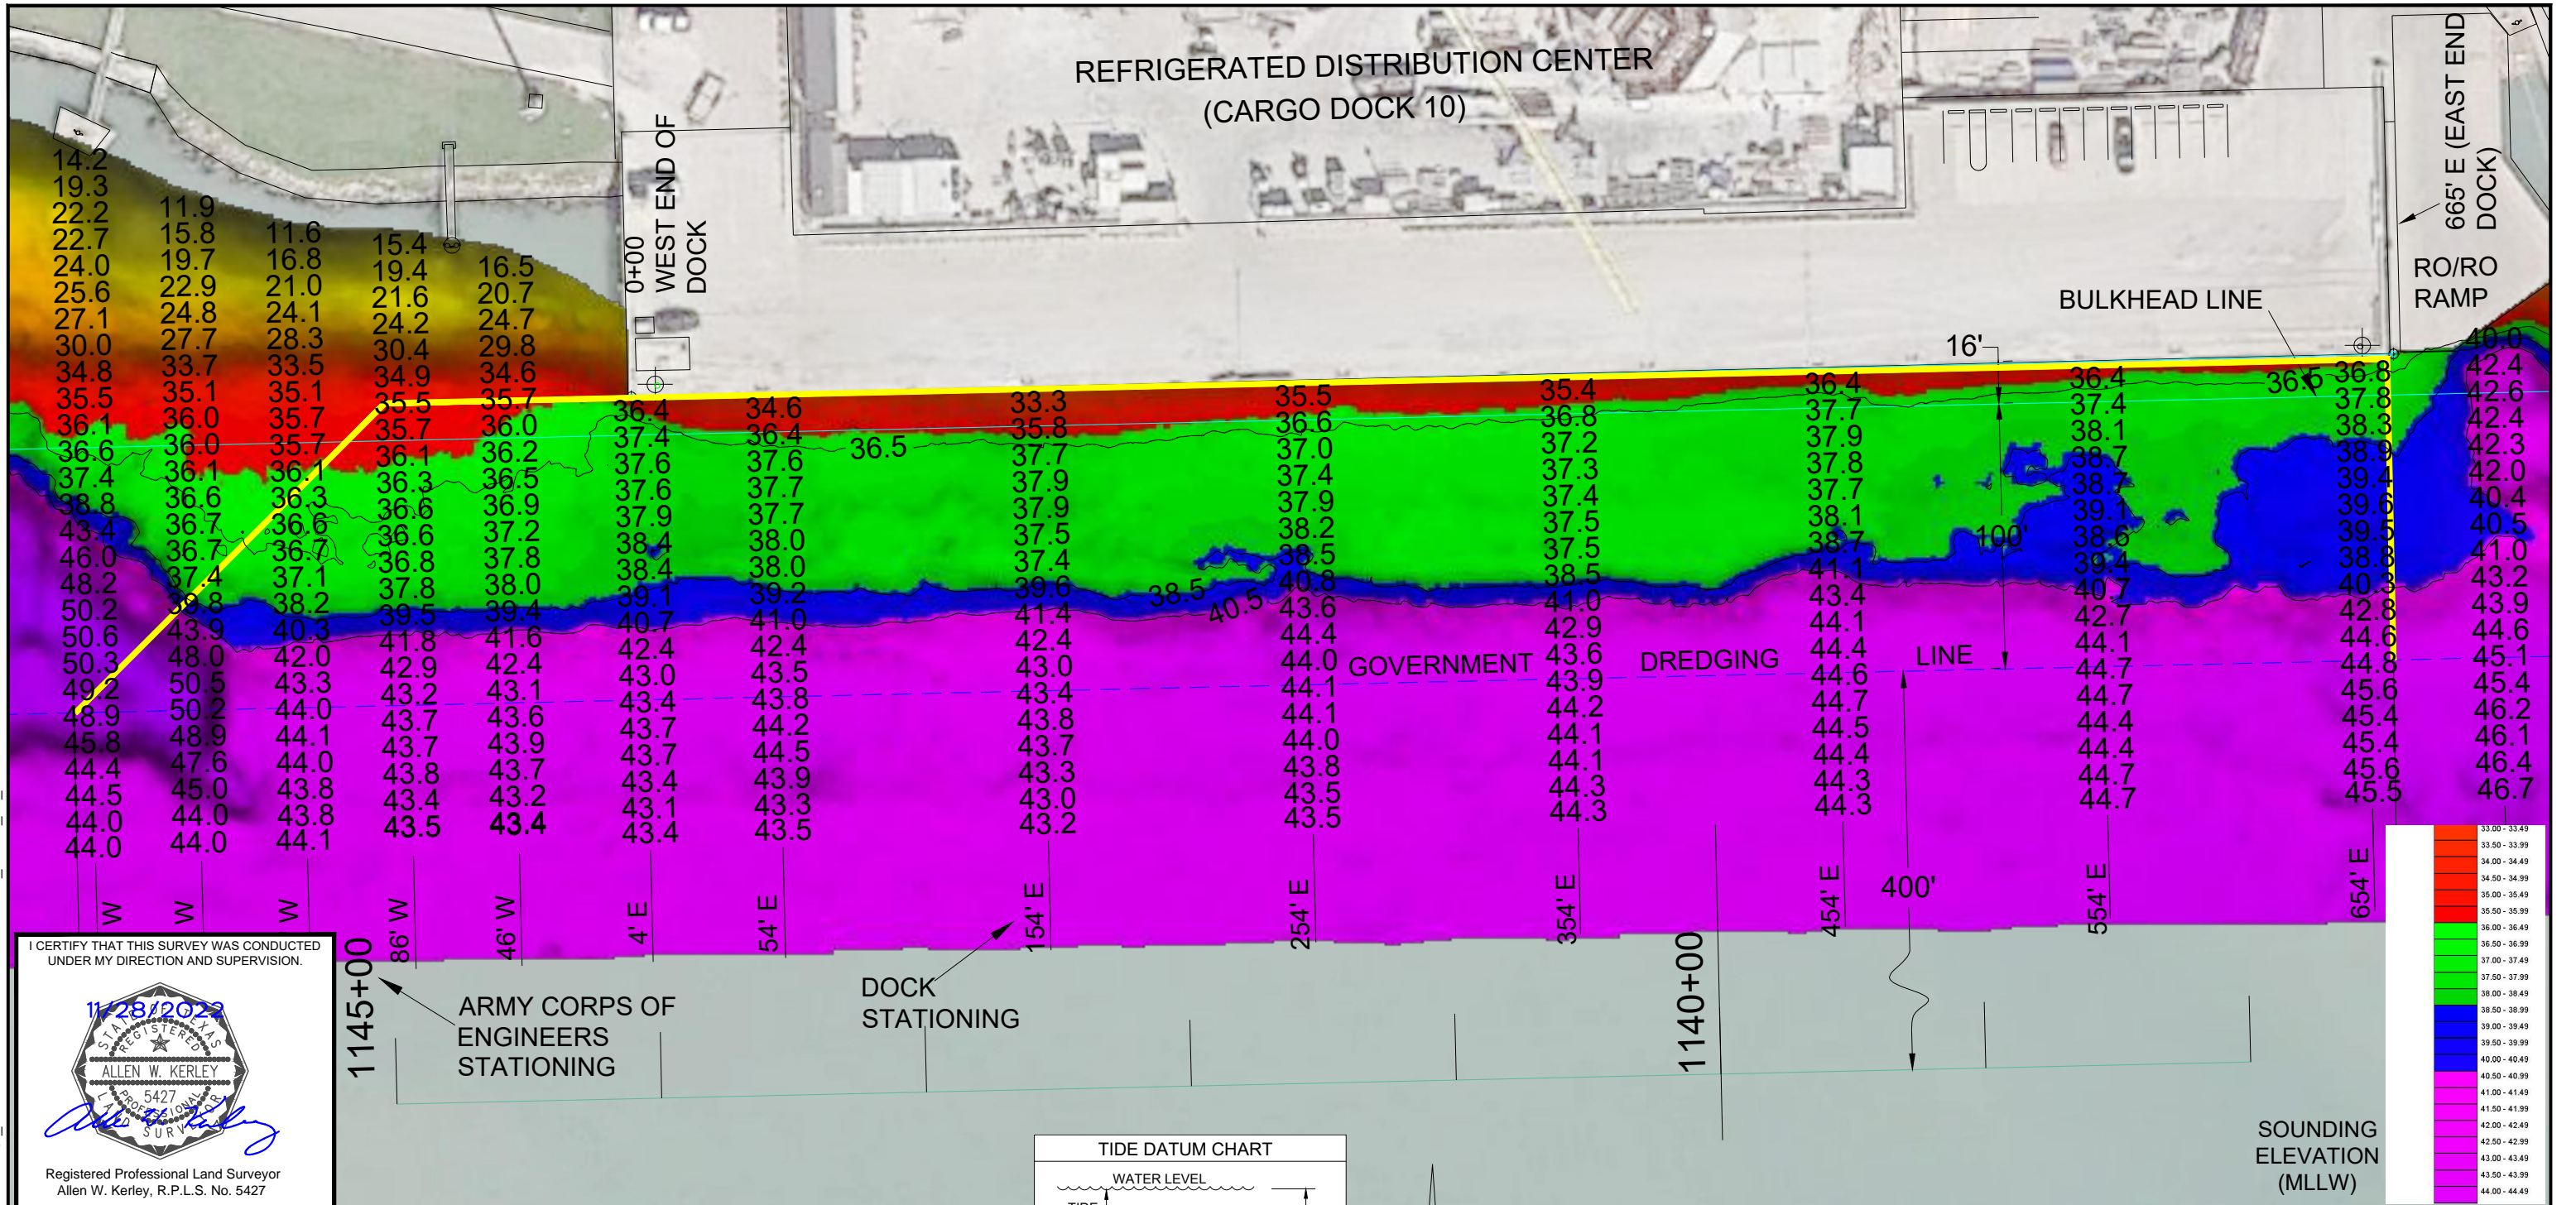
- NOTES:**
- VESSEL LENGTH LIMIT IS 700 FEET.
 - SOUNDINGS WERE RECORDED BY T BAKER SMITH ON 8 NOVEMBER, 2022. SEA FLOOR CONDITIONS ARE SUBJECT TO CHANGE.
 - THE PORT OF CORPUS CHRISTI ASSUMES NO LIABILITY FOR THE ACCURACY OF THIS INFORMATION. THE INFORMATION DEPICTED ON THIS MAP REPRESENTS THE RESULTS OF SURVEYS MADE ON THE DATE DEPICTED AND CAN ONLY BE CONSIDERED AS INDICATING THE GENERAL CONDITIONS AT THAT TIME. THESE CONDITIONS ARE SUBJECT TO RAPID CHANGE DUE TO SHOALING EVENTS.
 - ALL READINGS ARE BASED ON THE NATIONAL OCEANIC AND ATMOSPHERIC ADMINISTRATION (NOAA) MEAN LOWER LOW WATER (MLLW) DATUM, (O.O')
 - HORIZONTAL DATUM: NAD-83, STATE PLANE, TEXAS SOUTH ZONE, US FEET.
 - TO GET THE DEPTH OF WATER, ADD THE CURRENT TIDE LEVEL TO THE READINGS SHOWN. (SEE TIDE DATUM CHART).
