CORPUS CHRISTI TURNING BASIN

PORT OF CORPUS CHRISTI AUTHORITY

CARGO DOCK 14-15
2026-Q1
AN EXHIBIT OF A
BATHYMETRIC SURVEY
LOCATED IN
CORPUS CHRISTI, TEXAS

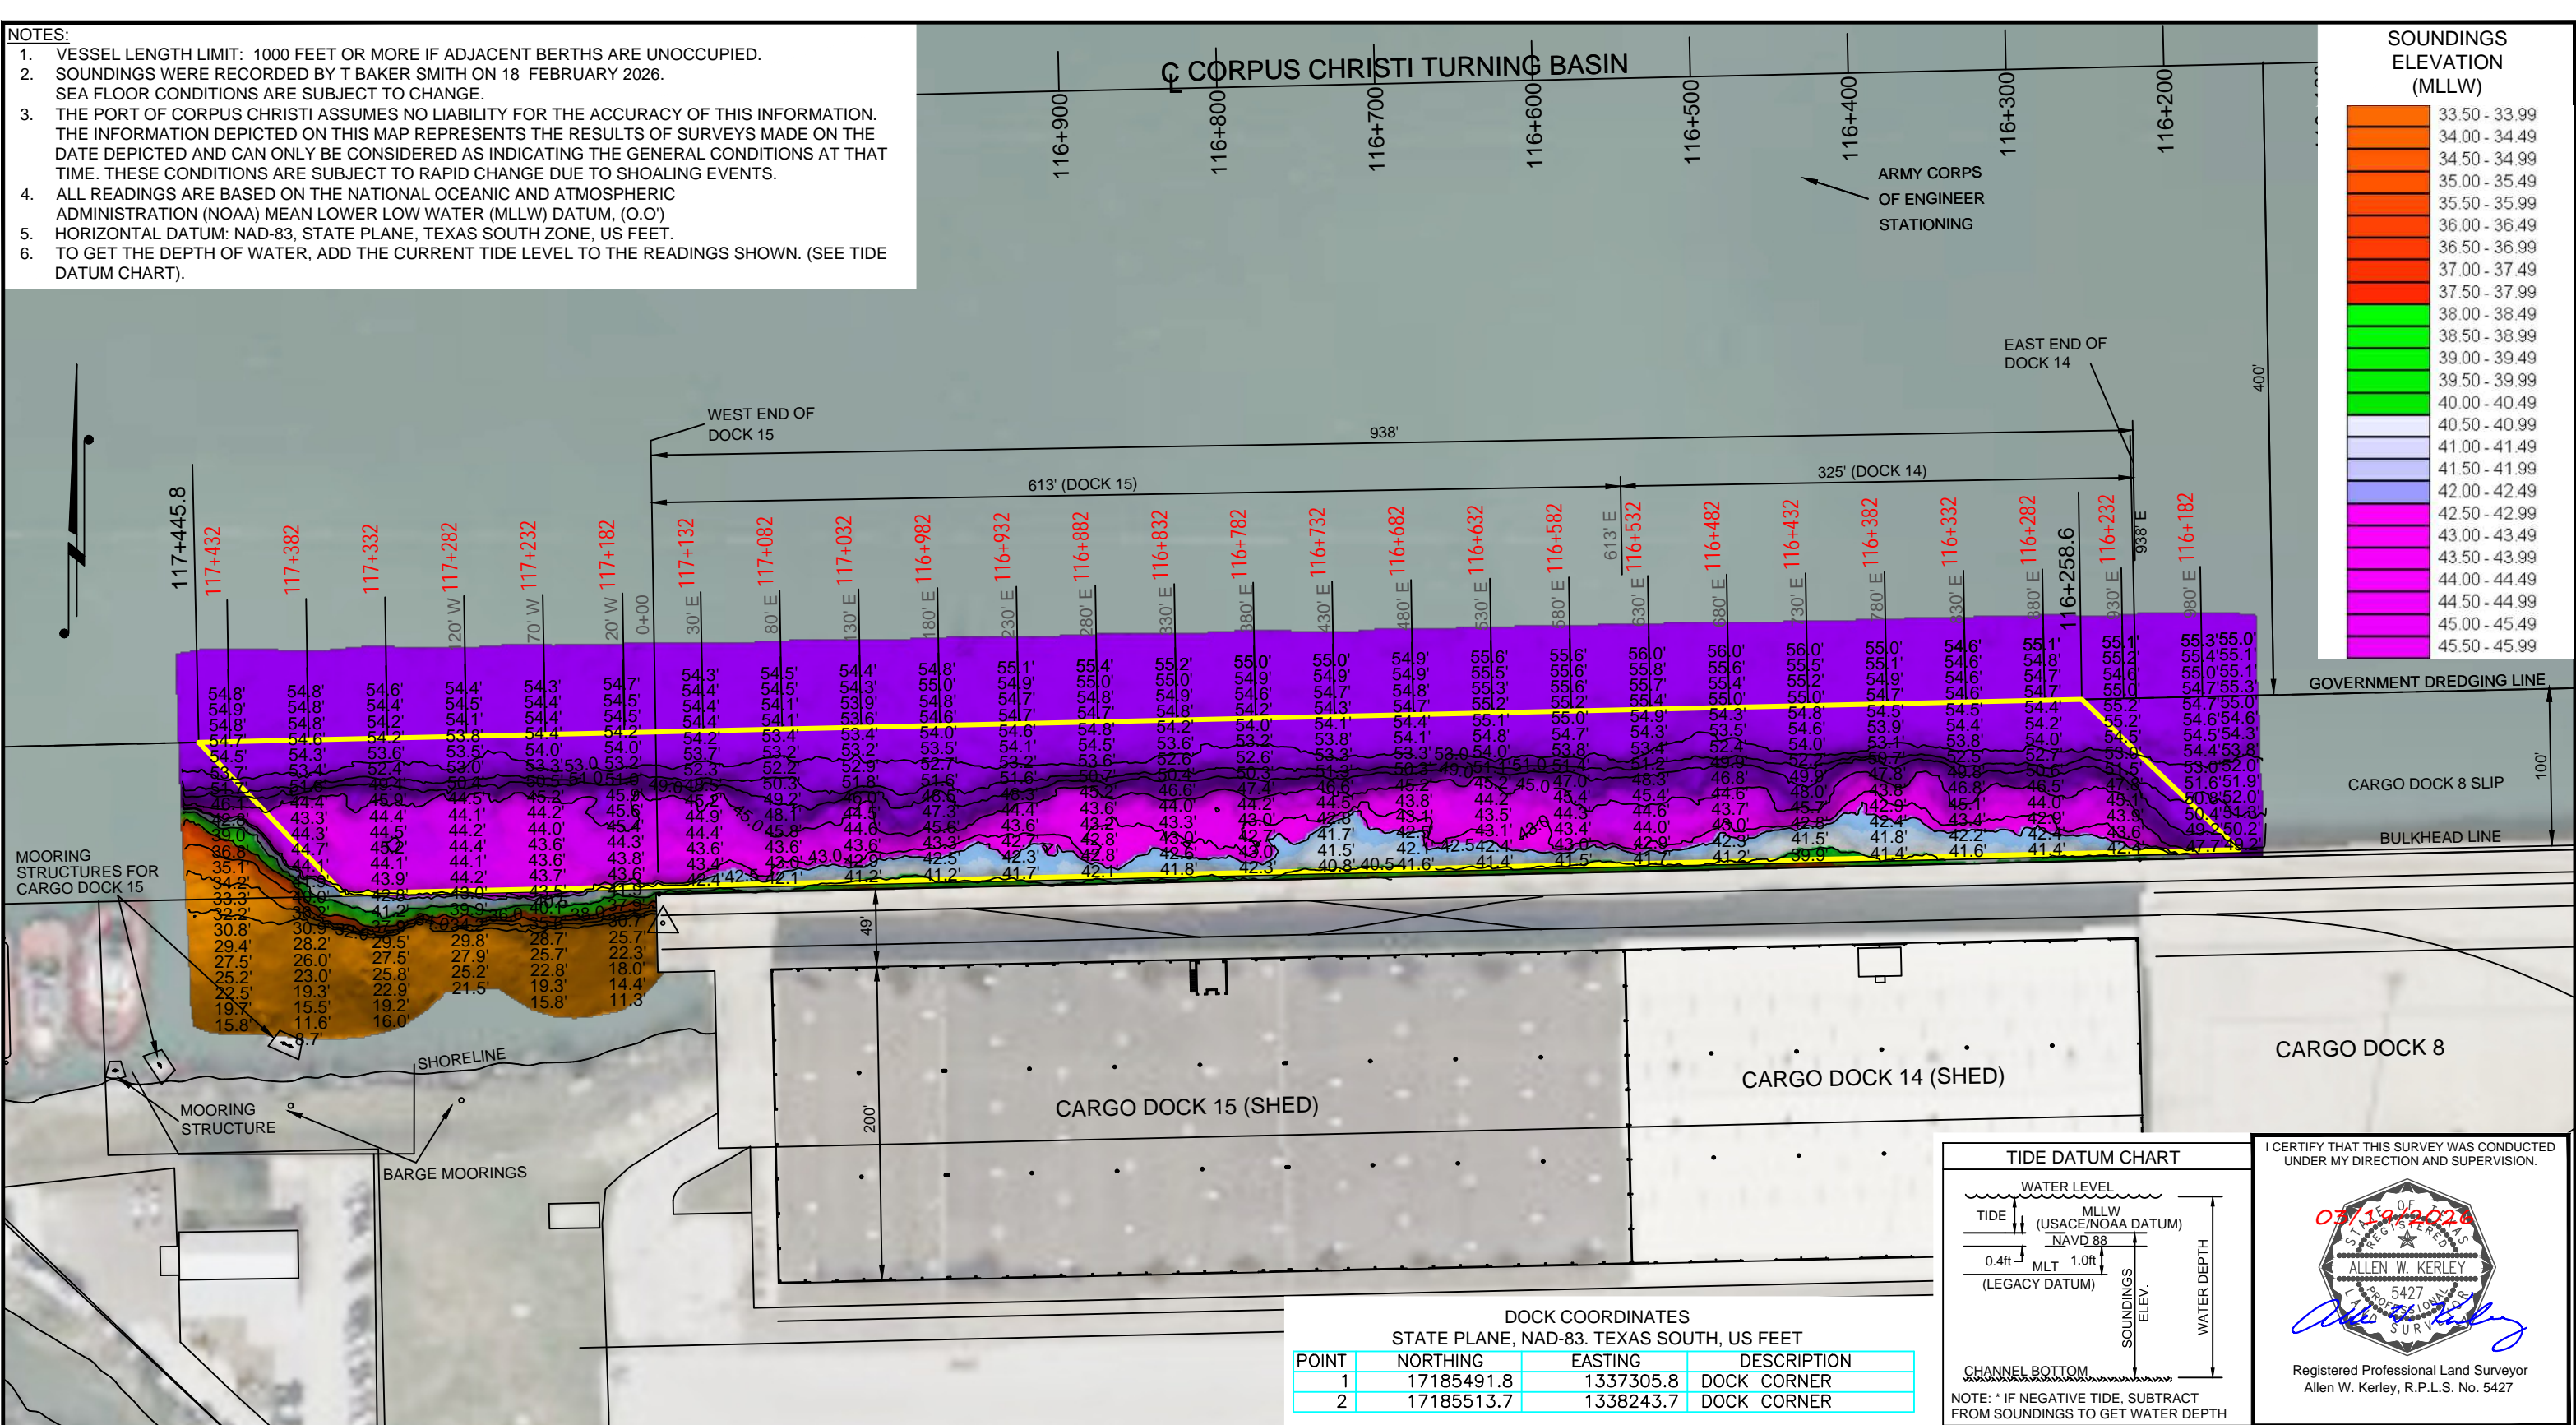
- NOTES:**
1. VESSEL LENGTH LIMIT: 1000 FEET OR MORE IF ADJACENT BERTHS ARE UNOCCUPIED.
 2. SOUNDINGS WERE RECORDED BY T BAKER SMITH ON 18 FEBRUARY 2026. SEA FLOOR CONDITIONS ARE SUBJECT TO CHANGE.
 3. THE PORT OF CORPUS CHRISTI ASSUMES NO LIABILITY FOR THE ACCURACY OF THIS INFORMATION. THE INFORMATION DEPICTED ON THIS MAP REPRESENTS THE RESULTS OF SURVEYS MADE ON THE DATE DEPICTED AND CAN ONLY BE CONSIDERED AS INDICATING THE GENERAL CONDITIONS AT THAT TIME. THESE CONDITIONS ARE SUBJECT TO RAPID CHANGE DUE TO SHOALING EVENTS.
 4. ALL READINGS ARE BASED ON THE NATIONAL OCEANIC AND ATMOSPHERIC ADMINISTRATION (NOAA) MEAN LOWER LOW WATER (MLLW) DATUM, (O.O') HORIZONTAL DATUM: NAD-83, STATE PLANE, TEXAS SOUTH ZONE, US FEET.
 5. TO GET THE DEPTH OF WATER, ADD THE CURRENT TIDE LEVEL TO THE READINGS SHOWN. (SEE TIDE DATUM CHART).
