- NOTES:**
1. LENGTH LIMIT : VESSEL LENGTH LIMIT : 685 FT
 2. SOUNDINGS WERE RECORDED BY T BAKER SMITH ON 14 NOVEMBER, 2023. SEA FLOOR CONDITIONS ARE SUBJECT TO CHANGE.
 3. THE PORT OF CORPUS CHRISTI ASSUMES NO LIABILITY FOR THE ACCURACY OF THIS INFORMATION. THE INFORMATION DEPICTED ON THIS MAP REPRESENTS THE RESULTS OF SURVEYS MADE ON THE DATE DEPICTED AND CAN ONLY BE CONSIDERED AS INDICATING THE GENERAL CONDITIONS AT THAT TIME. THESE CONDITIONS ARE SUBJECT TO RAPID CHANGE DUE TO SHOALING EVENTS.
 4. ALL READINGS ARE BASED ON THE NATIONAL OCEANIC AND ATMOSPHERIC ADMINISTRATION (NOAA) MEAN LOWER LOW WATER (MLLW) DATUM, (0.0')
 5. HORIZONTAL DATUM: NAD-83, STATE PLANE, TEXAS SOUTH ZONE, US FEET.
 6. TO GET THE DEPTH OF WATER, ADD THE CURRENT TIDE LEVEL TO THE READINGS SHOWN. (SEE TIDE DATUM CHART).

PORT CORPUS CHRISTI		 T. BAKER SMITH A CENTURY OF SOLUTIONS 3854 FM 1069 Aransas Pass, TX 78336 (361)334-5719 - tbsmith.com TBPLS #10194575		<p>SCALE: 1" = 100'</p> <p>100' 50' 0' 100'</p> <p>REV. NO: 00 REV. DATE: --/-- REV. BY: ---</p> <p>REVISION DESCRIPTION: --</p>		<p>DRAWN BY: MMC APPROVED BY: AWK</p> <p>DATE: 11/29/2023 JOB NO: 2023.0091</p> <p>DRAWING NAME: CARGO DOCK 9_14NOV2023

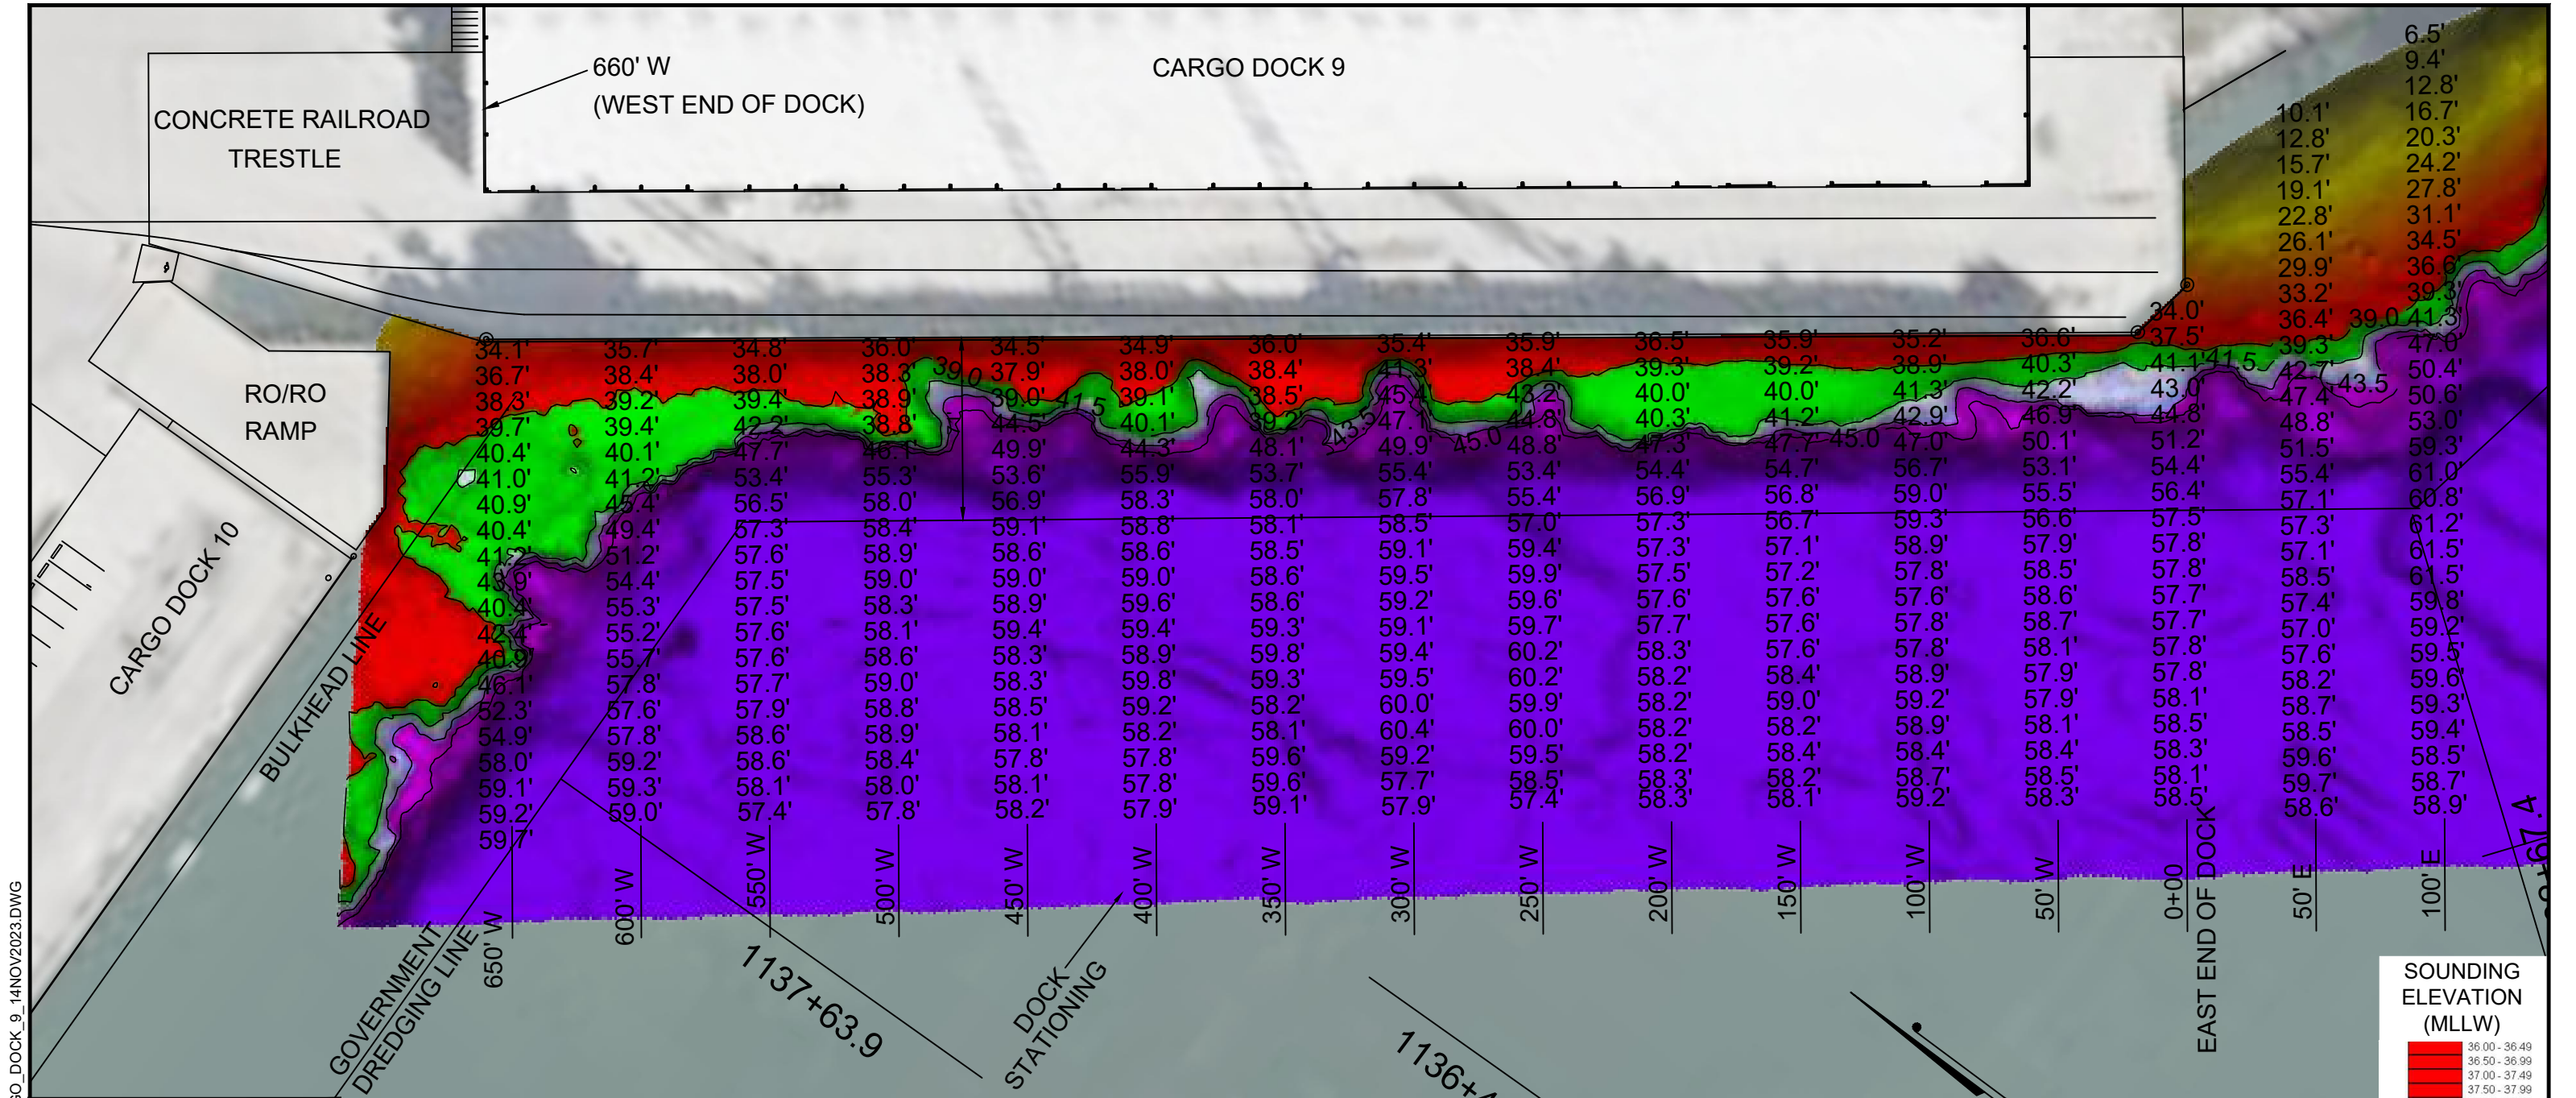
DOCK COORDINATES STATE PLANE, NAD-83, TEXAS SOUTH, US FEET			
POINT	NORTHING	EASTING	DESCRIPTION
1	17186599.0	1340871.9	DOCK CORNER
2	17186086.4	1341256.6	DOCK CORNER
3	17186082.1	1341282.8	DOCK CORNER
