PORT OF CORPUS CHRISTI AUTHORITY

**SOUNDINGS
CARGO DOCK 9**

DATE: NOV. 2022

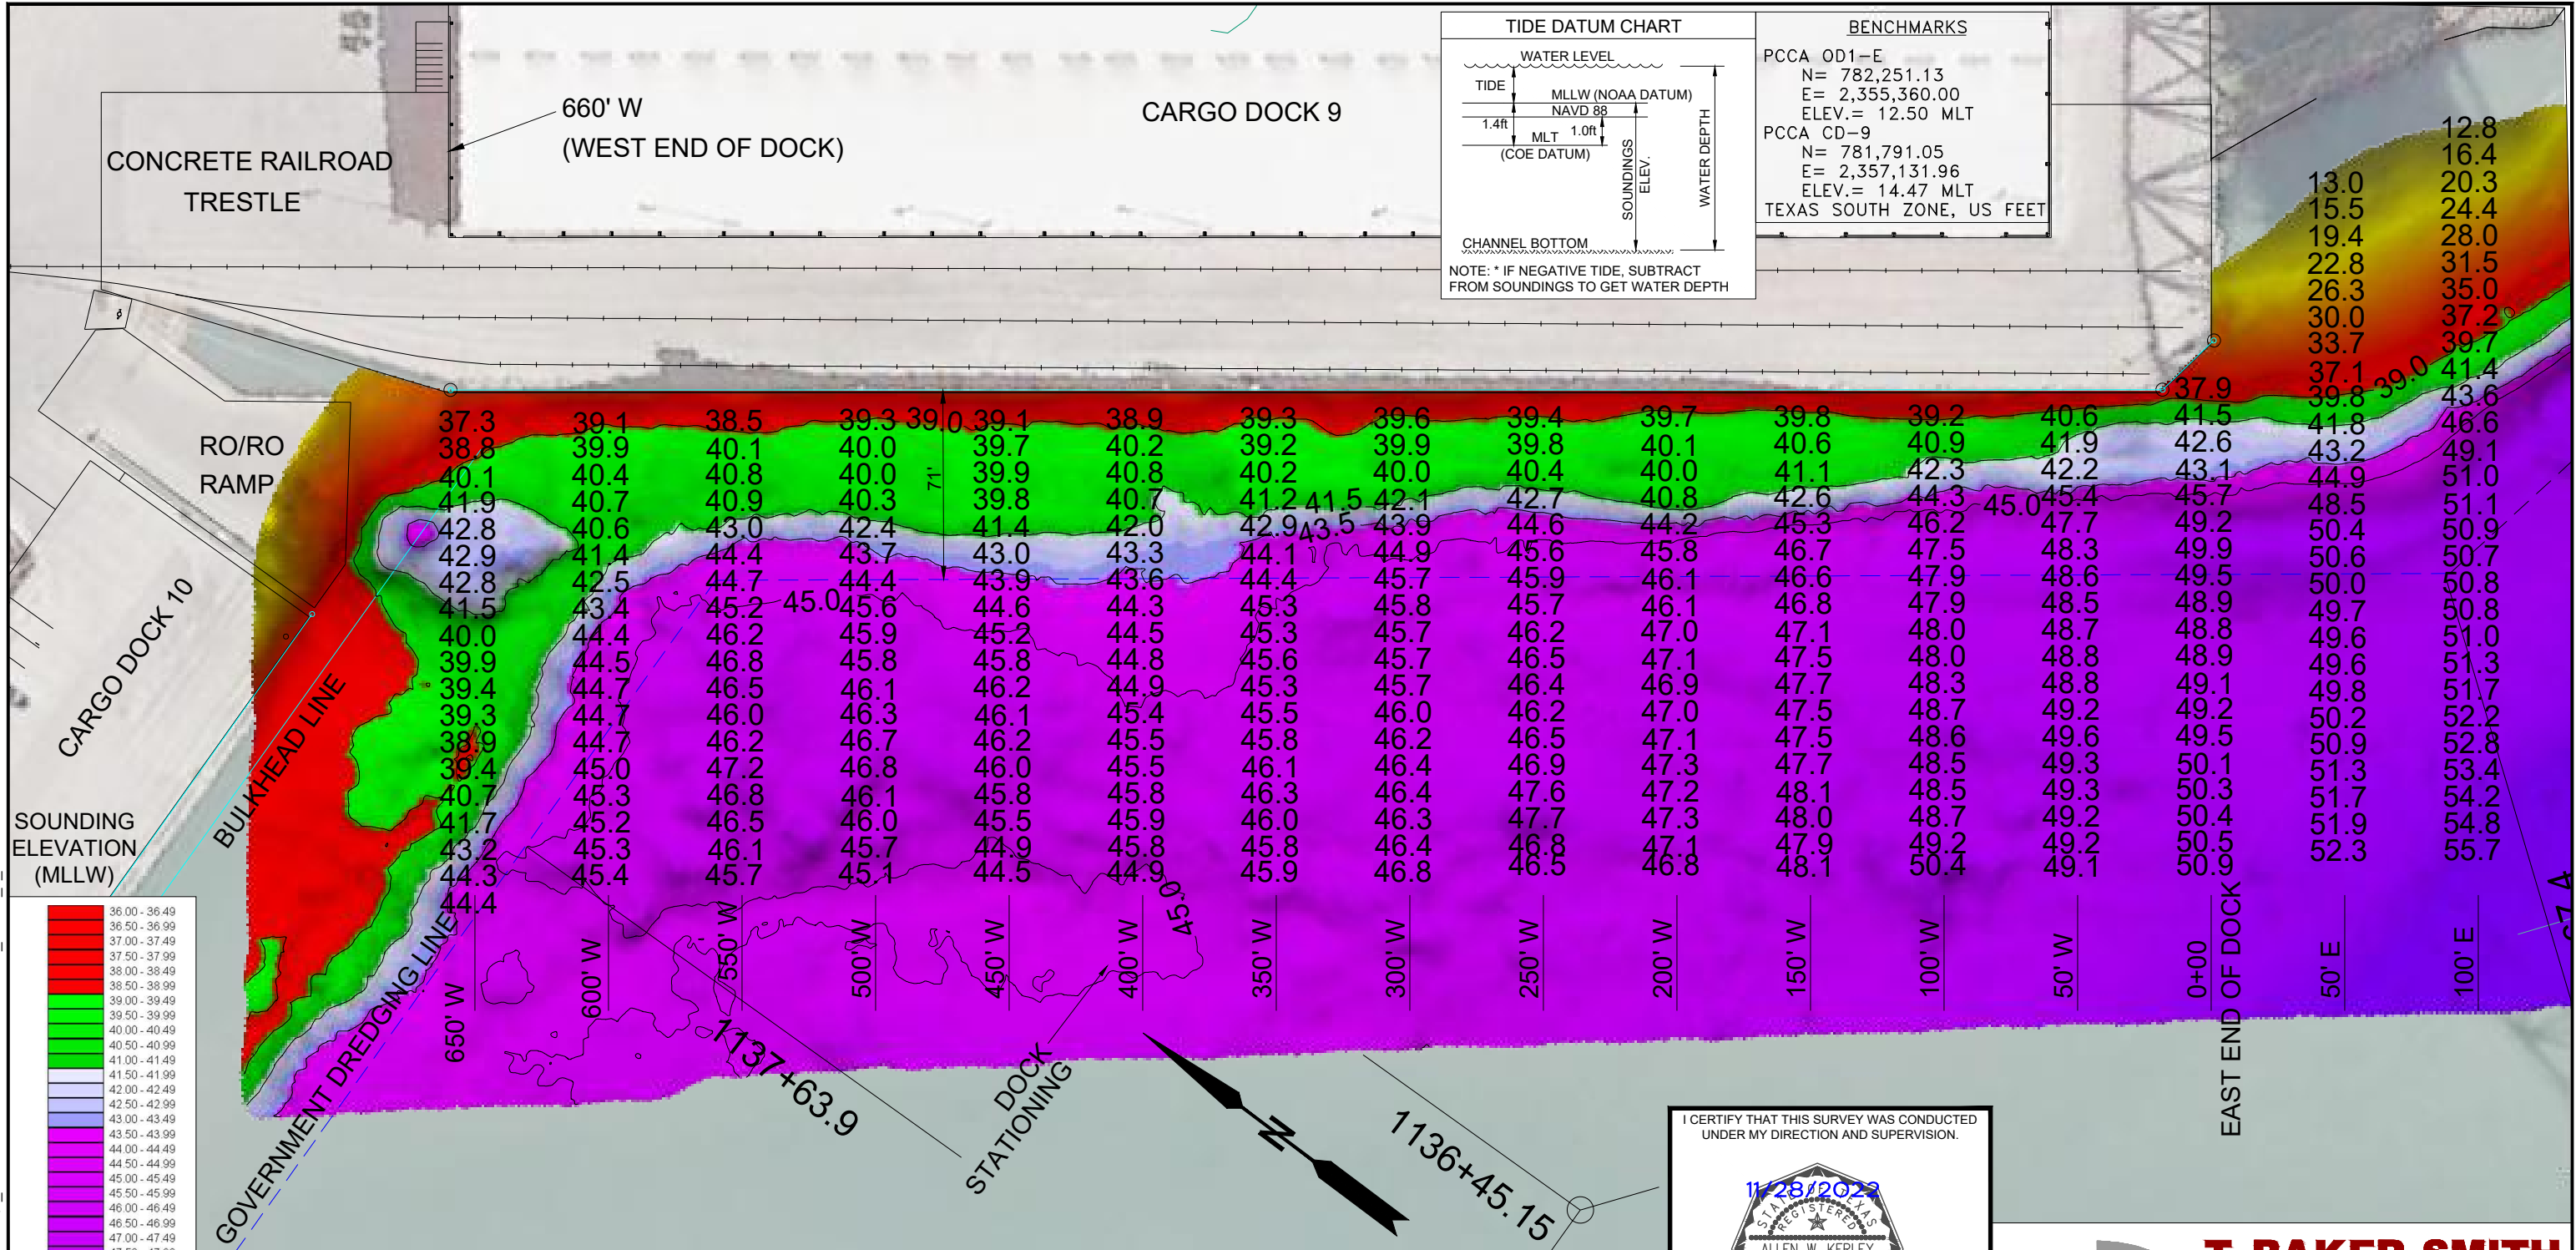
PLAN

- NOTES:**
1. LENGTH LIMIT : VESSEL LENGTH LIMIT : 750 FT
 2. SOUNDINGS WERE RECORDED BY T BAKER SMITH ON 8 NOVEMBER, 2022. SEA FLOOR CONDITIONS ARE SUBJECT TO CHANGE.
 3. THE PORT OF CORPUS CHRISTI ASSUMES NO LIABILITY FOR THE ACCURACY OF THIS INFORMATION. THE INFORMATION DEPICTED ON THIS MAP REPRESENTS THE RESULTS OF SURVEYS MADE ON THE DATE DEPICTED AND CAN ONLY BE CONSIDERED AS INDICATING THE GENERAL CONDITIONS AT THAT TIME. THESE CONDITIONS ARE SUBJECT TO RAPID CHANGE DUE TO SHOALING EVENTS.
 4. ALL READINGS ARE BASED ON THE NATIONAL OCEANIC AND ATMOSPHERIC ADMINISTRATION (NOAA) MEAN LOWER LOW WATER (MLLW) DATUM, (O.O')
 5. HORIZONTAL DATUM: NAD-83, STATE PLANE, TEXAS SOUTH ZONE, US FEET.
 6. TO GET THE DEPTH OF WATER, ADD THE CURRENT TIDE LEVEL TO THE READINGS SHOWN. (SEE TIDE DATUM CHART).
