#### PORT OF CORPUS CHRISTI AUTHORITY

OIL DOCK 12  
SOUNDINGS  
AN EXHIBIT OF A  
BATHYMETRIC SURVEY  
LOCATED IN  
CORPUS CHRISTI, TEXAS

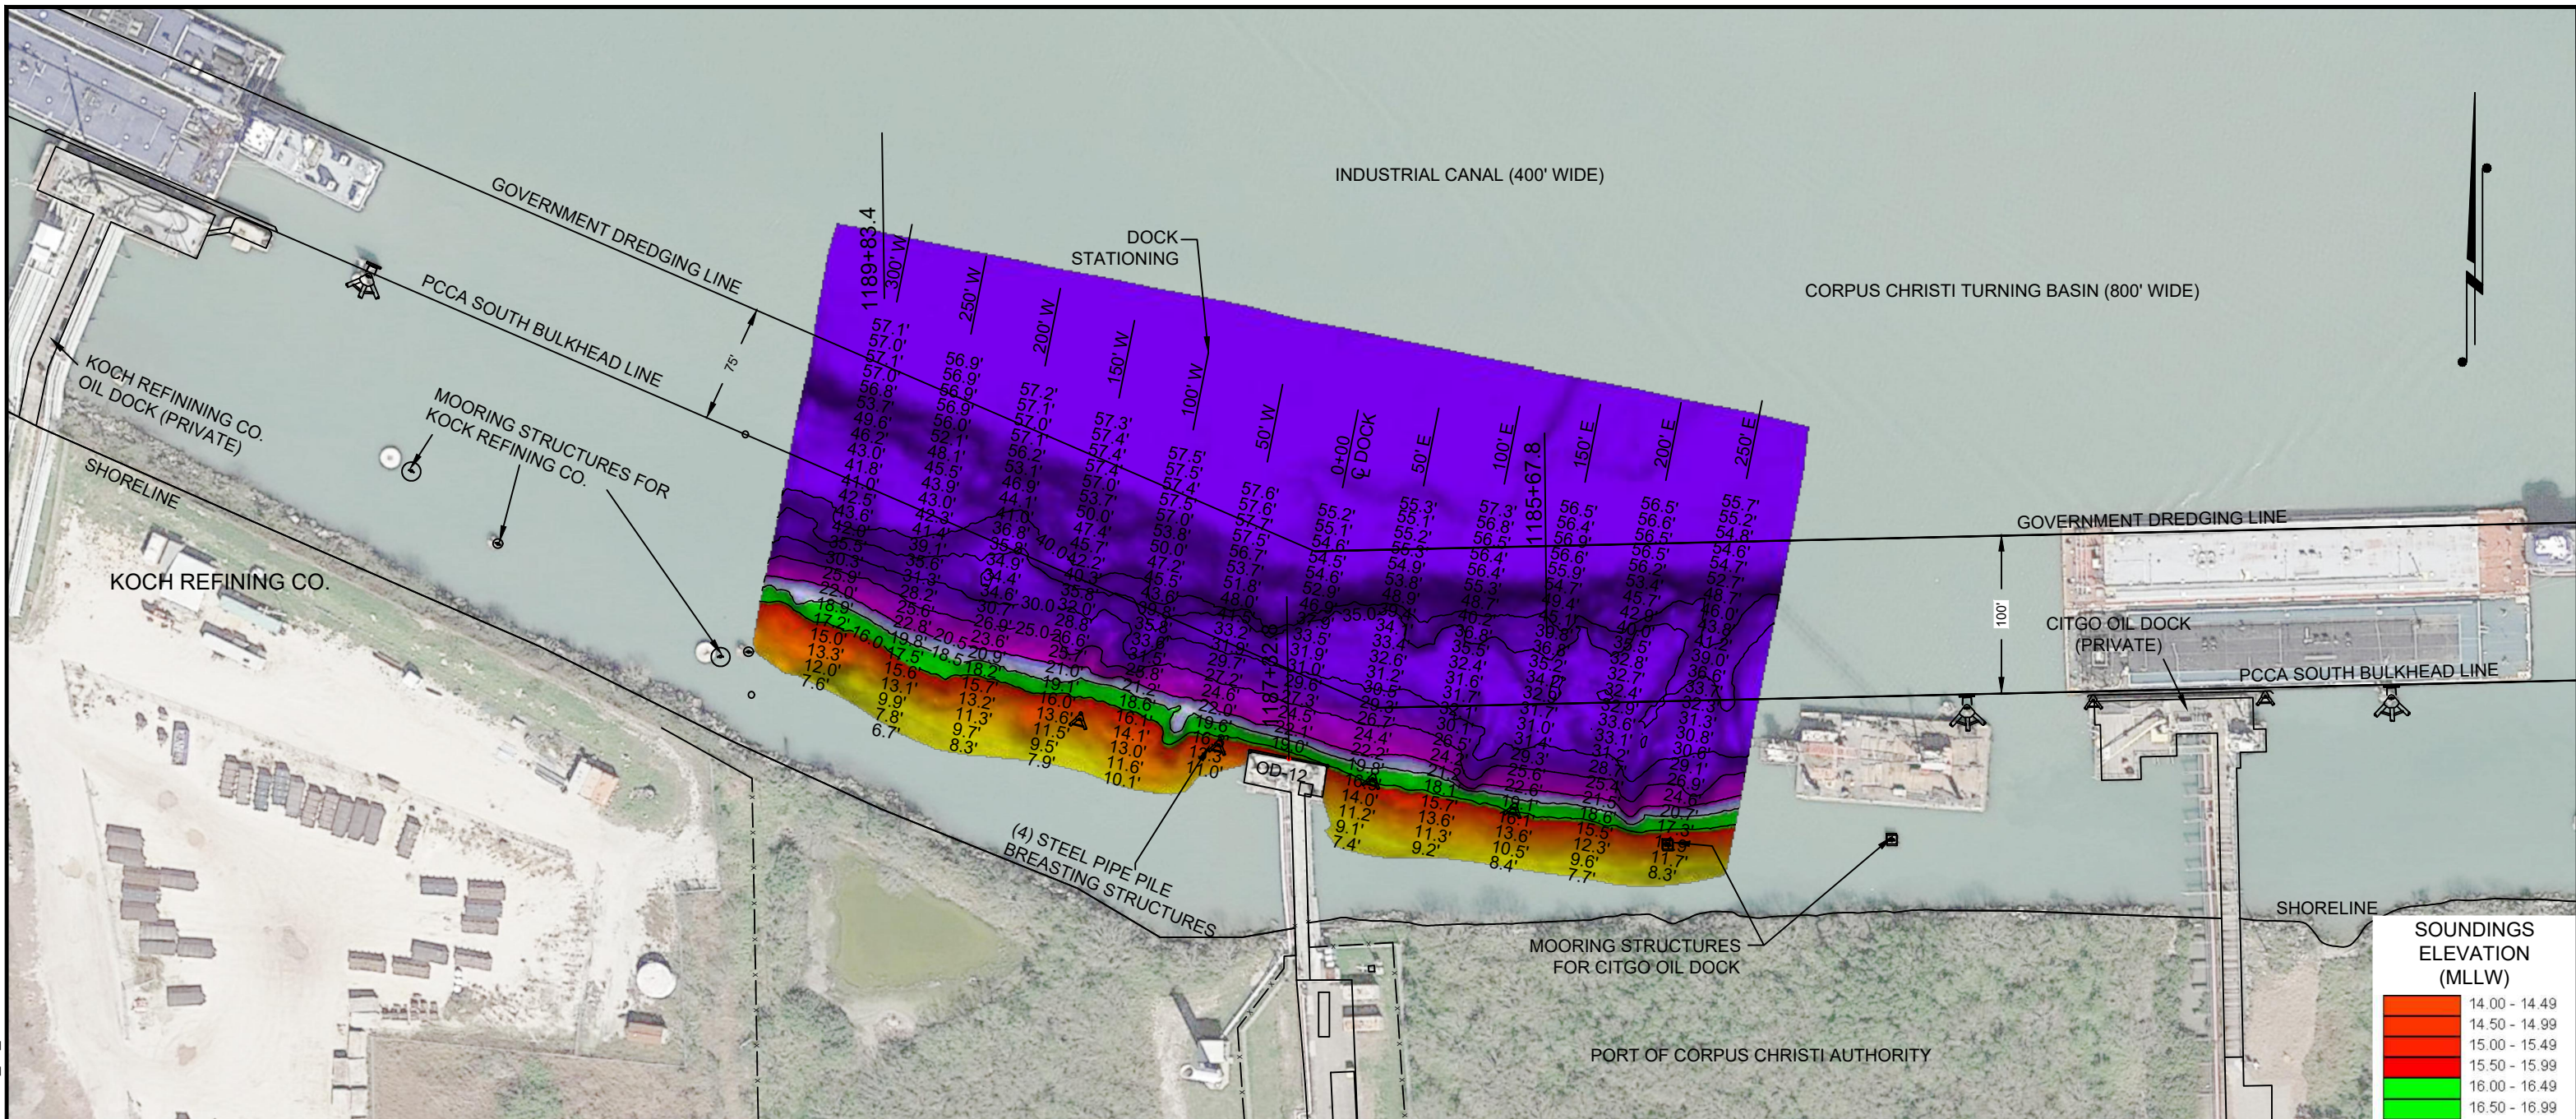
1. VESSEL LENGTH LIMIT: BARGE USE ONLY.
2. SOUNDINGS WERE RECORDED BY T BAKER SMITH ON 7 DECEMBER, 2023. SEA FLOOR CONDITIONS ARE SUBJECT TO CHANGE. THE PORT OF CORPUS CHRISTI ASSUMES NO LIABILITY FOR THE ACCURACY OF THIS INFORMATION. THE INFORMATION DEPICTED ON THIS MAP REPRESENTS THE RESULTS OF SURVEYS MADE ON THE DATE DEPICTED AND CAN ONLY BE CONSIDERED AS INDICATING THE GENERAL CONDITIONS AT THAT TIME. THESE CONDITIONS ARE SUBJECT TO RAPID CHANGE DUE TO SHOALING EVENTS.
3. ALL READINGS ARE BASED ON THE NATIONAL OCEANIC AND ATMOSPHERIC ADMINISTRATION (NOAA) MEAN LOWER LOW WATER (MLLW) DATUM, (O.O').
4. HORIZONTAL DATUM: NAD-83, STATE PLANE, TEXAS SOUTH ZONE, US FEET.
5. TO GET THE DEPTH OF WATER, ADD THE CURRENT TIDE LEVEL TO THE READINGS SHOWN. (SEE TIDE DATUM CHART).
- 6.

BENCHMARK: PCCA "OD-12"  
PCCA BRASS DISK NE COR.  
STRUCTURE, ELEV. +7.58 (MLT) +6.28 (MLLW)  
N: 17185425.73  
E: 1335829.73
