**PORT OF CORPUS CHRISTI AUTHORITY**

**OIL DOCK 12**  
**SOUNDINGS**  
AN EXHIBIT OF A  
BATHYMETRIC SURVEY  
LOCATED IN  
CORPUS CHRISTI, TEXAS

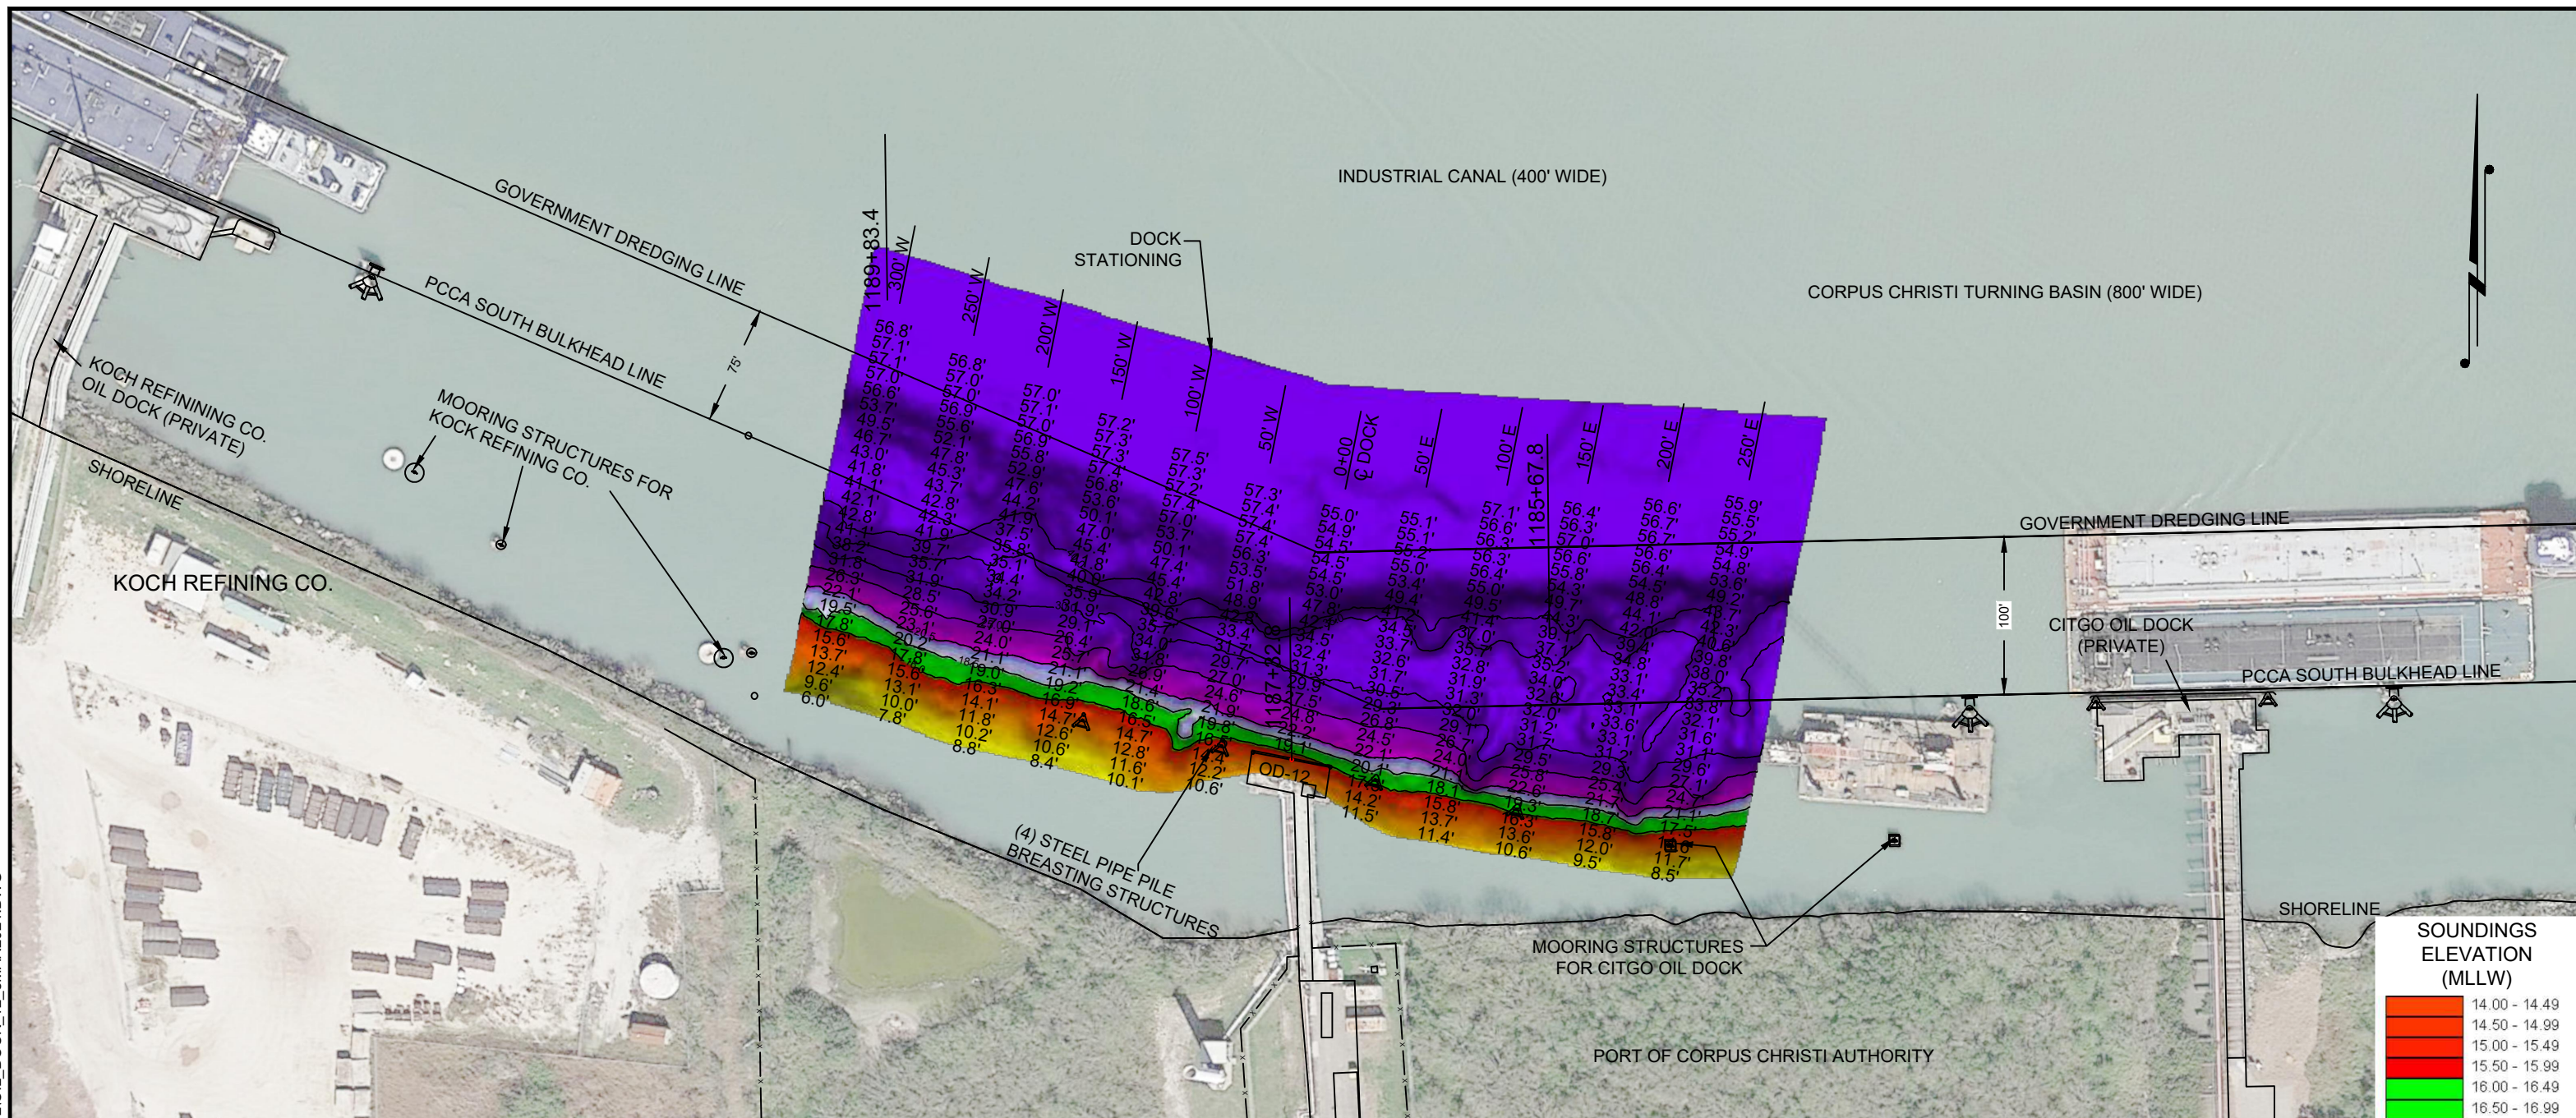
- NOTES:**
- VESSEL LENGTH LIMIT: BARGE USE ONLY.
  - SOUNDINGS WERE RECORDED BY T BAKER SMITH ON 8 MARCH, 2024. SEA FLOOR CONDITIONS ARE SUBJECT TO CHANGE.
  - THE PORT OF CORPUS CHRISTI ASSUMES NO LIABILITY FOR THE ACCURACY OF THIS INFORMATION. THE INFORMATION DEPICTED ON THIS MAP REPRESENTS THE RESULTS OF SURVEYS MADE ON THE DATE DEPICTED AND CAN ONLY BE CONSIDERED AS INDICATING THE GENERAL CONDITIONS AT THAT TIME. THESE CONDITIONS ARE SUBJECT TO RAPID CHANGE DUE TO SHOALING EVENTS.
  - ALL READINGS ARE BASED ON THE NATIONAL OCEANIC AND ATMOSPHERIC ADMINISTRATION (NOAA) MEAN LOWER LOW WATER (MLLW) DATUM, (O.O')
  - HORIZONTAL DATUM: NAD-83, STATE PLANE, TEXAS SOUTH ZONE, US FEET.
  - TO GET THE DEPTH OF WATER, ADD THE CURRENT TIDE LEVEL TO THE READINGS SHOWN. (SEE TIDE DATUM CHART).
