DRAWN BY:	CDW	APPROVED BY:	AWK
DATE:	09/10/2024	JOB NO:	2024.0287
DRAWING NAME:	OIL DOCK 14 16AUG2024		
PROJECTION:	TEXAS STATE PLANE SOUTH ZONE		
GEO. DATUM:	NAD83 (2011) VERT. DATUM: NAVD88		
GRID UNITS:	US SURVEY FEET		
SHEET NO:	1	OF	1

PORT OF CORPUS CHRISTI AUTHORITY

OIL DOCK 14
SOUNDINGS
AN EXHIBIT OF A
BATHYMETRIC SURVEY
LOCATED IN
CORPUS CHRISTI, TEXAS

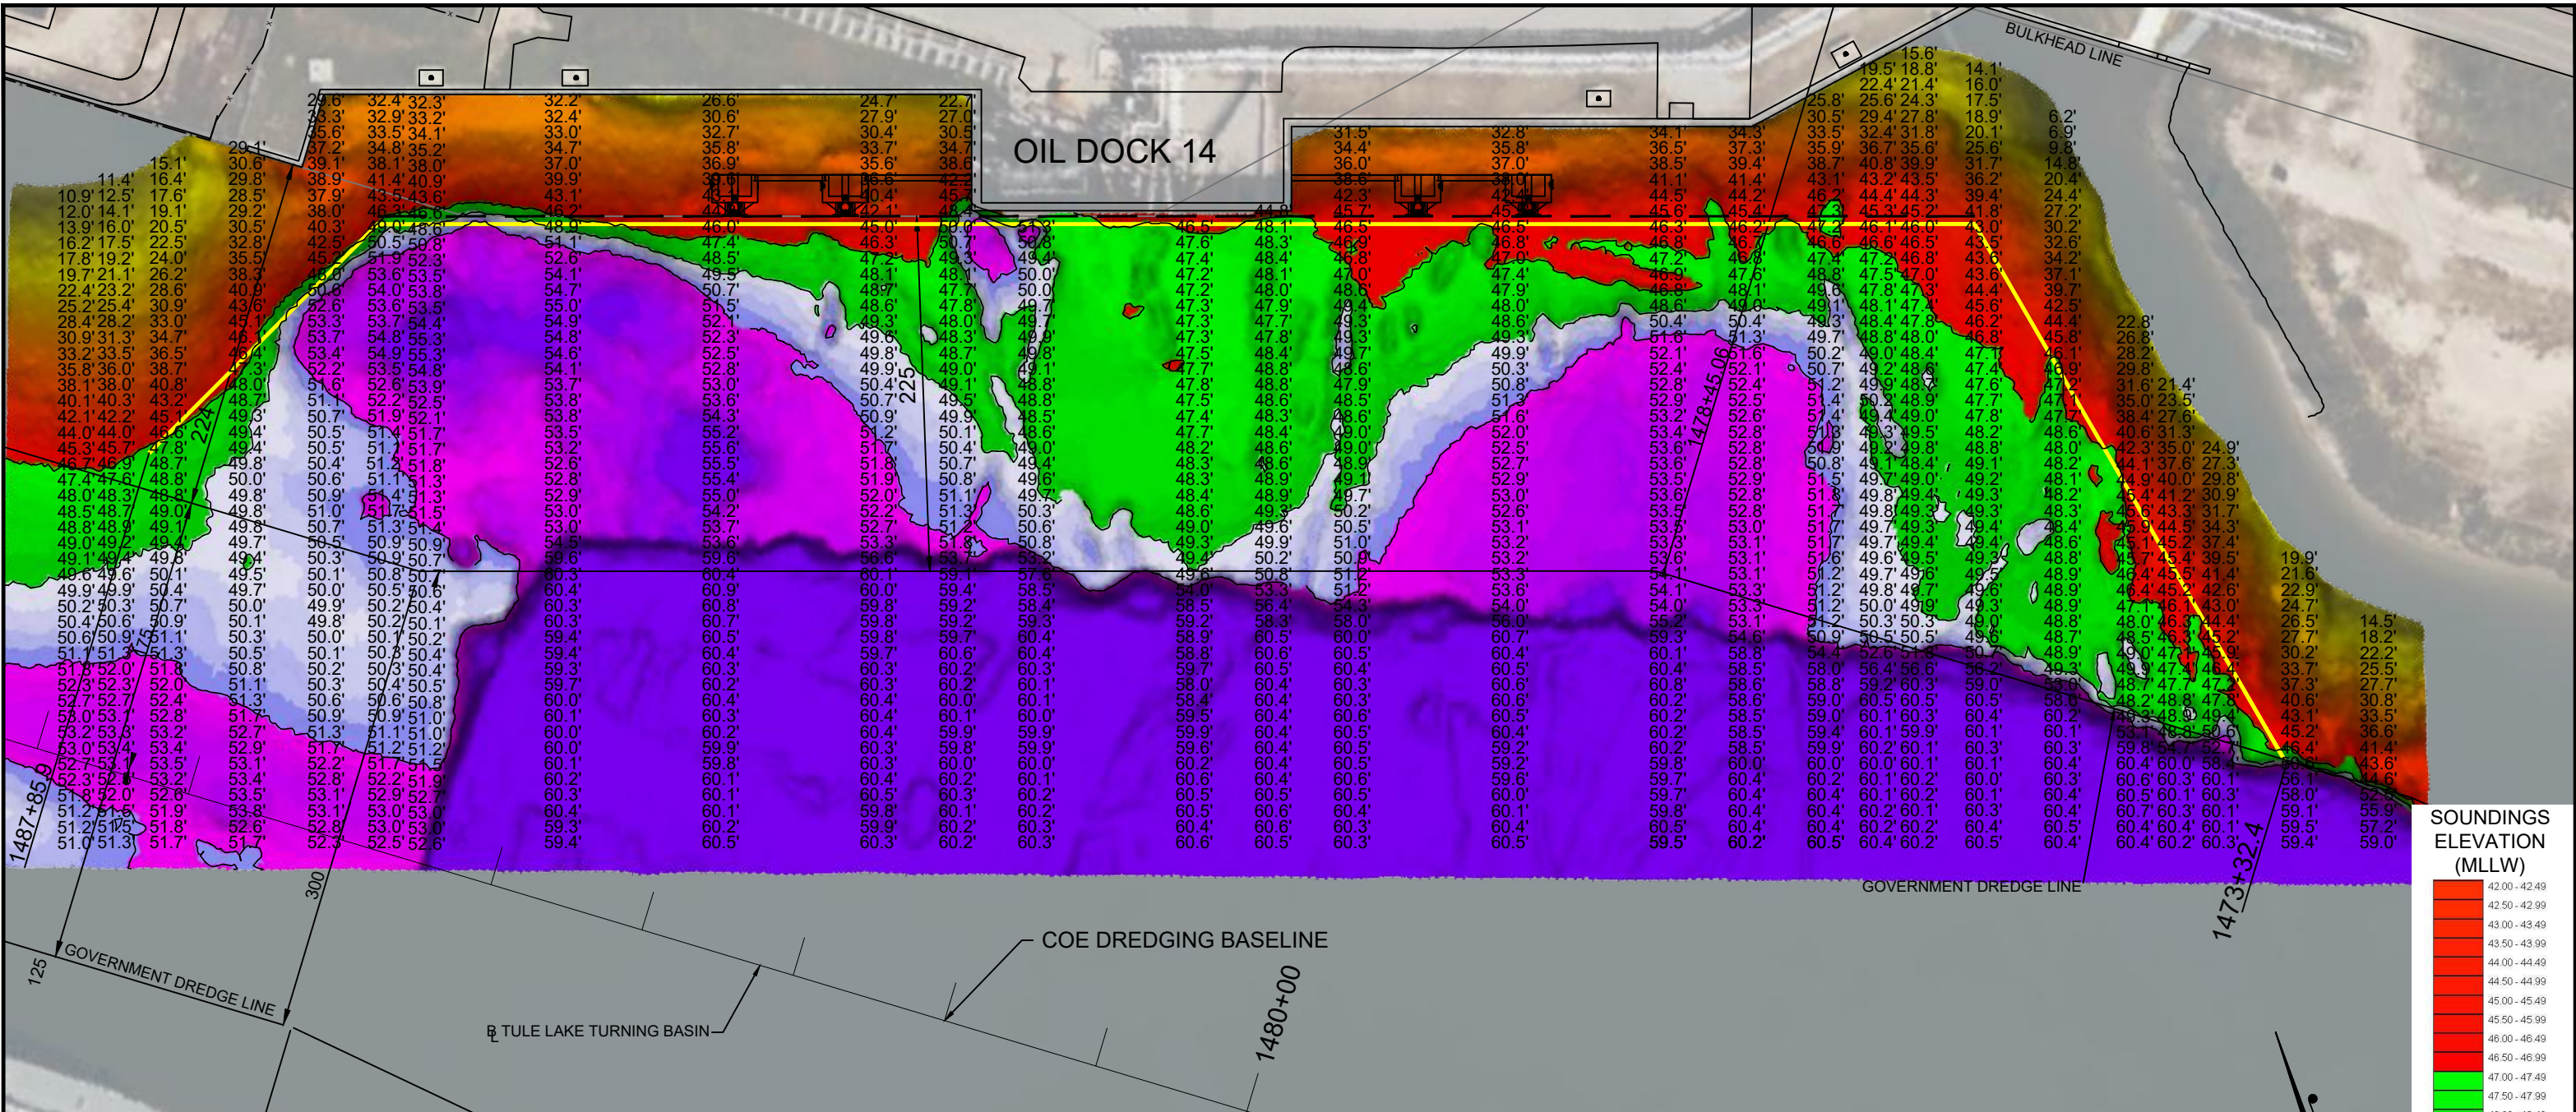
- NOTES:**
- SOUNDINGS WERE RECORDED BY T.BAKER SMITH SERVICES ON 16 AUGUST, 2024. SEA FLOOR CONDITIONS ARE SUBJECT TO CHANGE.
 - THE PORT OF CORPUS CHRISTI ASSUMES NO LIABILITY FOR THE ACCURACY OF THIS INFORMATION. THE INFORMATION DEPICTED ON THIS MAP REPRESENTS THE RESULTS OF SURVEYS MADE ON THE DATE DEPICTED AND CAN ONLY BE CONSIDERED AS INDICATING THE GENERAL CONDITIONS AT THAT TIME. THESE CONDITIONS ARE SUBJECT TO RAPID CHANGE DUE TO SHOALING EVENTS.
 - ALL READINGS ARE BASED ON THE NATIONAL OCEANIC AND ATMOSPHERIC ADMINISTRATION (NOAA) MEAN LOWER LOW WATER (MLLW) DATUM, (O.O') HORIZONTAL DATUM: NAD-83, STATE PLANE, TEXAS SOUTH ZONE, US FEET.
 - TO GET THE DEPTH OF WATER, ADD THE CURRENT TIDE LEVEL TO THE READINGS SHOWN. (SEE TIDE DATUM CHART).
