DRAWING NAME: OIL DOCK 15 28FEB2023

PORT OF CORPUS CHRISTI AUTHORITY

OIL DOCK 15  
SOUNDINGS  
AN EXHIBIT OF A  
BATHYMETRIC SURVEY  
LOCATED IN  
CORPUS CHRISTI, TEXAS

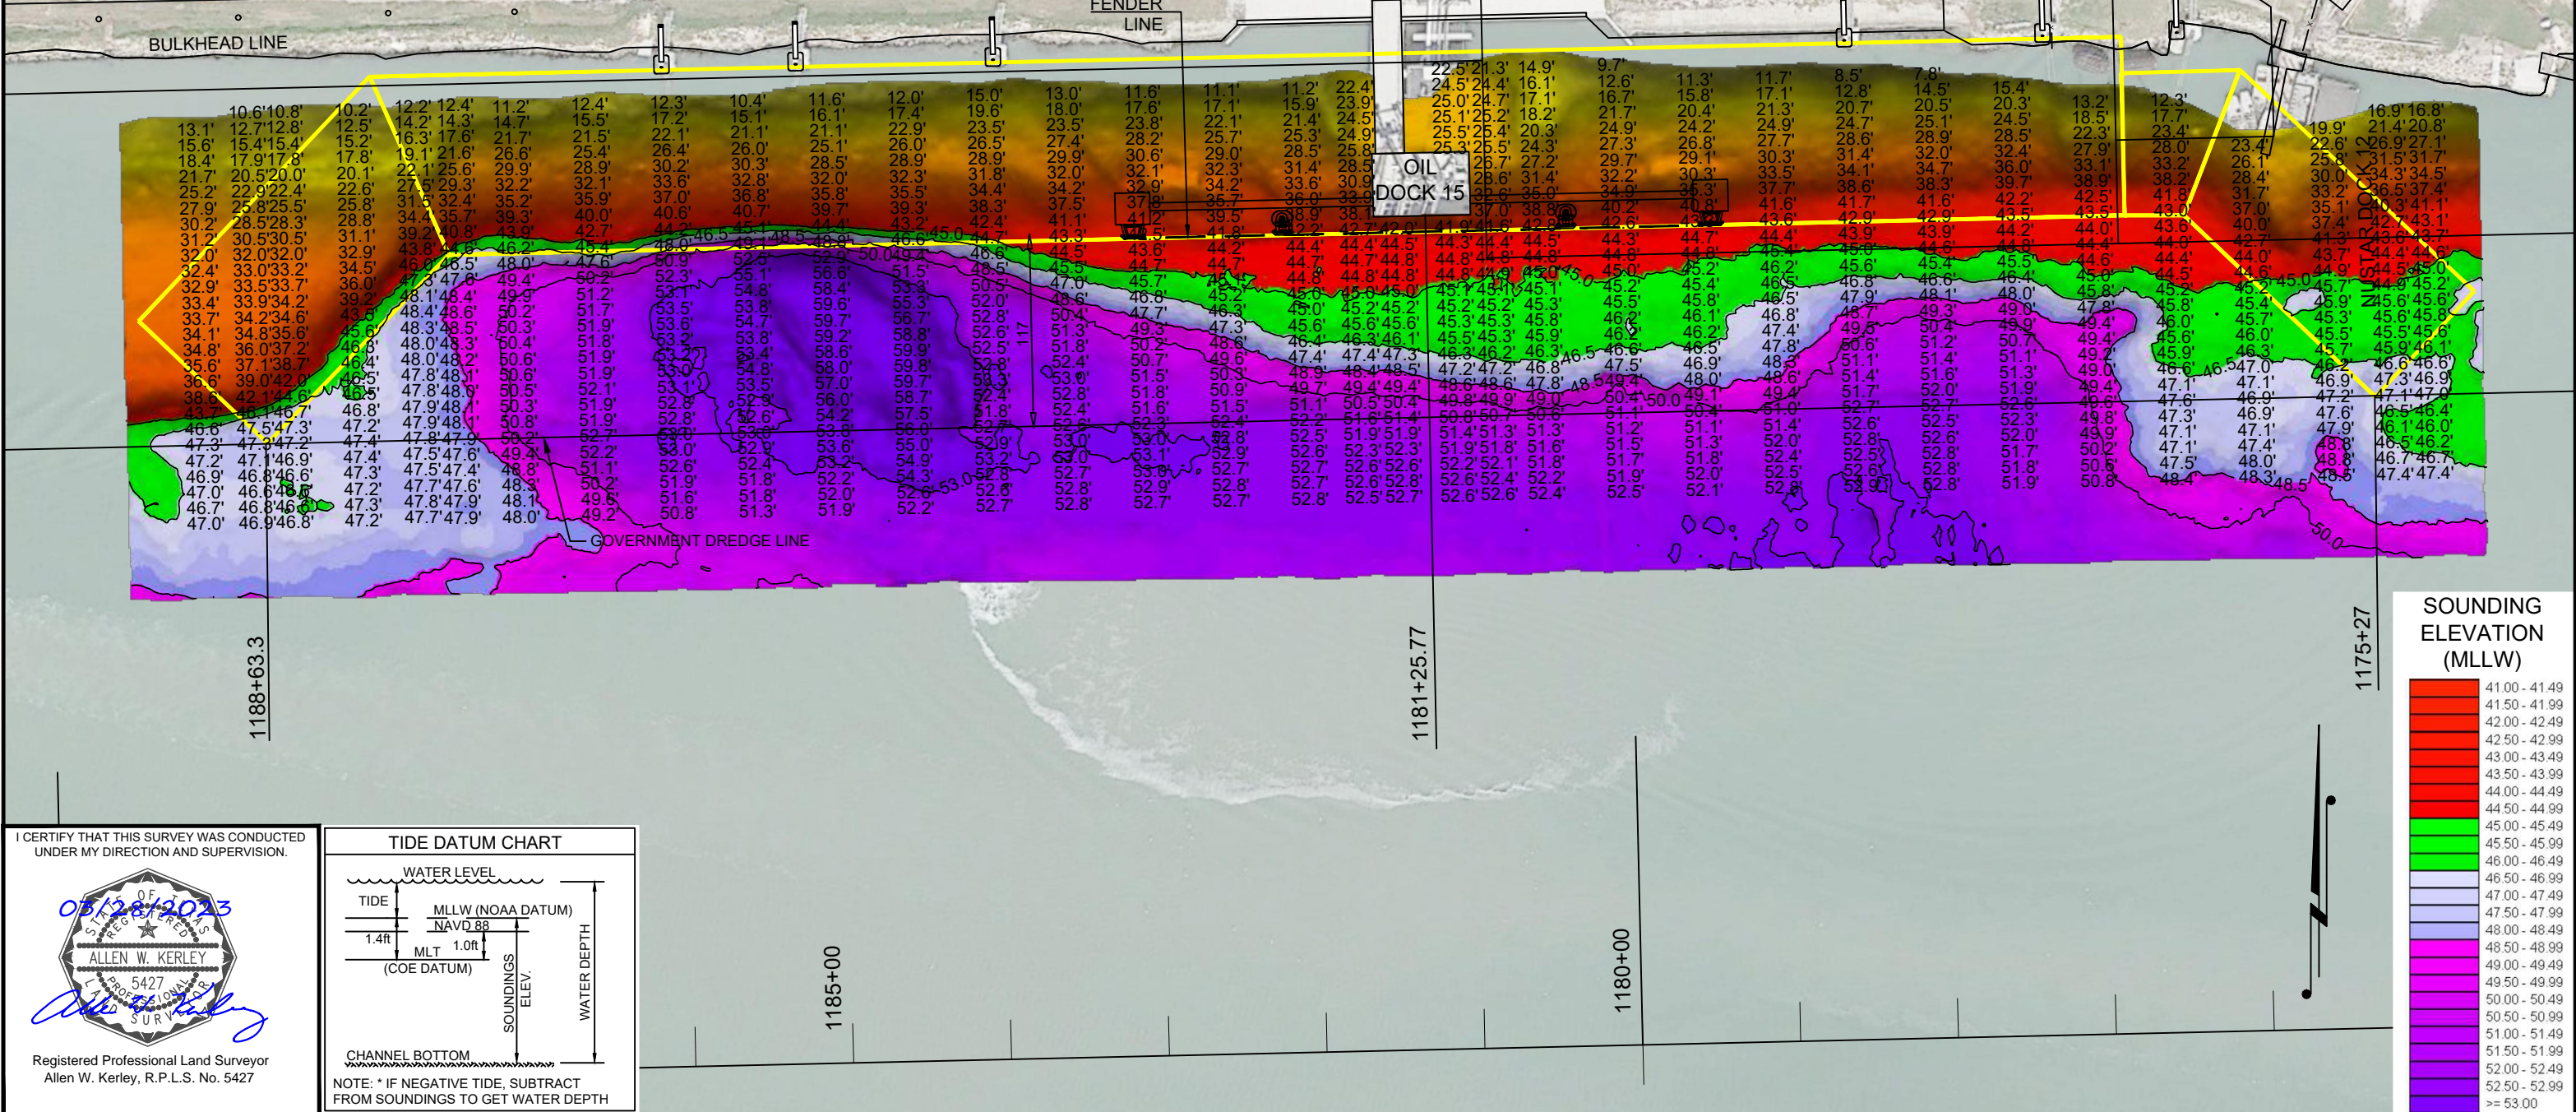
- NOTES:
- SOUNDINGS WERE RECORDED BY T BAKER SMITH ON 28 FEBRUARY, 2023. SEA FLOOR CONDITIONS ARE SUBJECT TO CHANGE.
  - THE PORT OF CORPUS CHRISTI ASSUMES NO LIABILITY FOR THE ACCURACY OF THIS INFORMATION. THE INFORMATION DEPICTED ON THIS MAP REPRESENTS THE RESULTS OF SURVEYS MADE ON THE DATE DEPICTED AND CAN ONLY BE CONSIDERED AS INDICATING THE GENERAL CONDITIONS AT THAT TIME. THESE CONDITIONS ARE SUBJECT TO RAPID CHANGE DUE TO SHOALING EVENTS.
  - ALL READINGS ARE BASED ON THE NATIONAL OCEANIC AND ATMOSPHERIC ADMINISTRATION (NOAA) MEAN LOWER LOW WATER (MLLW) DATUM, (O.O')
  - HORIZONTAL DATUM: NAD-83, STATE PLANE, TEXAS SOUTH ZONE, US FEET.
  - TO GET THE DEPTH OF WATER, ADD THE CURRENT TIDE LEVEL TO THE READINGS SHOWN. (SEE TIDE DATUM CHART).
