PORT OF CORPUS CHRISTI AUTHORITY

OIL DOCK 15
SOUNDINGS
AN EXHIBIT OF A
BATHYMETRIC SURVEY
LOCATED IN
CORPUS CHRISTI, TEXAS

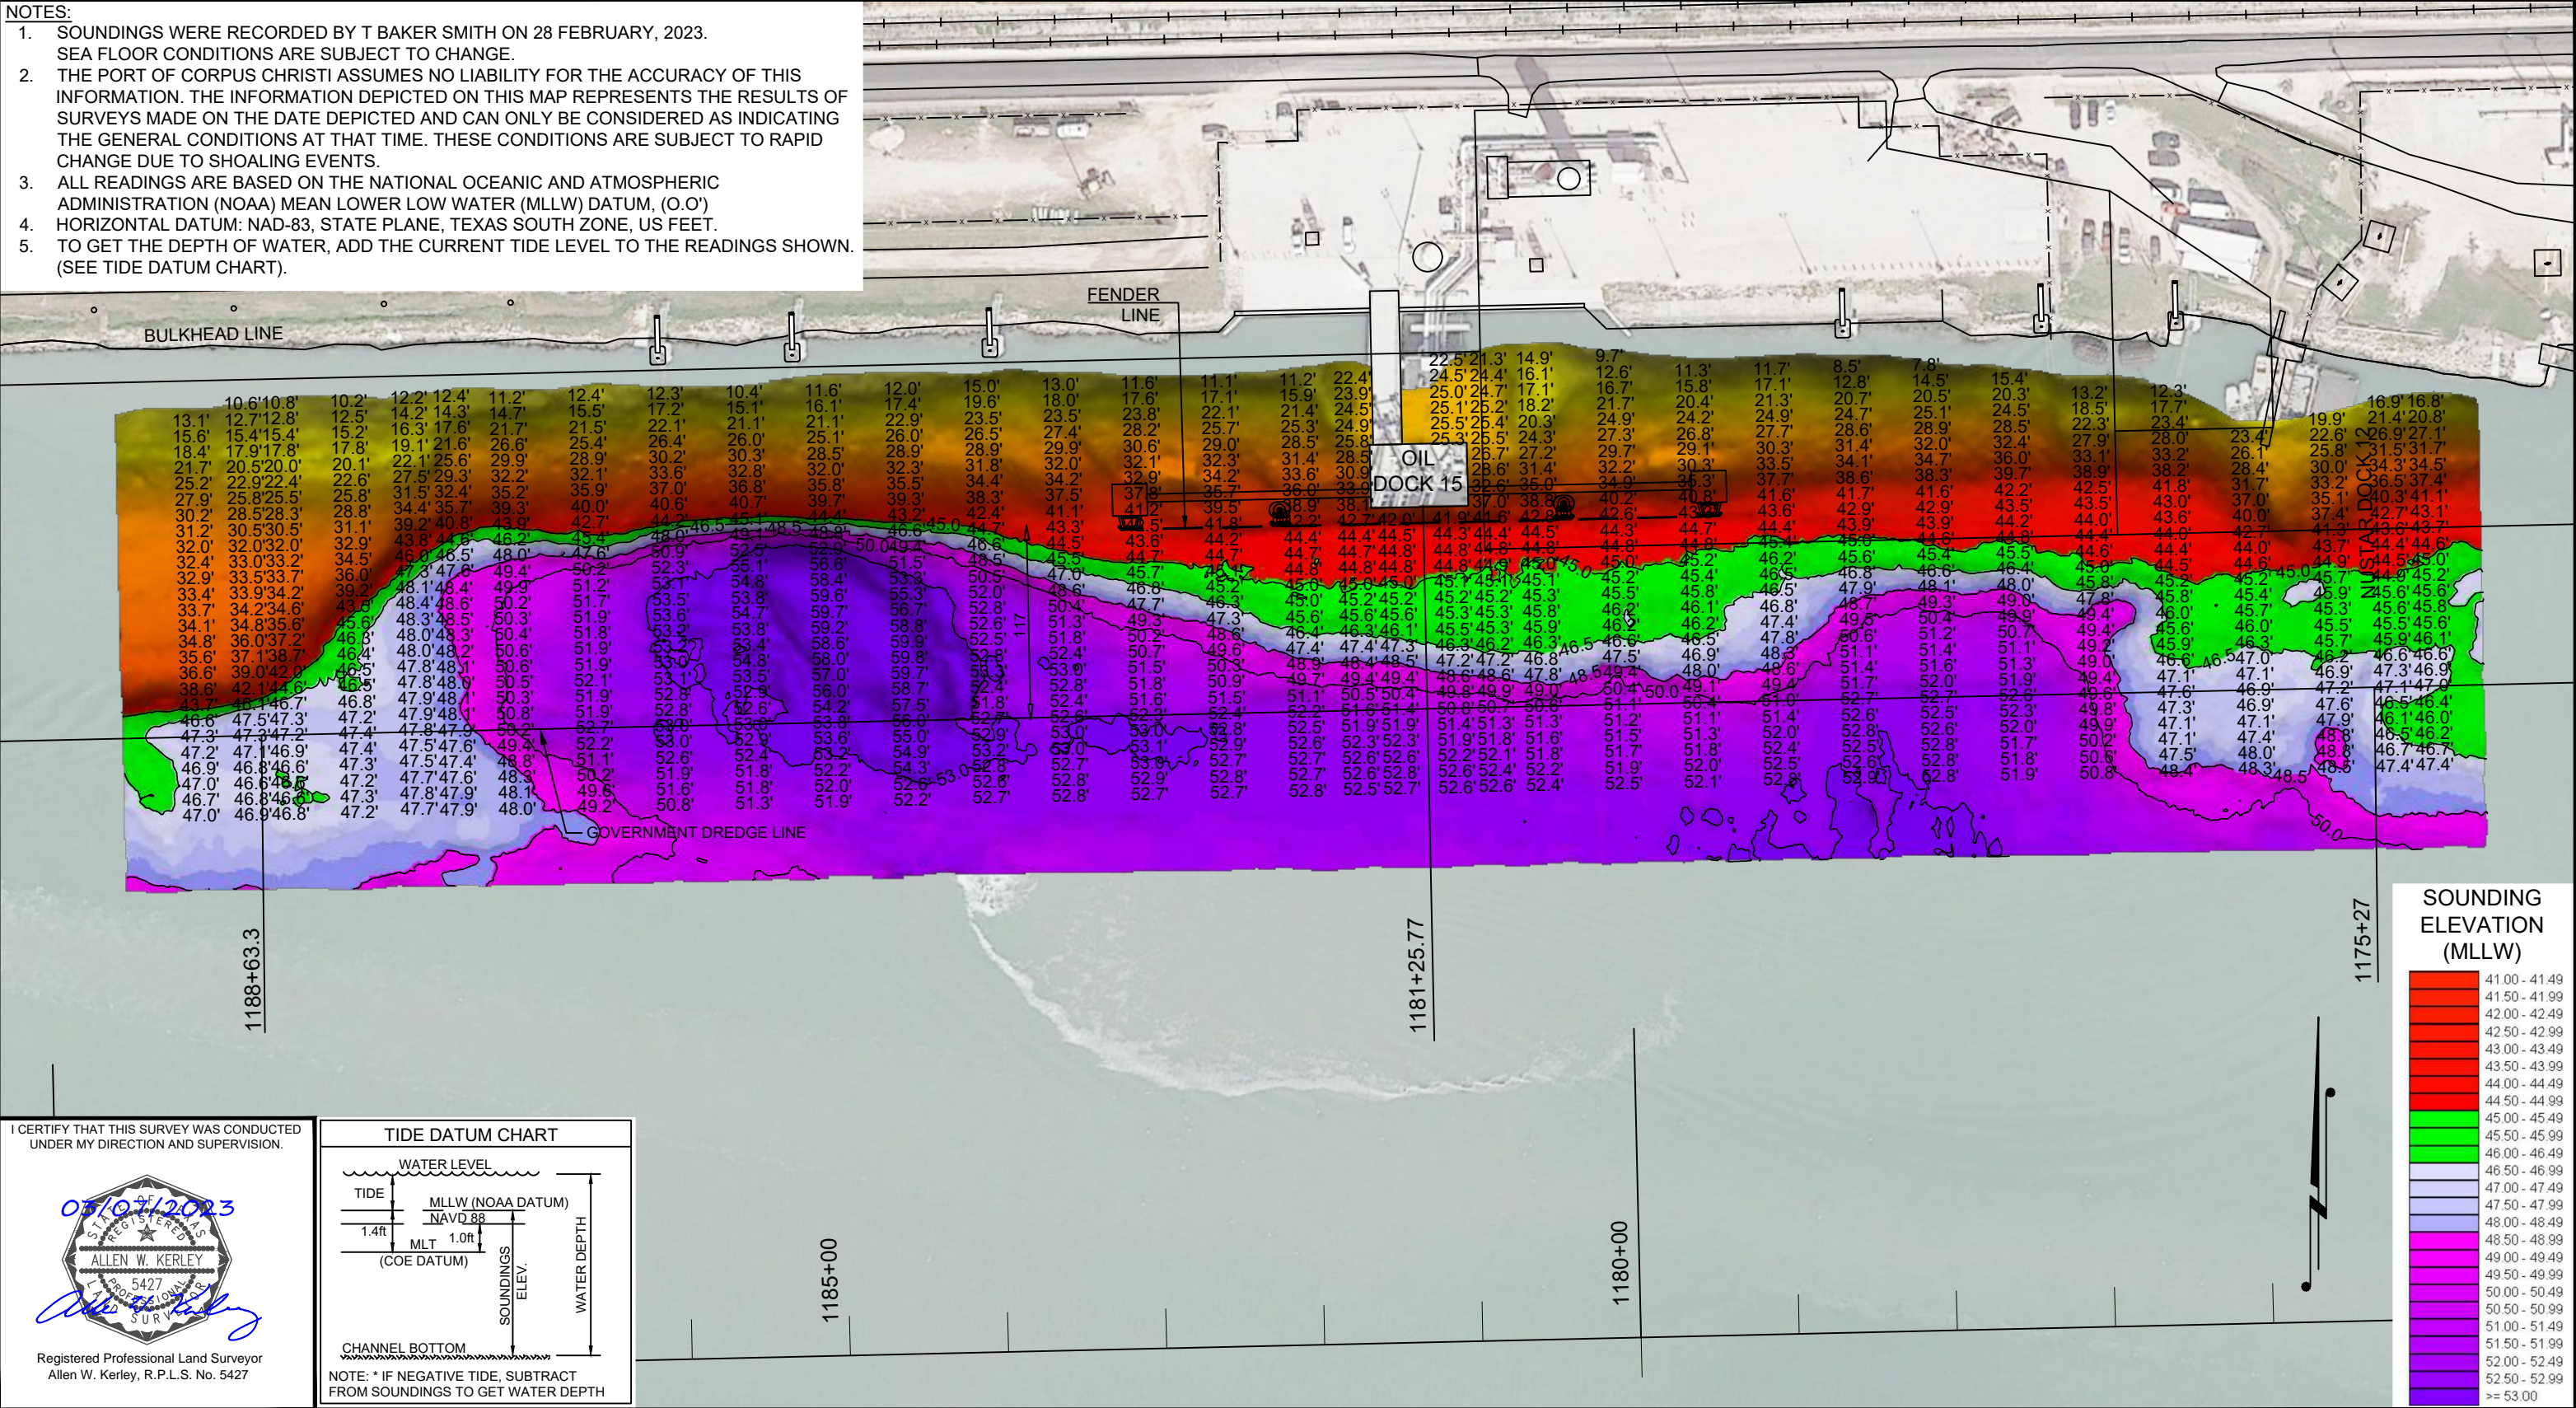
- NOTES:
1. SOUNDINGS WERE RECORDED BY T BAKER SMITH ON 28 FEBRUARY, 2023. SEA FLOOR CONDITIONS ARE SUBJECT TO CHANGE.
 2. THE PORT OF CORPUS CHRISTI ASSUMES NO LIABILITY FOR THE ACCURACY OF THIS INFORMATION. THE INFORMATION DEPICTED ON THIS MAP REPRESENTS THE RESULTS OF SURVEYS MADE ON THE DATE DEPICTED AND CAN ONLY BE CONSIDERED AS INDICATING THE GENERAL CONDITIONS AT THAT TIME. THESE CONDITIONS ARE SUBJECT TO RAPID CHANGE DUE TO SHOALING EVENTS.
 3. ALL READINGS ARE BASED ON THE NATIONAL OCEANIC AND ATMOSPHERIC ADMINISTRATION (NOAA) MEAN LOWER LOW WATER (MLLW) DATUM, (O.O')
 4. HORIZONTAL DATUM: NAD-83, STATE PLANE, TEXAS SOUTH ZONE, US FEET.
 5. TO GET THE DEPTH OF WATER, ADD THE CURRENT TIDE LEVEL TO THE READINGS SHOWN. (SEE TIDE DATUM CHART).
