## PORT OF CORPUS CHRISTI AUTHORITY

OIL DOCK 15  
2026-Q2  
AN EXHIBIT OF A  
BATHYMETRIC SURVEY  
LOCATED IN  
CORPUS CHRISTI, TEXAS

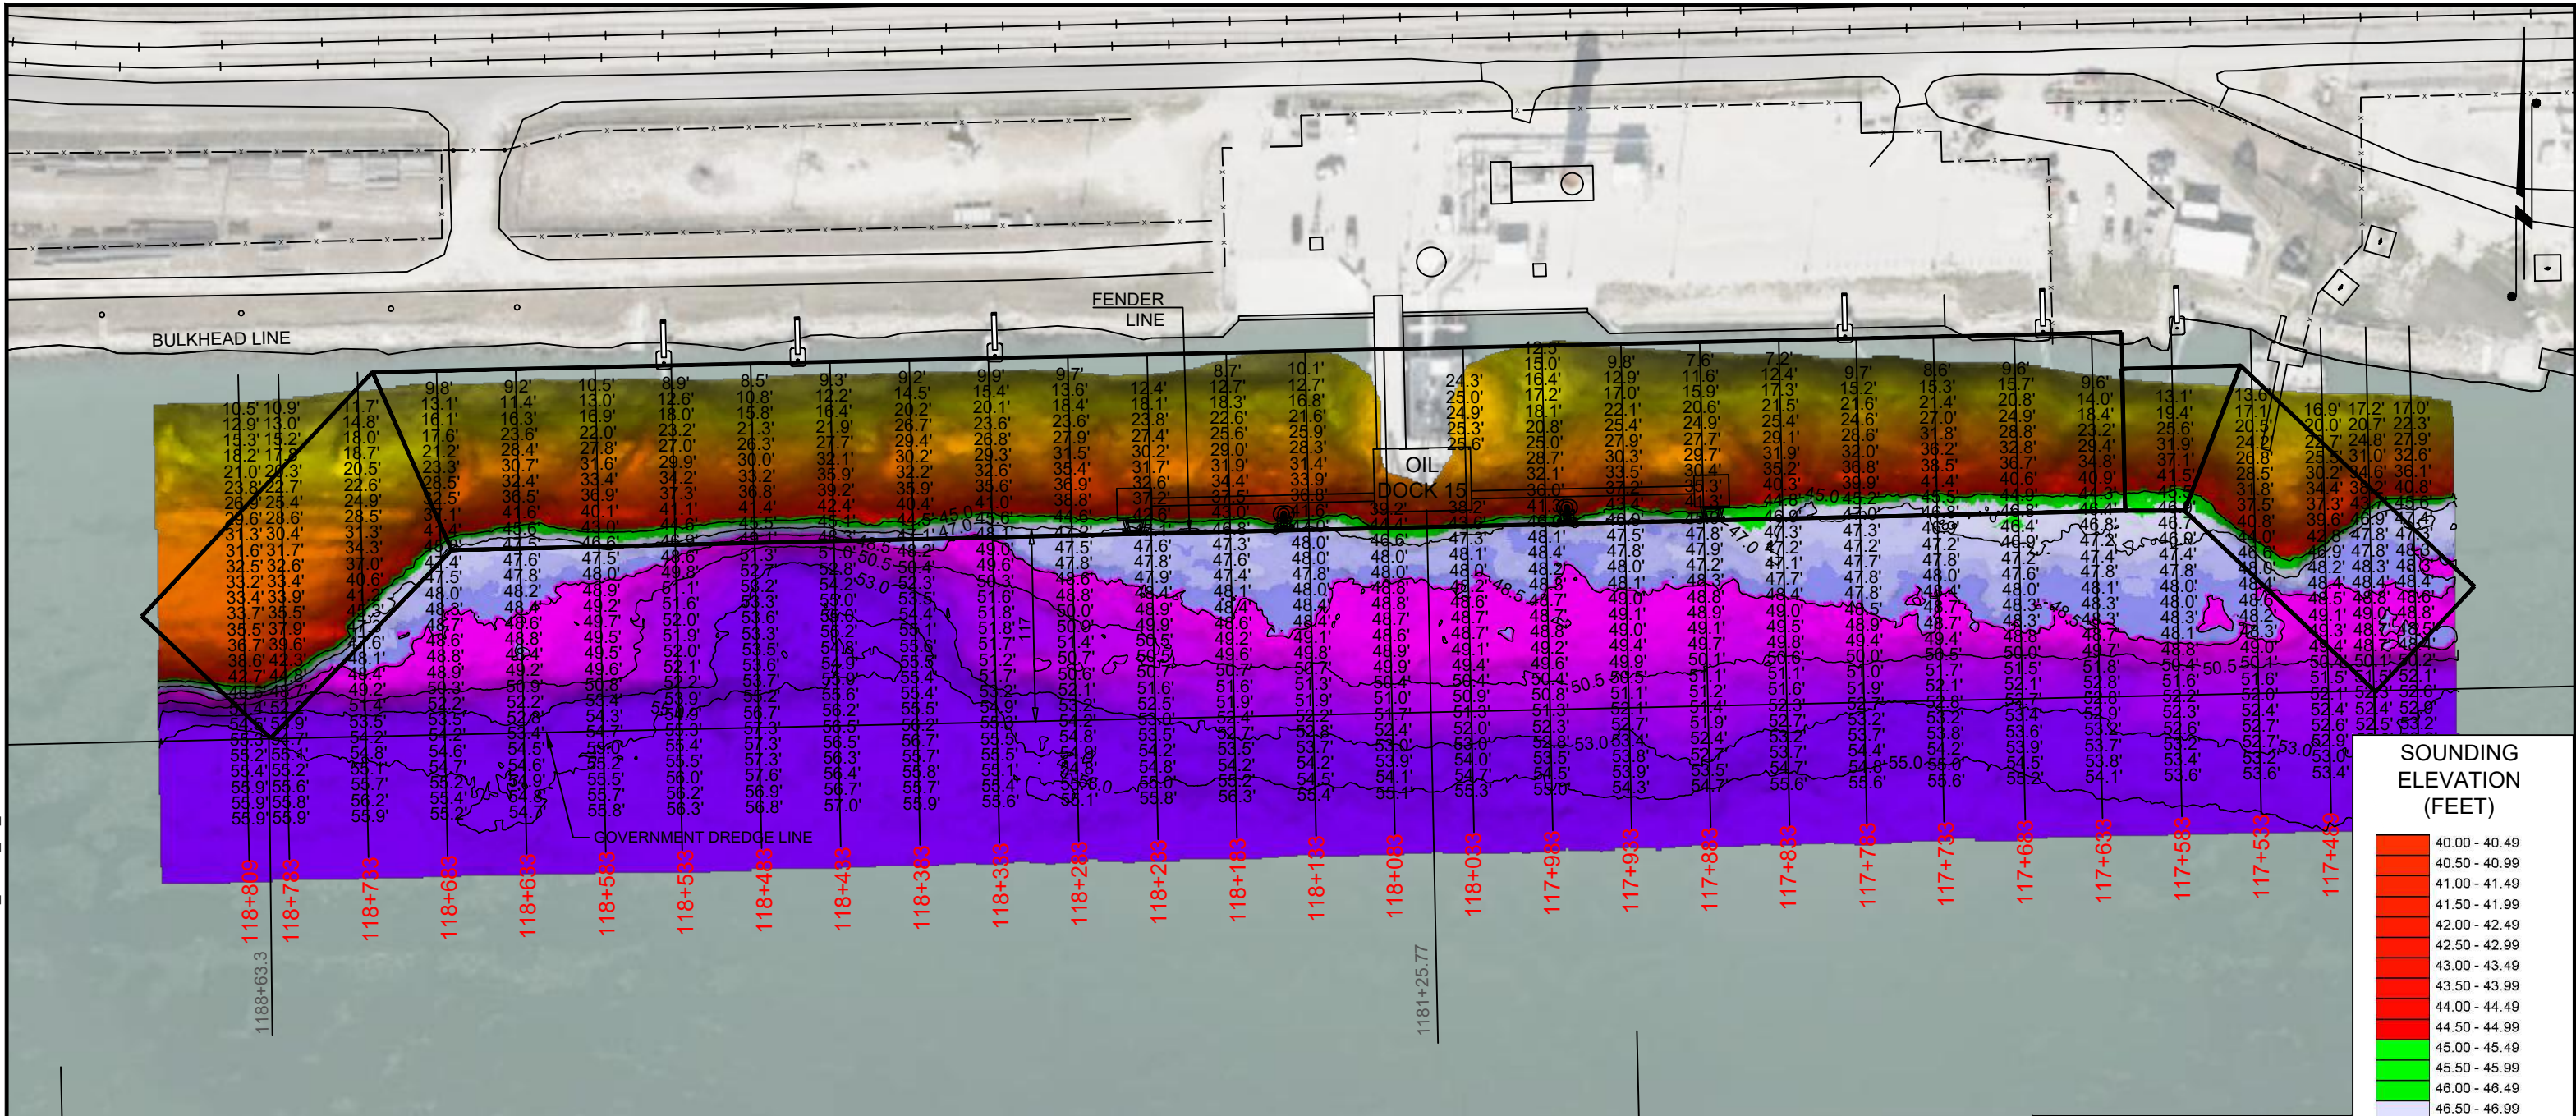
- NOTES:**
- SOUNDINGS WERE RECORDED BY T BAKER SMITH ON 21 MAY, 2026.
  - SEA FLOOR CONDITIONS ARE SUBJECT TO CHANGE.
  - THE PORT OF CORPUS CHRISTI ASSUMES NO LIABILITY FOR THE ACCURACY OF THIS INFORMATION. THE INFORMATION DEPICTED ON THIS MAP REPRESENTS THE RESULTS OF SURVEYS MADE ON THE DATE DEPICTED AND CAN ONLY BE CONSIDERED AS INDICATING THE GENERAL CONDITIONS AT THAT TIME. THESE CONDITIONS ARE SUBJECT TO RAPID CHANGE DUE TO SHOALING EVENTS.
  - ALL READINGS ARE BASED ON THE NATIONAL OCEANIC AND ATMOSPHERIC ADMINISTRATION (NOAA) MEAN LOWER LOW WATER (MLLW) DATUM, (O.O')
  - HORIZONTAL DATUM: NAD-83, STATE PLANE, TEXAS SOUTH ZONE, US FEET.
  - TO GET THE DEPTH OF WATER, ADD THE CURRENT TIDE LEVEL TO THE READINGS SHOWN. (SEE TIDE DATUM CHART).
