DRAWING NAME: OIL\_DOCK\_15\_BATHY 24APR2025

**PORT OF CORPUS CHRISTI AUTHORITY**

**OIL DOCK 15**  
**SOUNDINGS**  
AN EXHIBIT OF A  
BATHYMETRIC SURVEY  
LOCATED IN  
CORPUS CHRISTI, TEXAS

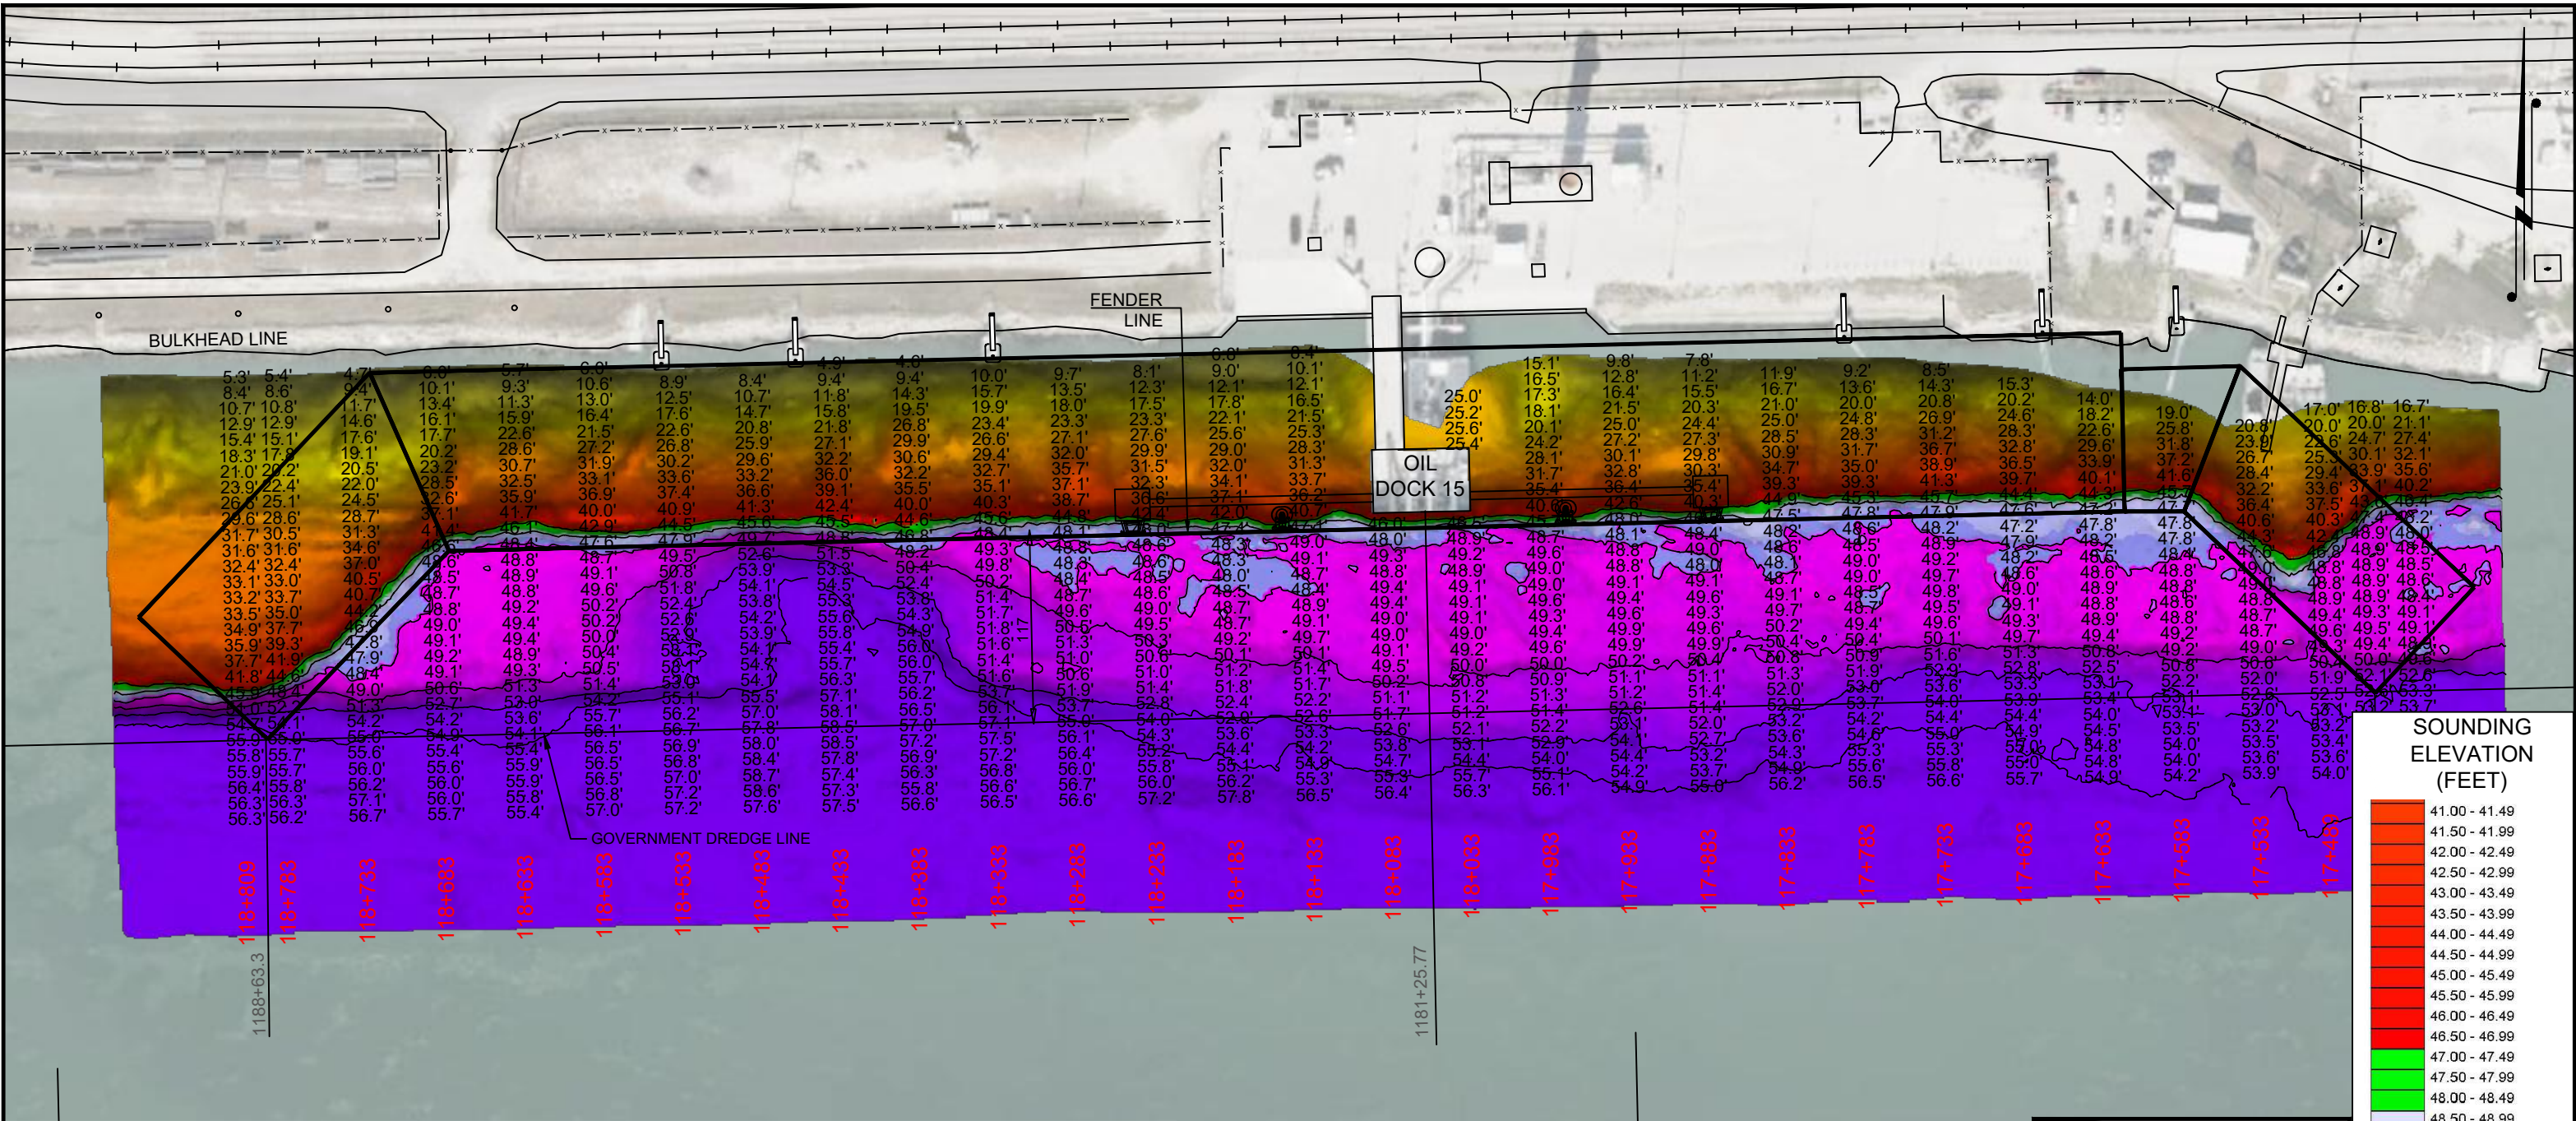
SHEET NO: 1 OF 1

- SOUNDINGS WERE RECORDED BY T BAKER SMITH ON 24 APRIL, 2025.
- SEA FLOOR CONDITIONS ARE SUBJECT TO CHANGE.
- THE PORT OF CORPUS CHRISTI ASSUMES NO LIABILITY FOR THE ACCURACY OF THIS INFORMATION. THE INFORMATION DEPICTED ON THIS MAP REPRESENTS THE RESULTS OF SURVEYS MADE ON THE DATE DEPICTED AND CAN ONLY BE CONSIDERED AS INDICATING THE GENERAL CONDITIONS AT THAT TIME. THESE CONDITIONS ARE SUBJECT TO RAPID CHANGE DUE TO SHOALING EVENTS.
- ALL READINGS ARE BASED ON THE NATIONAL OCEANIC AND ATMOSPHERIC ADMINISTRATION (NOAA) MEAN LOWER LOW WATER (MLLW) DATUM, (O.O')
- HORIZONTAL DATUM: NAD-83, STATE PLANE, TEXAS SOUTH ZONE, US FEET.
- TO GET THE DEPTH OF WATER, ADD THE CURRENT TIDE LEVEL TO THE READINGS SHOWN. (SEE TIDE DATUM CHART).
